### **COUNCIL MEETING**

**Meeting Date: Tuesday, 5 March 2019**

**SUBJECT:** CAPE KIDNAPPERS HAZARD MANAGEMENT

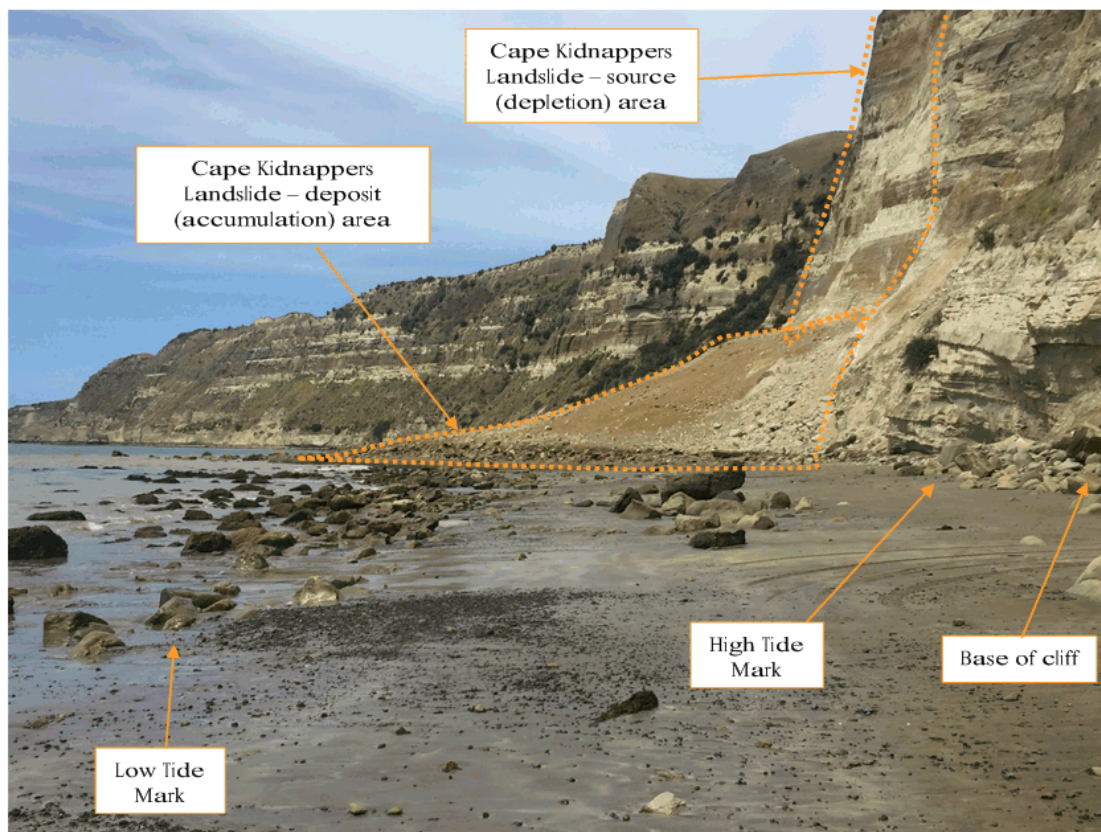
Rockfall deposits of various ages are present on the beach, at the base of the cliffs.

Figure 2-5: A view looking east along the beach at the landslide location (taken at low tide, 25 January 2019)

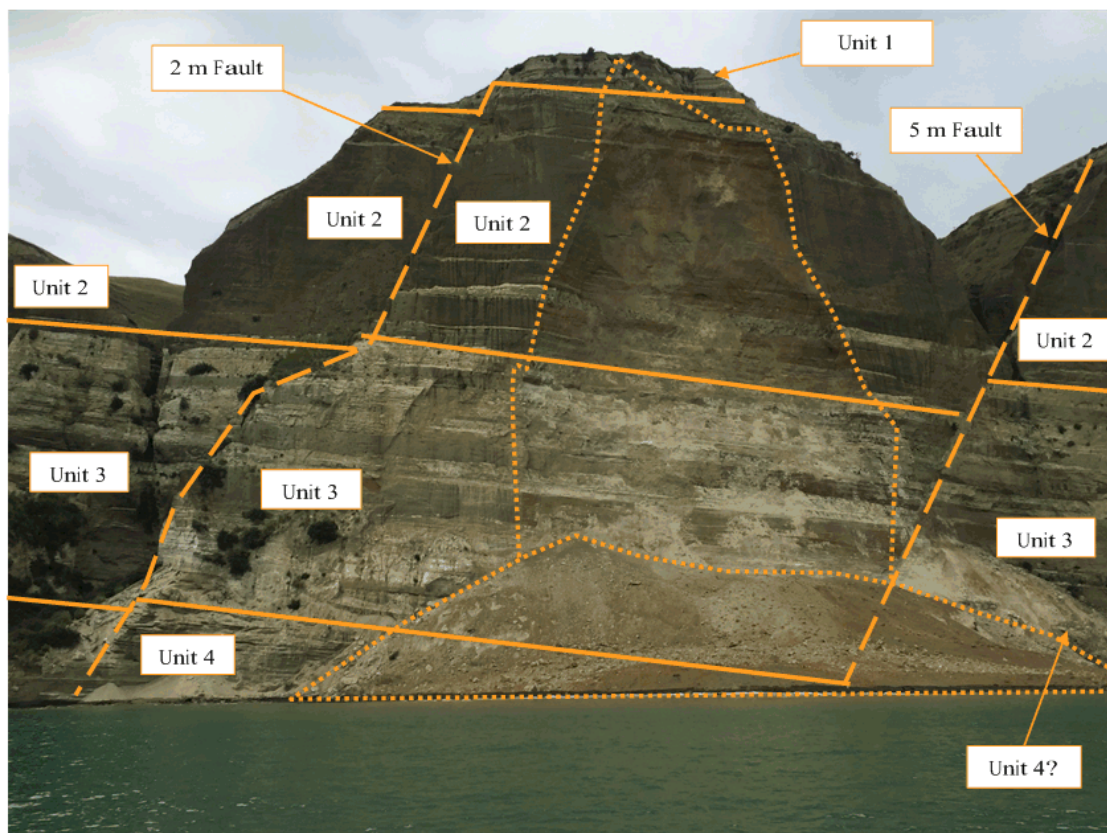
- Unit 4 – Sandstone – present within the very base of the cliff only. Variable, being a siltstone locally. These materials are slightly weathered and of very weak intact strength.

Figure 2-8: Geotechnical units within the cliff (25 January 2019)

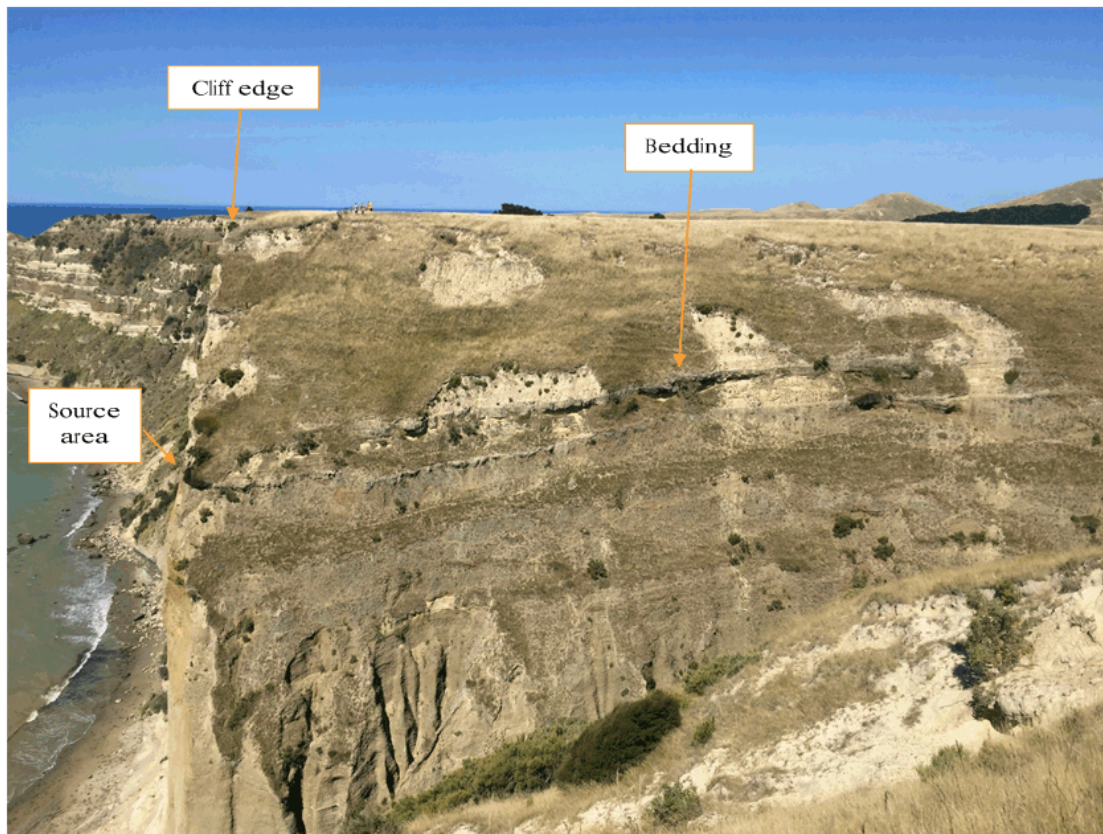
Bedding was measured to dip at  $12^\circ$  towards the northwest (slightly higher than the published map value of  $8^\circ$ ). This is obliquely (indirectly) out of slope (Figure 2-9). Bedding is flatter towards the east (Black Reef).

Figure 2-9: Bedding within the CKL cliff, viewed from the west, dipping obliquely out of slope (5 February 2019)

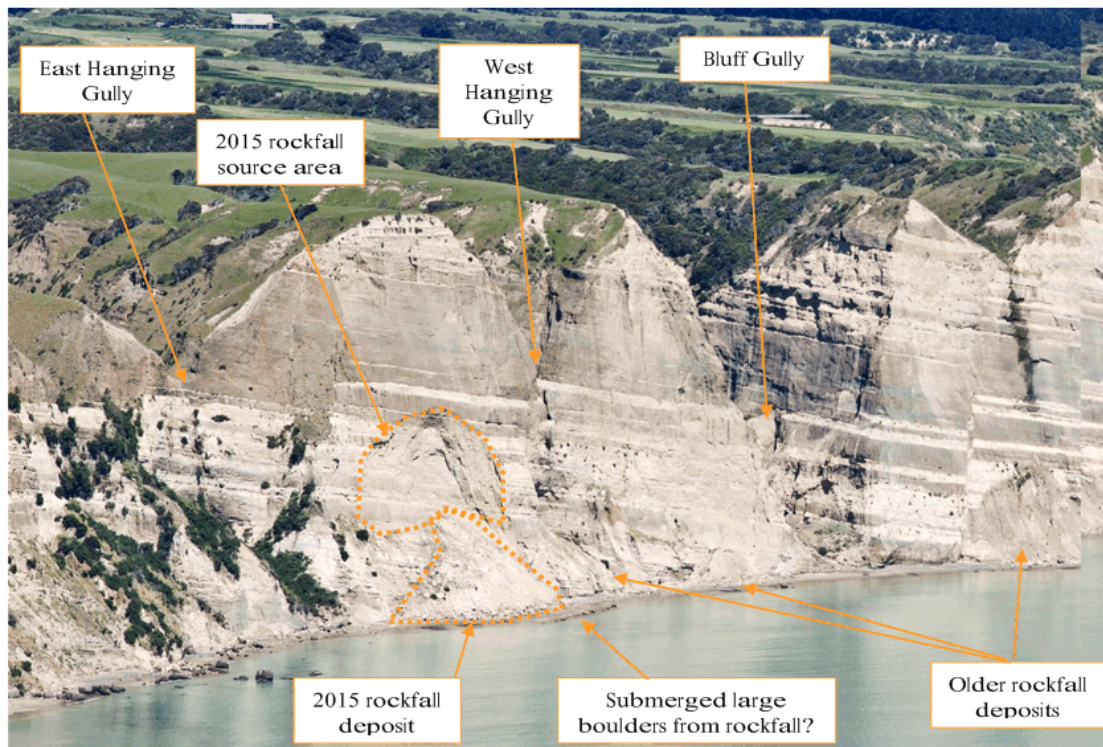
Figure 4-3: The location of the CKL viewed in October 2018, showing the earlier 2015 rockfall source area and deposit

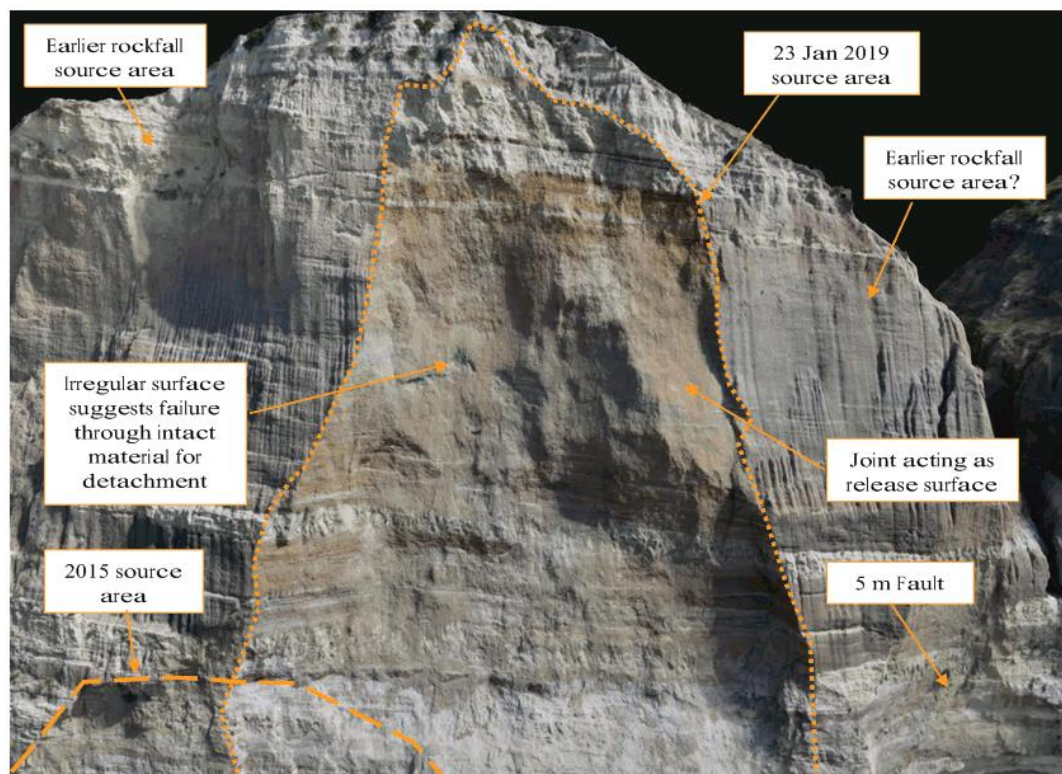
Figure 4-5: Oblique view of the rockfall source area, looking south (25 January 2019)

- The maximum width of the source area was 70 m.
- The elevation difference (height) of the source area was 110 m.
- The maximum thickness of the source area appears to have been around 15 m.
- Detachment at the source area appears to have occurred largely through intact material. Locally, there is evidence that some joints may have acted as the detachment/release surface (Figure 4-6).

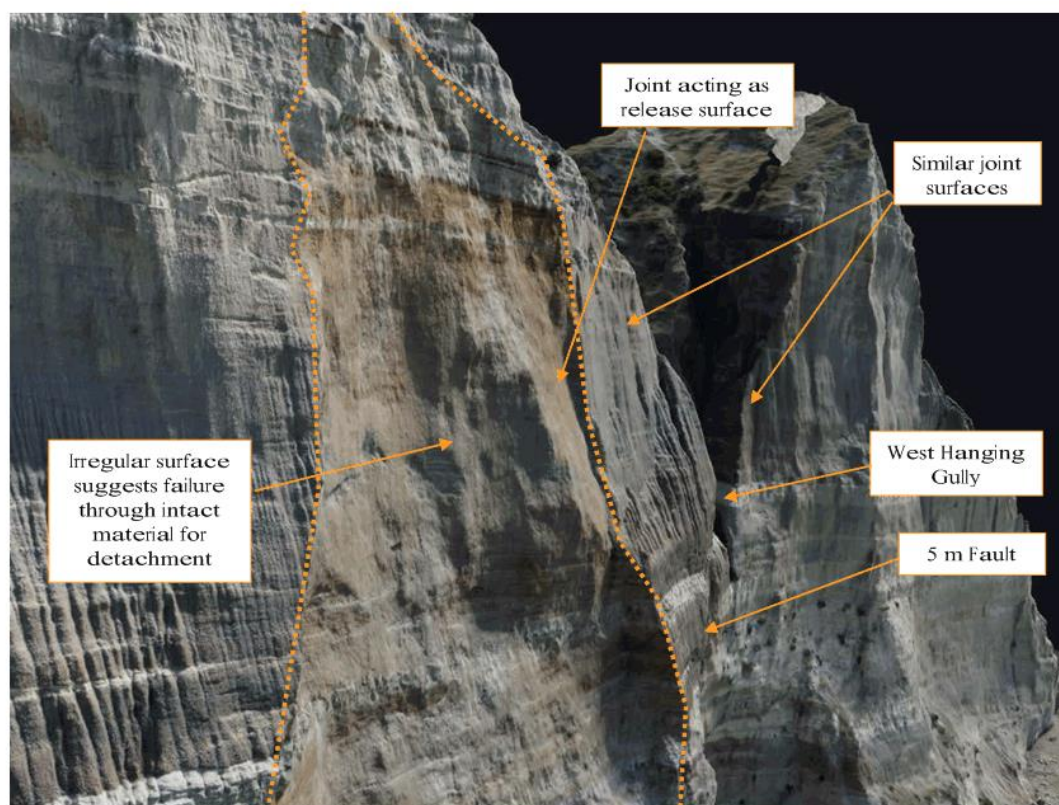
- The CKL had a source area volume of approximately 25,000 m<sup>3</sup>. The source area was largely the mid to upper two thirds of the cliff and primarily occurred in conglomerate interbedded with some tuff. Failure appears to have been through the 'intact' rock material and does not appear to be significantly controlled by rock mass defects, such as joints. Locally however, some joints may have acted as the release surface for the rockfall.

Figure 4-6: Oblique view of the rockfall source area, showing pre-existing rock defects that acted as release surfaces (25 January 2019)

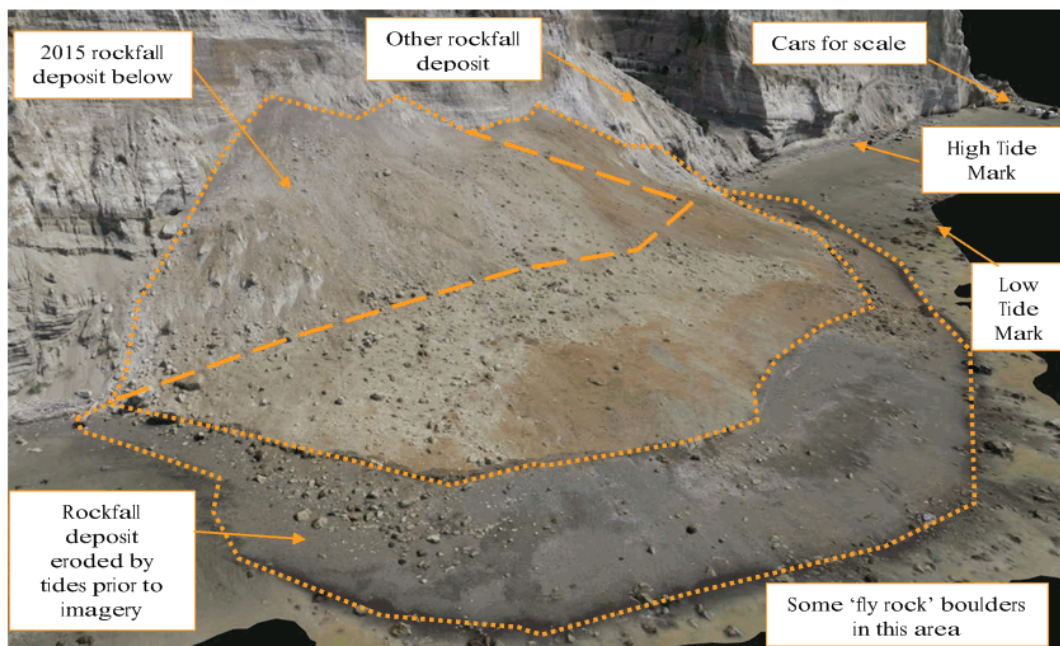
- There is no information available for the impulse wave generated as the rockfall deposit displaced the sea.
- The source area material was dry to moist at the time of failure, based upon the significant dust cloud generated.

Figure 4-7: Oblique view of the rockfall deposit, looking southwest (25 January 2019)

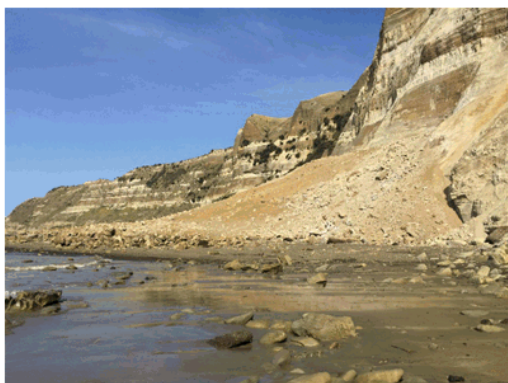
Figure 4-8: Rockfall deposit viewed on the 28 January 2019 from the west

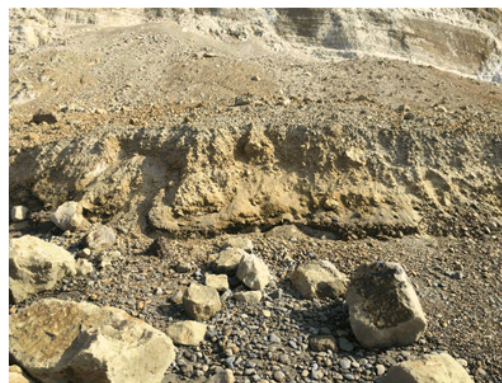
Figure 4-9: Example of the rockfall deposit following erosion, viewed on the 28 January 2019

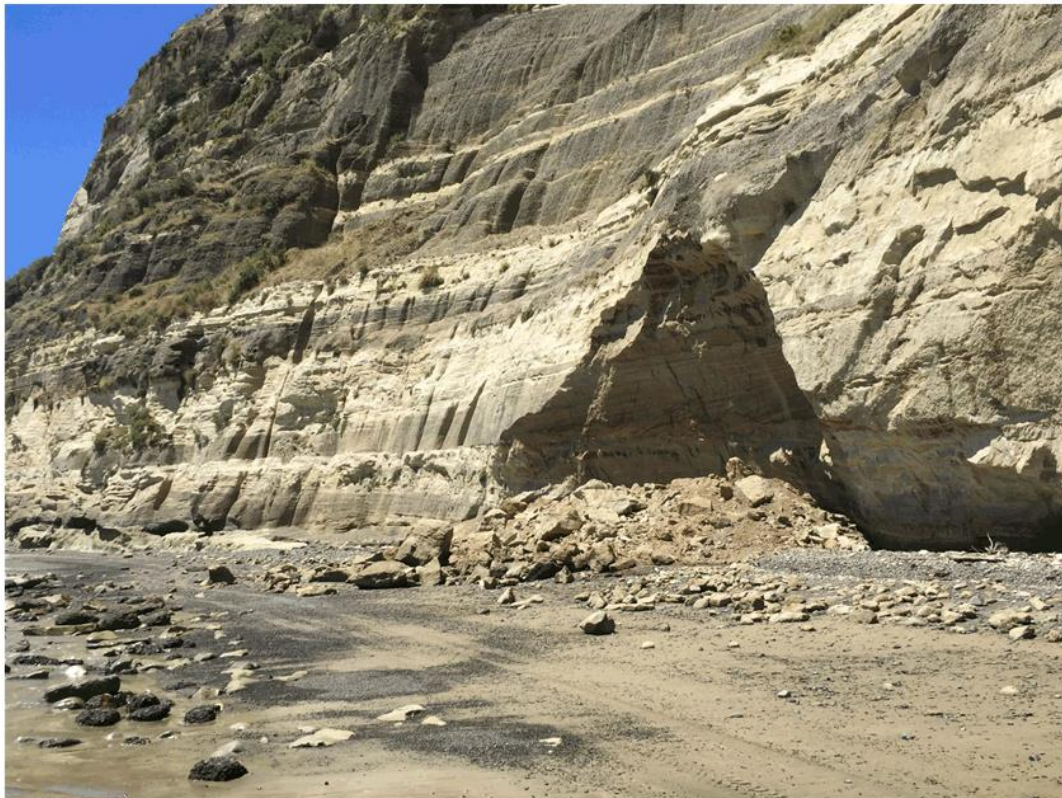
Another cause which should be investigated would be the effects of the overall climatic trends leading up to the landslide (i.e. hot and dry, potential desiccation or loss of strength of materials).

Figure 4-10: An example of recent landsliding triggered by erosion at the toe of the slope, location around 500 m east of the CKL (5 February 2019)

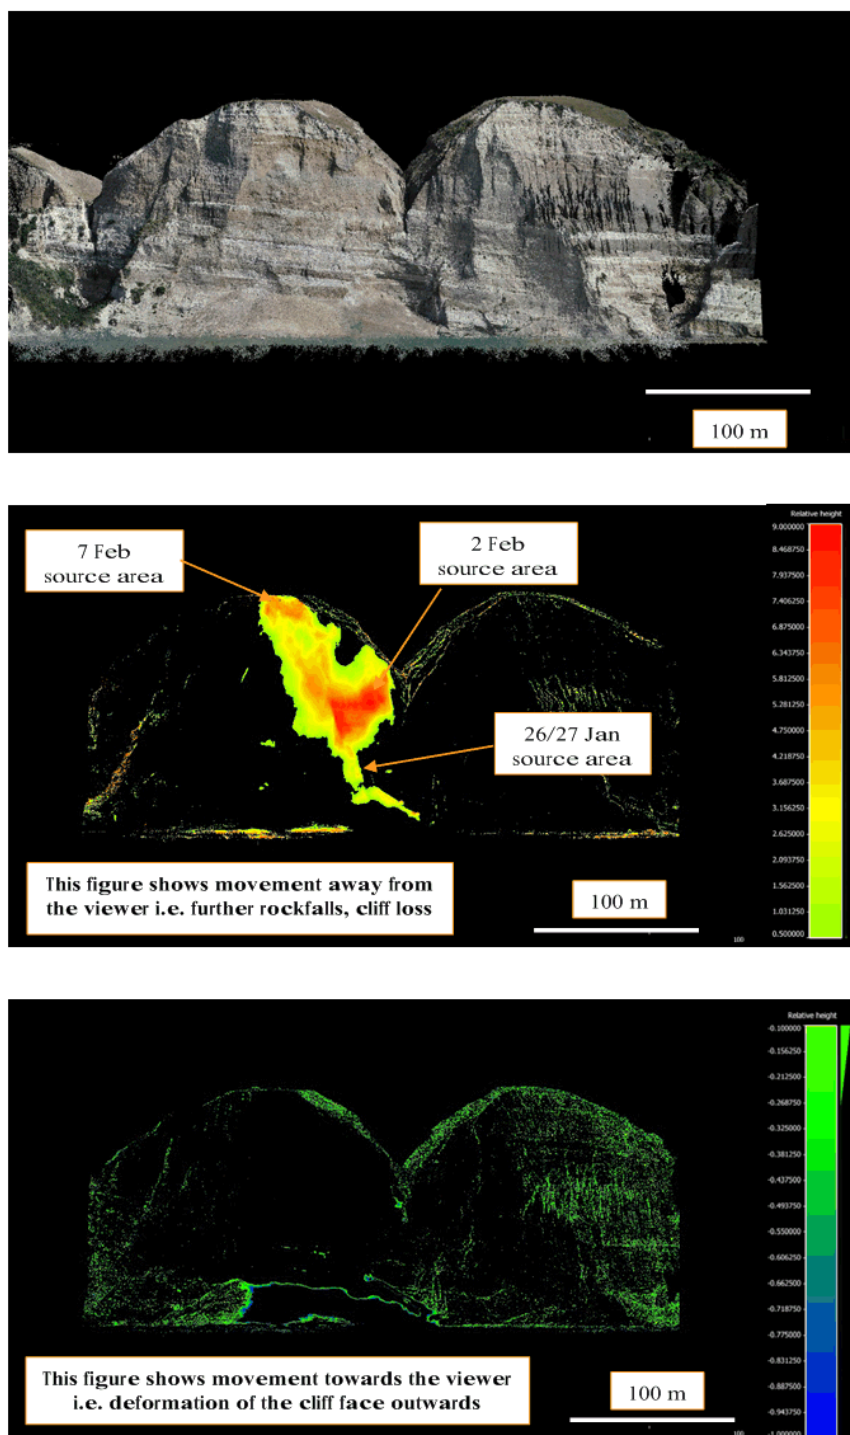
Figure 5-2: Elevation changes in the CKL between the 25 January 2019 and 8 February 2019 (scale m)

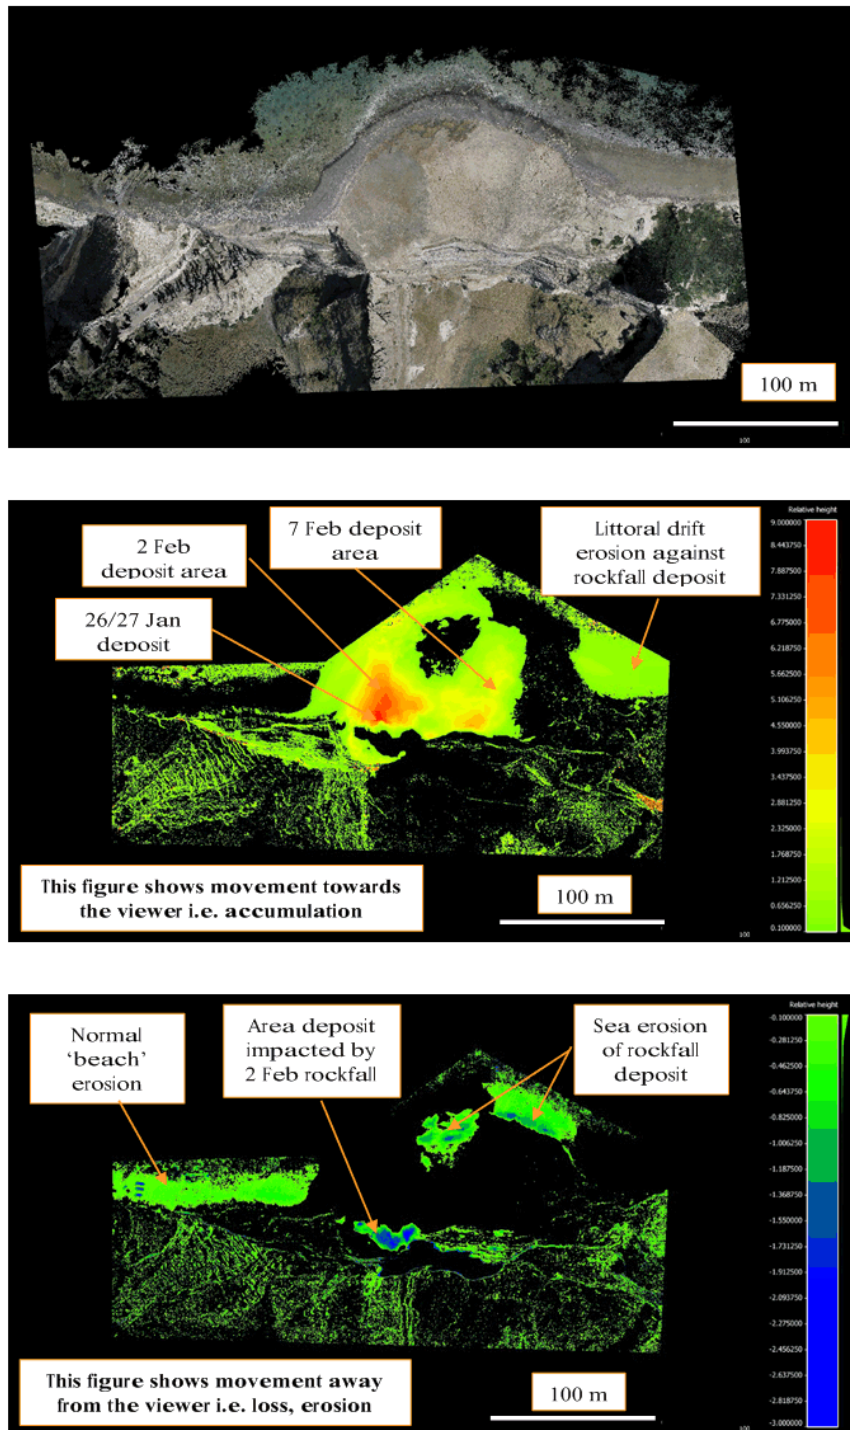
Figure 5-3: Plan changes in the CKL between the 25 January 2019 and 8 February 2019 (scale m)

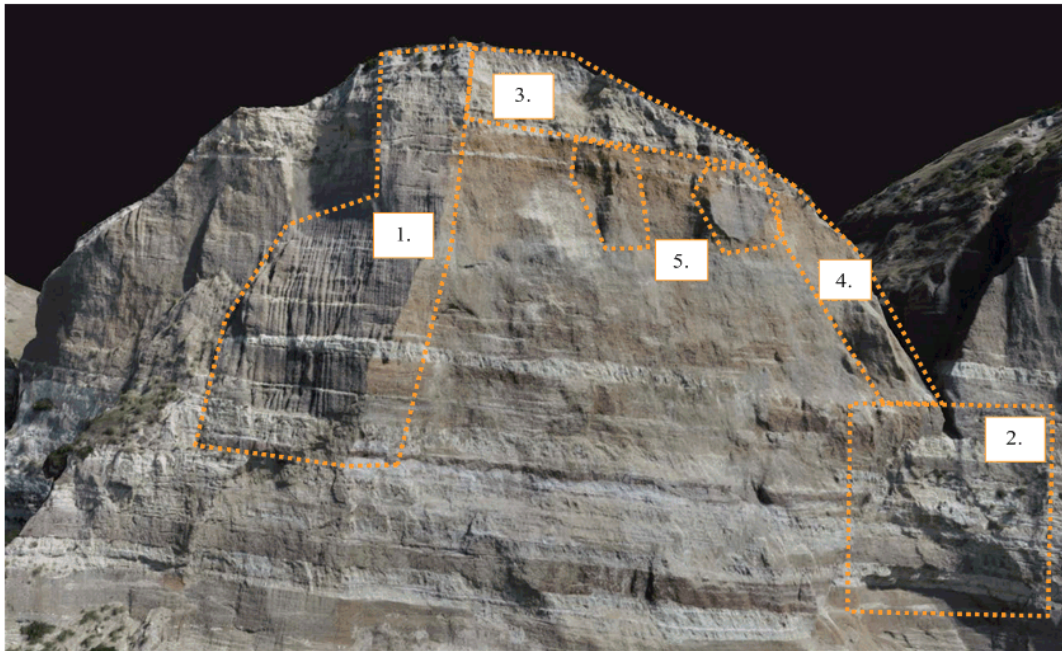
Figure 5-4: Key areas of likely future changes in the CKL source area (image 8 February 2019)

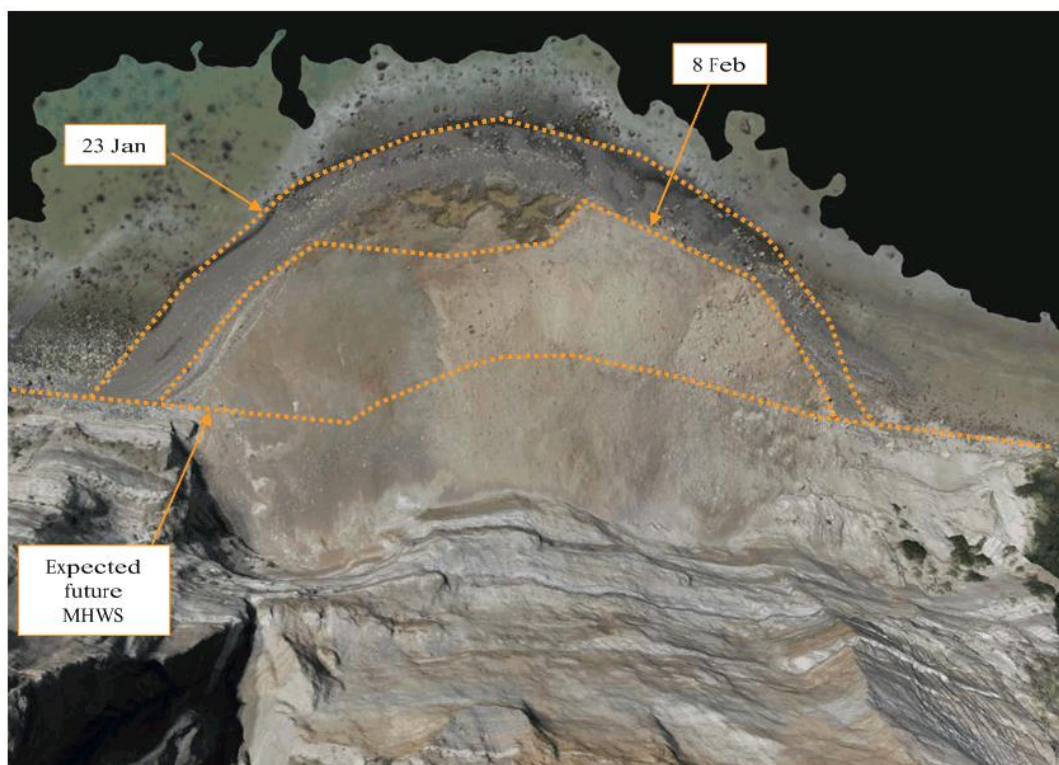
The current rate of landsliding will reflect current climatic and marine conditions. This may change in the future, as a result of climate change (sea level rise and increased storminess). The current 'baseline' may not therefore be the future 'baseline'.

Figure 5-5: Key areas of likely future changes in the CKL deposit area (image 8 February 2019)

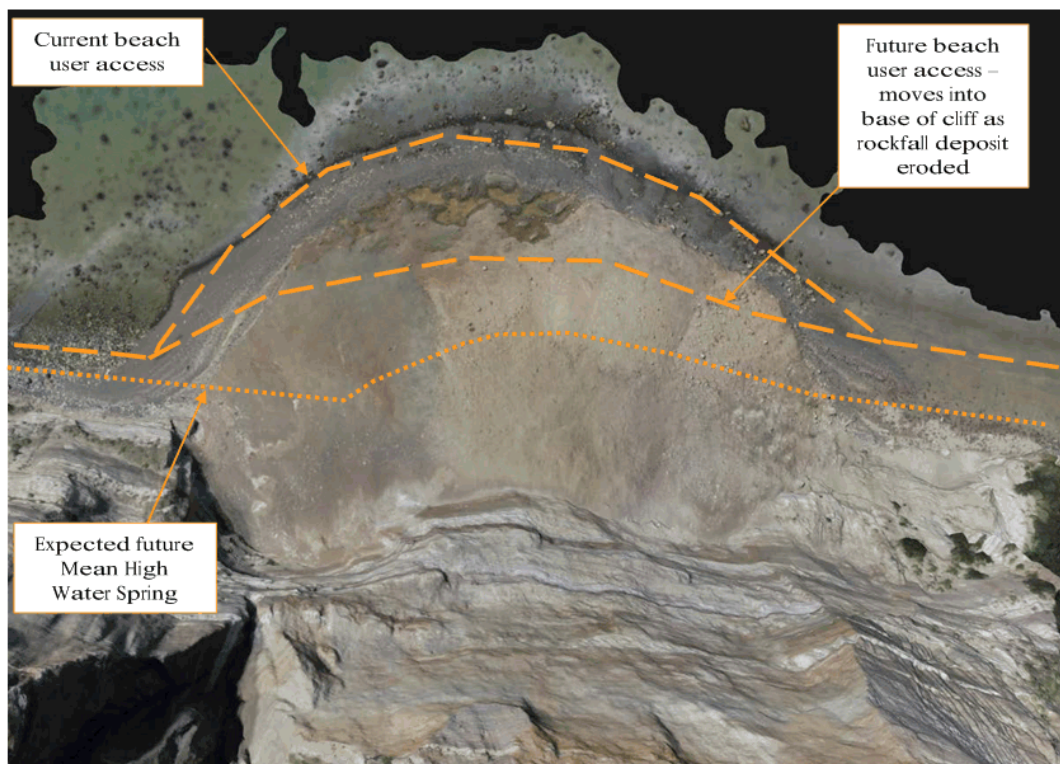
- Large volume rockfalls are not a necessity to cause injury or a fatality. Even a small rockfall, of less than 1 m<sup>3</sup>, could cause an injury or a fatality, considering the site characteristics (i.e. high steep cliffs and the potential for people to be at the base of the cliff considering the beach width).

Figure 6-1: How changes to the rockfall deposit impacts beach user risk

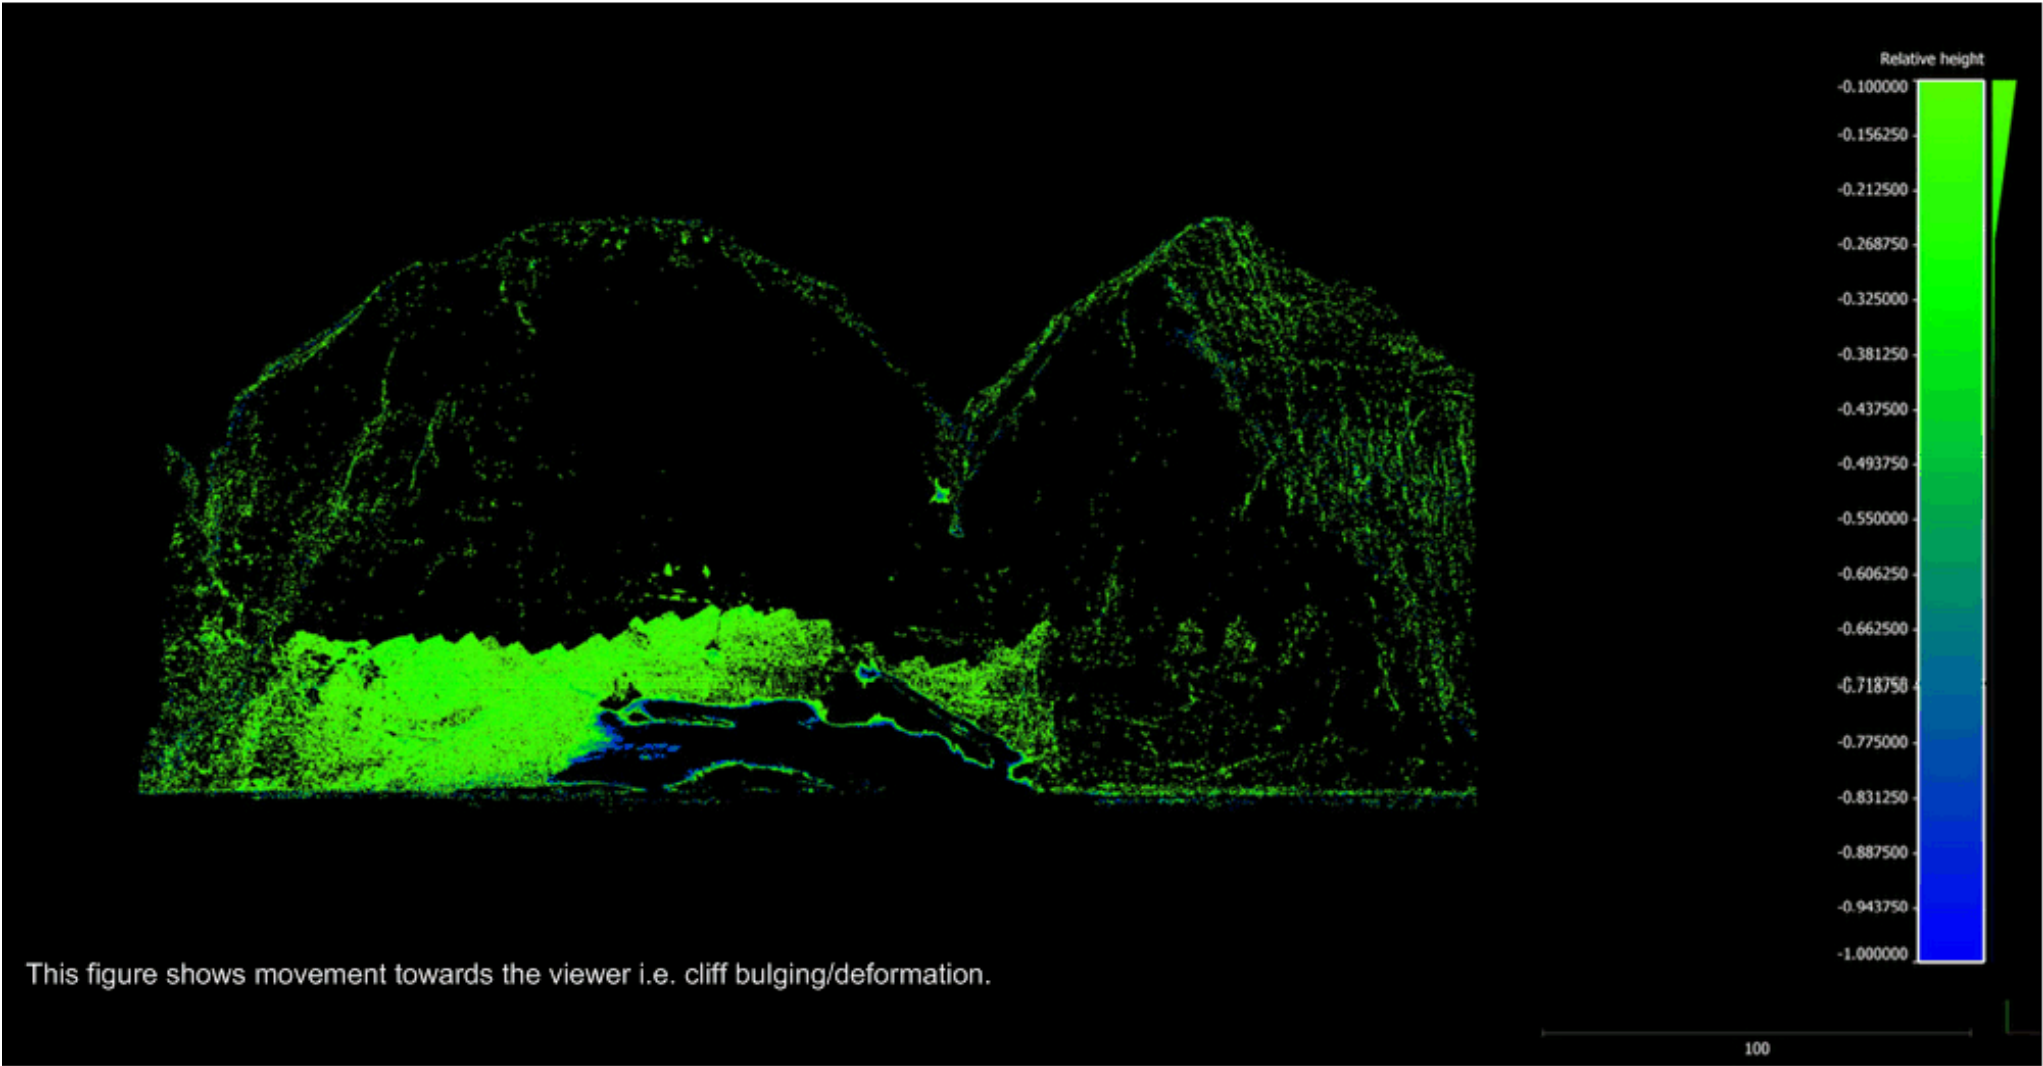
This figure shows movement towards the viewer i.e. cliff bulging/deformation.
