Review of Whakatu Wastewater Overflow - Final Report

Review of the Whakatu Wastewater overflow on Thursday 23 June 2022 (SH5 between Station Road and Railway Road)

EAST CLIVE WASTEWATER TREATMENT PLANT – Non-compliance with Condition 5b of Discharge Consent AUTH-120712- 01 (CD130214W)

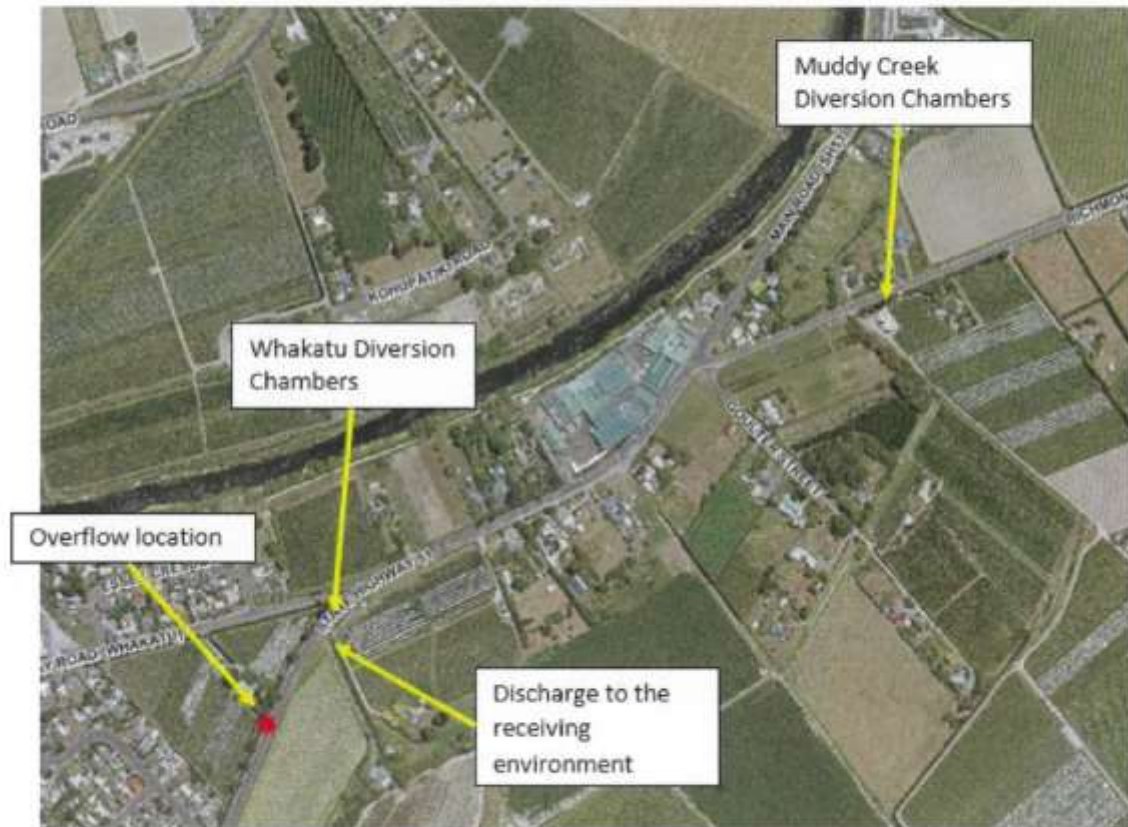
Appendix 3

- 7) The media release summarises the cause of this spill. The Council was undertaking a routine automatic sewer mains flushing operation which involves closing off the flow of sewage in one of the 'residential' mains and allowing a 'backup' to occur, gravity builds pressure in the pipe and the gate (valve) is then automatically released at 10.00am or earlier if the high level alarm is activated providing a significant flow that helps to scour any sewer pipe accumulations. On 23rd June 2022 the No3 gate at the 'Muddy Creek' penstock automatically closed at approximately 0800/0815. It was assumed that mains power on, however that was not the case because at 0901 the mains power outage at "Muddy Creek" penstock began (mains power was restored to this site at 1415). This mains power outage resulted in the "Muddy Creek" penstock No3 gate not being opened in the normal manner. The power outage also meant the high level alarm was not activated. This caused the flow of sewage to continue to build up in the pipe until it reached the lower ground surface level at the Whakatu orchard gates on the State Highway 51/Railway Road intersection where there are lidded sumps and penstocks – Aerial photo overview attached as Appendix 3.

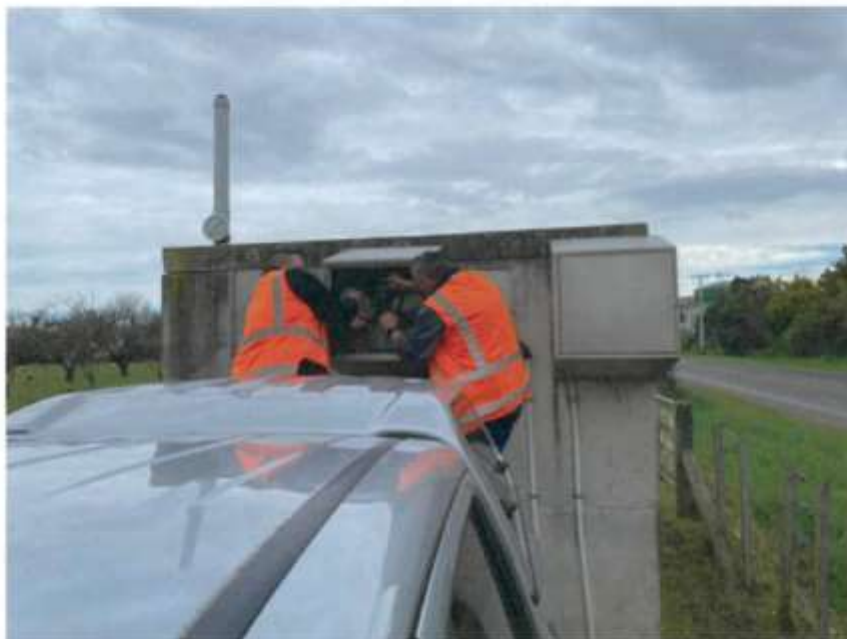
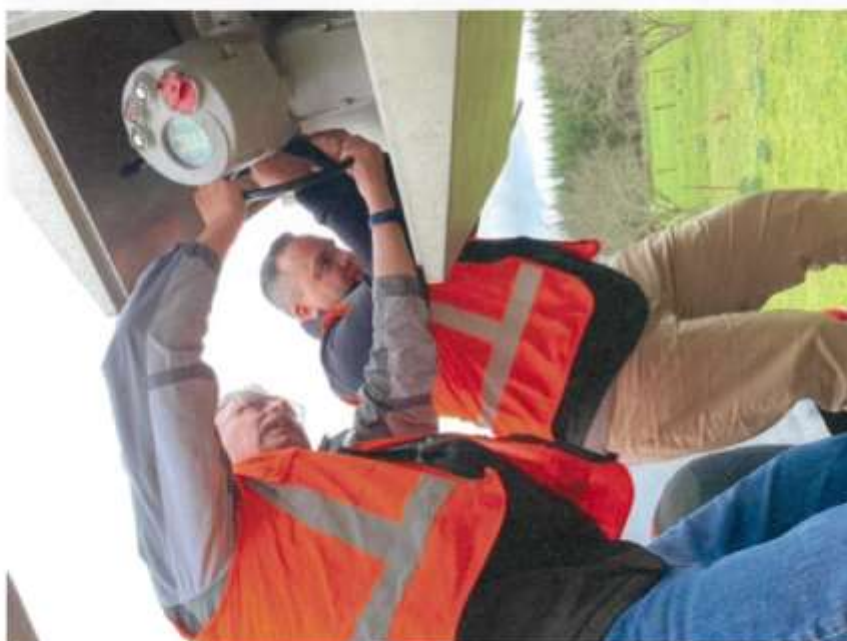
Appendix 5

26) The manual controls at the "Muddy Creek" penstocks are not easy to operate manually. Currently, the opening/closing of these gates manually requires a vehicle deck to be available for staff to stand on, also the manual wheel used to operate the geared screw to open/close the gate appears to be small and difficult to turn. Photograph attached as Appendix 5. It is noted that head pressure above any gate increases the effort required in the opening and closing process of gates and this can be significant in the manual mode. Ease of operation is essential to eliminate the risk of failing to open/close a gate manually when required (especially in urgent circumstances).

- 31) Critical alarm systems require an alternative power supply. Review all critical risk assets.
- 32) Upgrade the 'Muddy Creek' penstock manual controls to ensure ease of operation and safety of all staff and contractors.

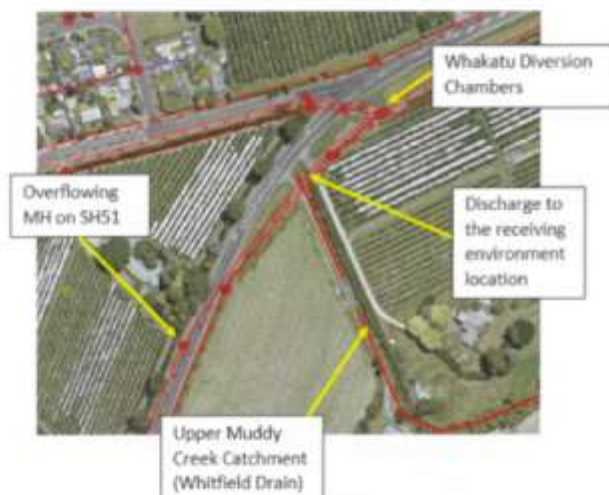
1. On the 23rd June 2022 around midday, Hastings District Council were alerted to a wastewater overflow on SH51 near Whakatu. Operations staff and Council's 3 Waters Maintenance Contractor attended the site and found wastewater overflowing from a manhole on SH51 discharging into the Whitford Drain (upper Muddy Creek system).

Figure 4: Whakatu wastewater overflow site & discharge to environment site

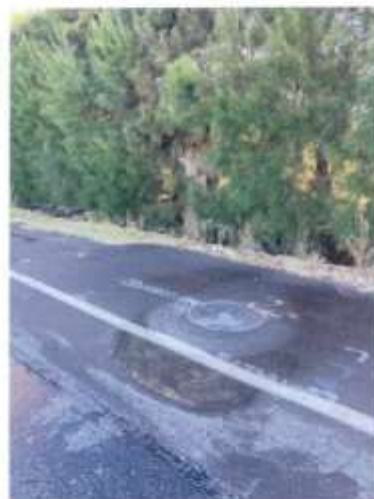
Figure 4: Overflow location SH51

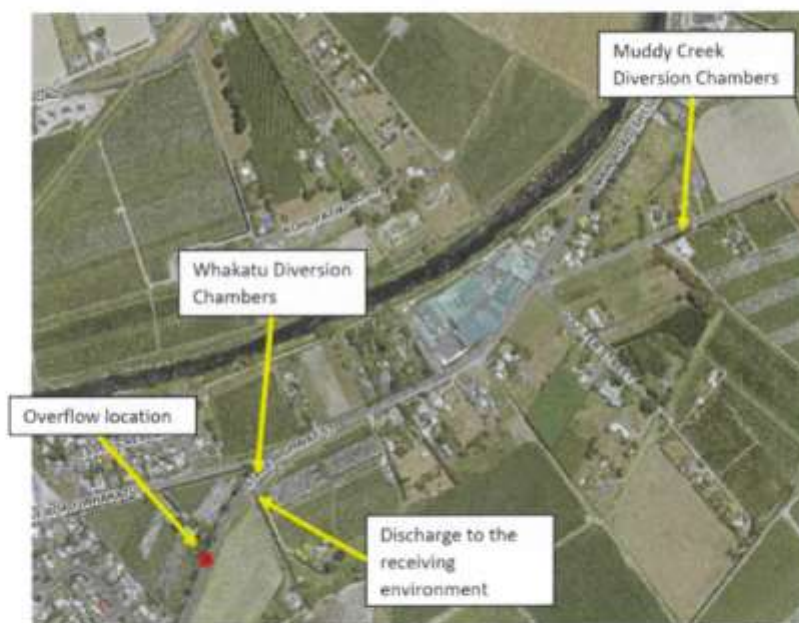
Figure 5: Whakatu wastewater overflow site & diversion chambers locations

2. A closed gate on the domestic sewer (Inland Trunk #3) at the Muddy Creek Diversion Chambers was found to be cause of the overflow into the Whitford Drain (upper Muddy Creek catchment). A power outage interrupted a routine wastewater flushing operation on the domestic sewer (Inland Trunk #3) at the Muddy Creek Diversion Chambers, disabling automatic gate function, resulting in wastewater backing up into the network over a number of hours and eventually overflowing at the lowest point in the network, a manhole on SH51 near Whakatu.

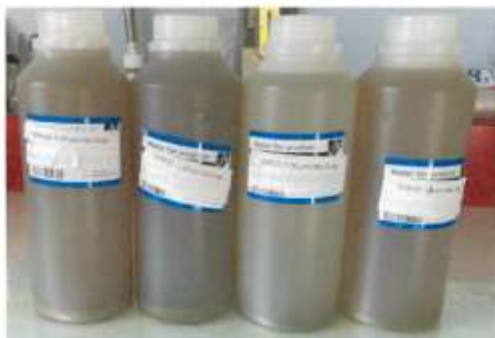
5. An increase in the industrial wastewater influent flow was observed at the East Clive WWTP for a duration of approximately 60 minutes between 1:30pm and 2:30pm (see below graph). Industrial wastewater influent samples were taken every 30mins between 1pm – 2:30pm to determine the duration and impact of the domestic wastewater diversion into the industrial sewer (see below summary table – lab results attached).

Figure 6: East Clive WWTP industrial influent samples @ 1pm, 1:30pm, 2pm & 2:30pm

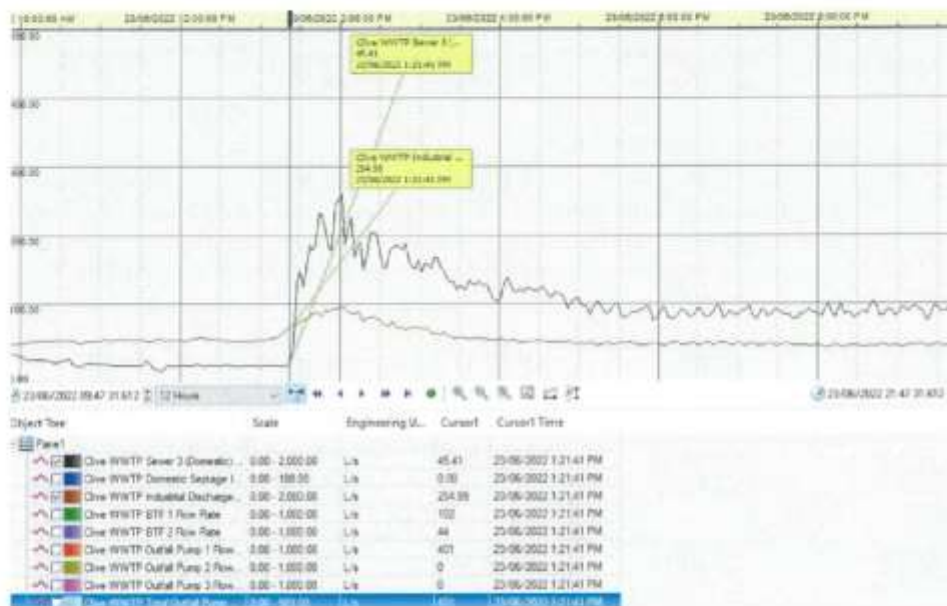
Figure 7: East Clive WWTP Influent flow rates on 23rd June 2022

Time	1pm	1:30pm	2pm	2:30pm
Flow	Industrial flows normal indicating domestic WW yet to arrive	Elevated industrial flows indicating a potential presence of domestic WW in industrial flow	Elevated industrial flows indicating a potential presence of domestic WW in industrial flow	Elevated industrial flows indicating a potential presence of domestic WW in industrial flow
Colour	Normal – control sample	Darker – Indicating a potential presence of domestic WW in industrial flow	Lighter – Indicating a potential presence of domestic WW in industrial flow	Normal – Indicating NO presence of domestic WW in industrial flow
Influent Characteristics	Normal characteristics	No noticeable difference of analytes from normal Influent characteristics	No noticeable difference of analytes from normal Influent characteristics	No noticeable difference of analytes from normal Influent characteristics
Summary	No presence of domestic WW in industrial flow	Presence of domestic WW in industrial flow	Presence of domestic WW in industrial flow	No presence of domestic WW in industrial flow
