COMMISSIONER HEARING

ITEM	SUBJECT	PAGE
2.	CRAGGY RANGE TRACK REMEDIATION HEARING	
	<u>Document 3</u> Containing these attachments	
	Public Notice	Pg 1
	Description of Proposal and Assessment of Environmental Effects	Pg 3
	Applicant response to request for clarification (use for hearing)	Pg 115

Land Use Consent Application – Craggy Range Walking Track Removal, Waimarama Road, Havelock North

Appendix B – Landscape and Visual Effects Report

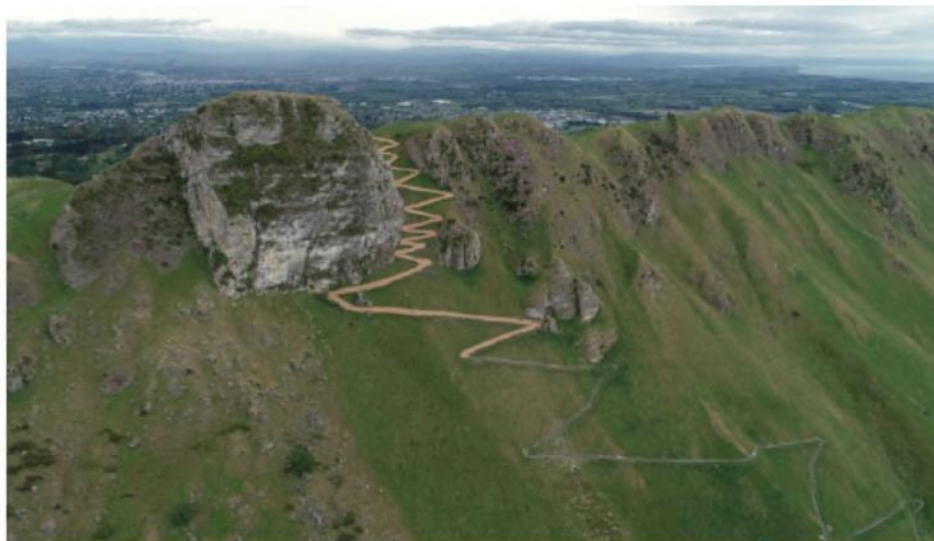
The upper section of track was removed (as Emergency Works pursuant to section 330 of the RMA) in late October/early November 2018 and is shown covered in coconut (BioCoir) matting in Figure 4 and Figure 5, with part of the remaining track visible below that. This is the subject of a separate resource consent application and is not part of this application.

Figure 4: Drone Photograph of coconut (BioCoir) matting covered emergency works from south east 9/11/2018

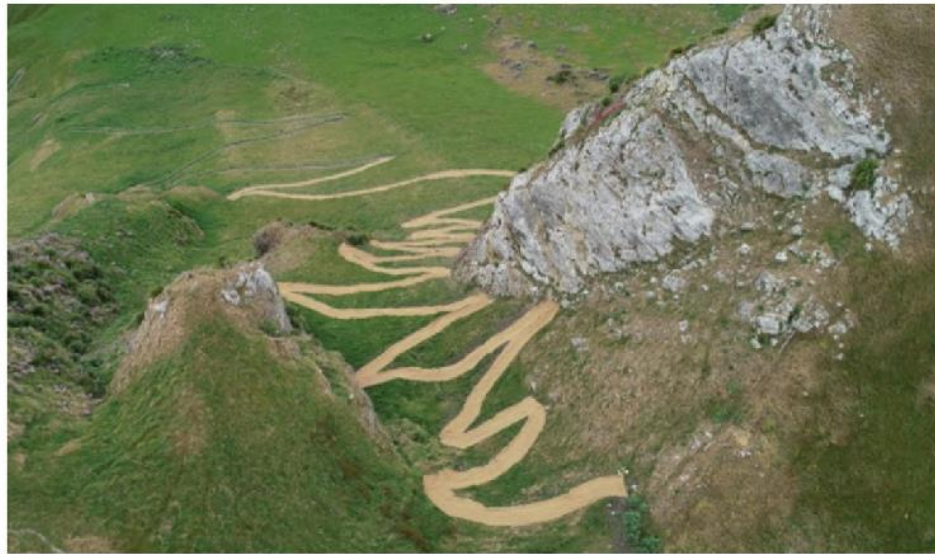
Figure 5: Drone Photograph of coconut (BioCair) matting covered emergency works from above 9/11/2018

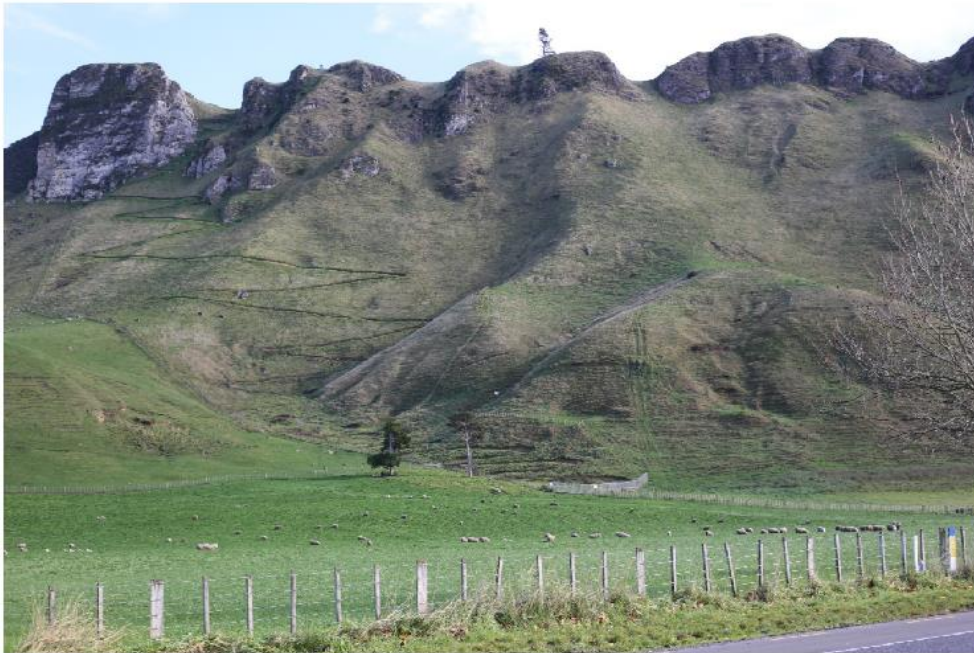
Figure 1 – Photo of installed track (June 2018)

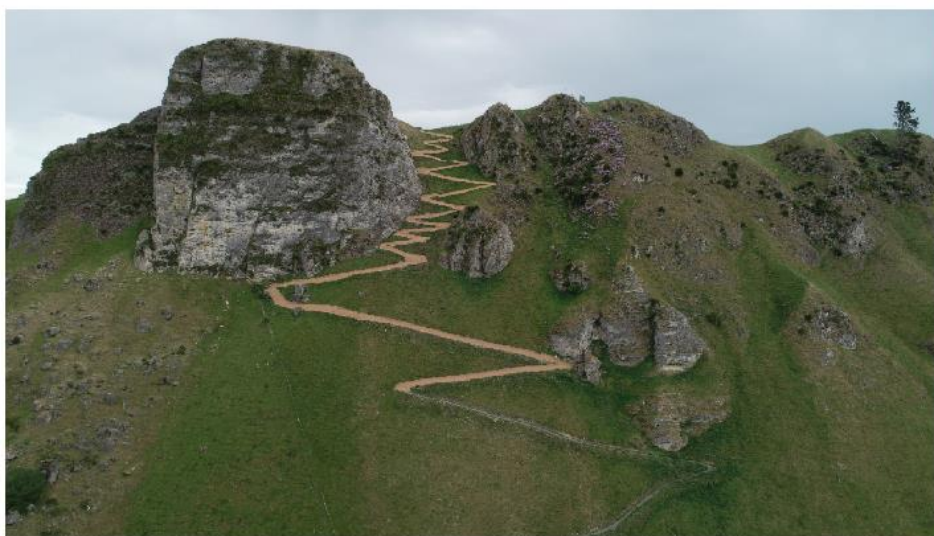
Figure 2 – Photo of remediated upper section of the track (November 2018)

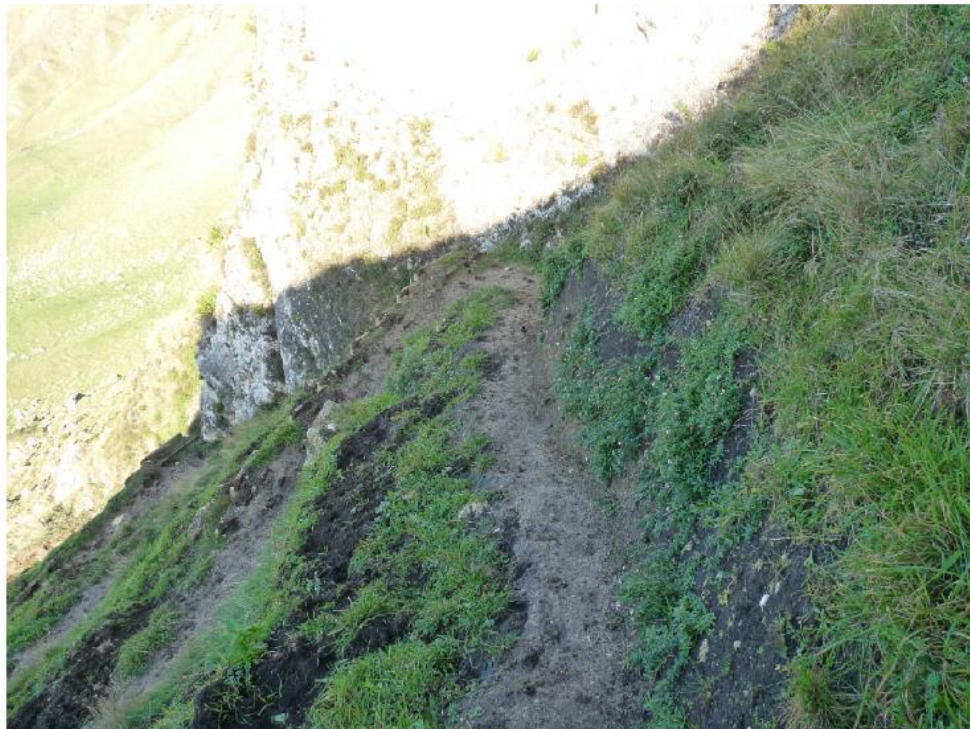
In these earlier visits, the zigzag track was highly visible when viewed from a distance, such as from Tukituki Road on the eastern side of the valley, or close range from Waimarama Road and environs. The raw track surface, the zig zag alignment and the activity on it with heavy public use all contributing to the track's prominence (Figure 10).

Figure 3 – Upper section track condition – July 2018

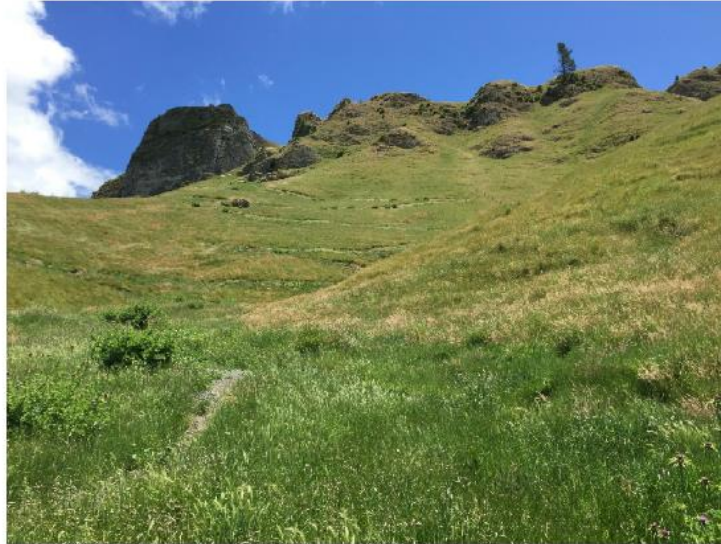
Tall pasture on both the upper and lower edges of the track had masked its presence in many places and the previously prominent zigzag had disappeared along many stretches (Figure 11). Weeds, especially thistles, dock, dandelion were also present, especially on track edges and on the side-cast material of the middle and lower track sections (Figure 12 and 13). Flat weeds were also becoming established on the actual track surface.

Figure 11 – Existing track amongst long grass

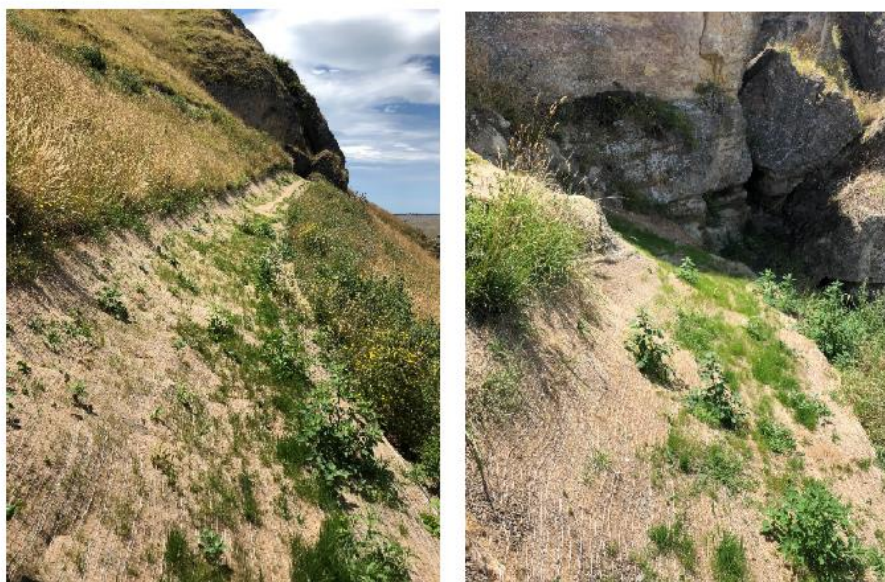
As with Section D, the upper section of the track, the introduction of the BioCoir matting on Sections B and C will be a temporary measure, however this will accentuate the alignment of the track on the eastern escarpment. This is a temporary measure which will begin biodegrading at 6 months and will continue to degrade amongst dominating grass cover over a period of up to 5 years. Recent examples of growth on the remediated section of the track (Section D) demonstrates the rapid grass and weed growth through the matting.

Figure 21 – View of Section D of track – January 2019

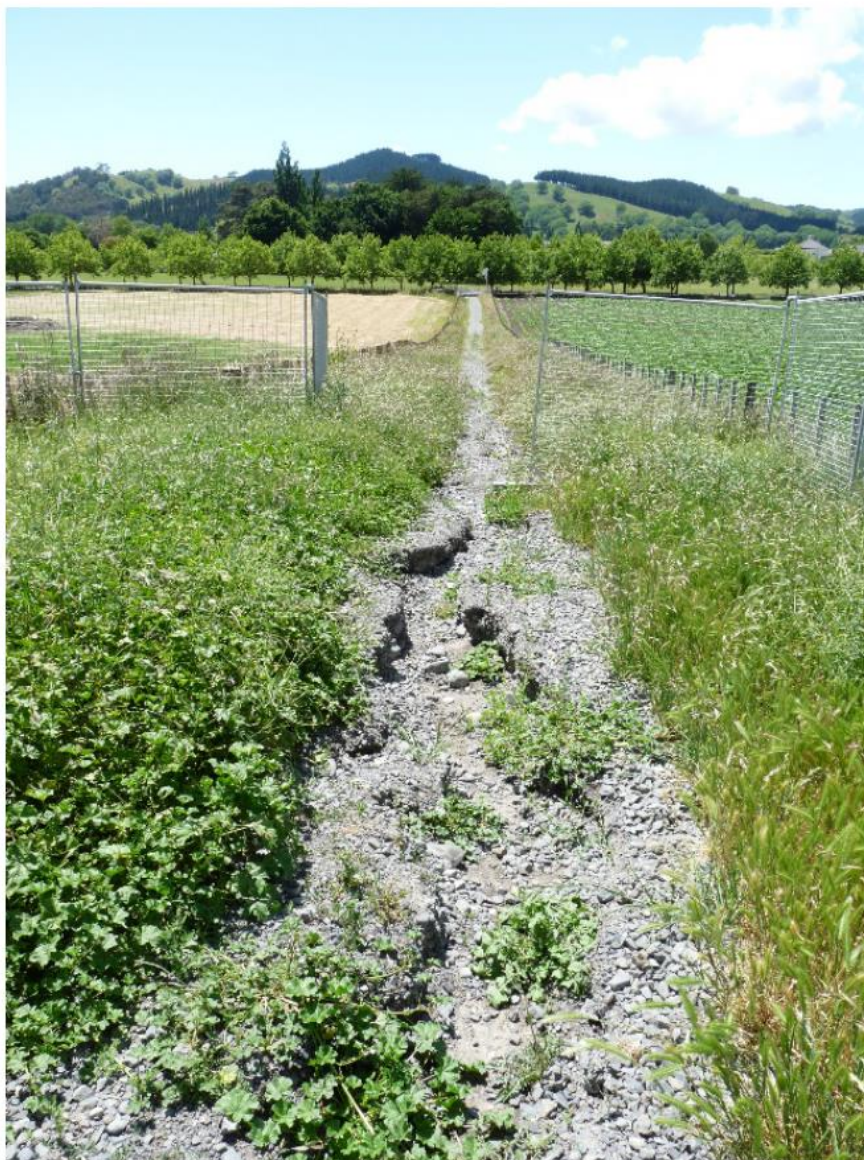
Section A of the track will not require BioCoir matting due to the flat gradient. A silt dominated topsoil will be placed on the site and seeded with a productive pasture mix dominated by ryegrass (Refer to Appendix 4). This will see this area visually integrate within 1-2years with a dominant pasture cover in three years.

Figure 22 - View of Section A track condition (October 2018)

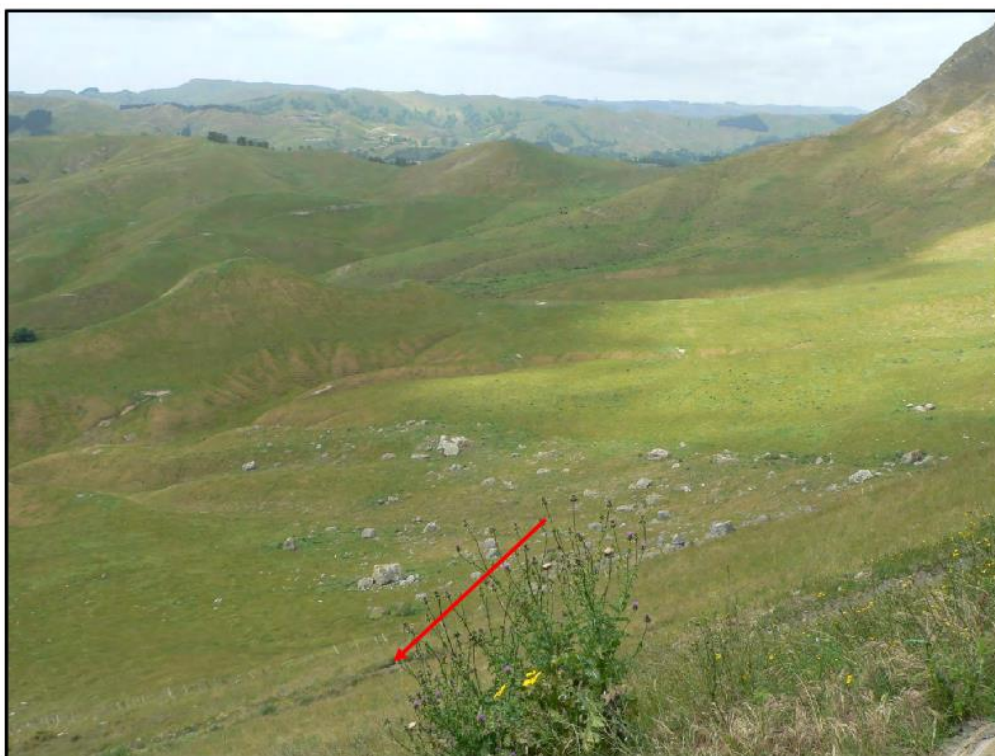
Observing the wider landscape it was evident that there was a large area immediately adjacent to the track that would have lent itself to occupation. Despite the long grass obscuring the ground, it did appear that there were several potential pit clusters in this area, along with possible terracing on several of the ridge spurs. This area lies within < 50 m of the 'Zig Zag' track, a distance that *kainga* and their associated features are understood to frequently have extended from any observable surface evidence.

Location identified as represented by recorded sites V21/180 and V21/182 location in relation to the track (red arrow).
