Hastings District Council

NOTIFIED RESOURCE CONSENT APPLICATION FOR PROPOSED MEDIUM DENSITY RESIDENTIAL LIVING IN THE HASTINGS CENTRAL COMMERCIAL ZONE - 206 QUEEN STREET WEST, HASTINGS (RMA20220352)

3-WATERS SERVICING REPORT 206 QUEEN STREET WEST HASTINGS

DETAILED SITE INVESTIGATION

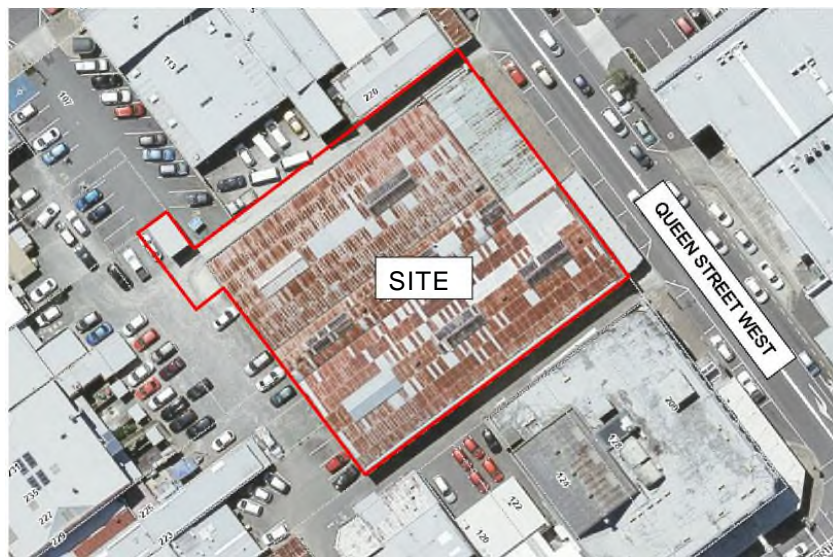
Figure 1: Site Location

The site is located at 206 Queen Street in Hastings, as shown in Figure 1. Vehicular access to the site will be via Queen Street West.

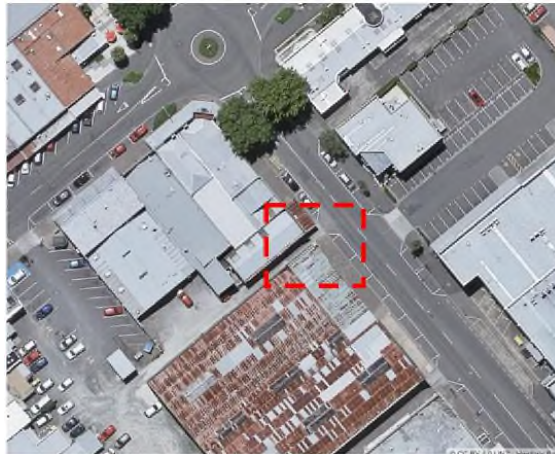
Figure 3: Existing vehicle access point

The site is intended to be served with a single vehicle access point, using the existing vehicle access from Queen Street West, as shown below in Figure 3.

At this access location, the footpath runs hard up against the building line, and intervisibility can be restricted between exiting vehicles and users on the footway.

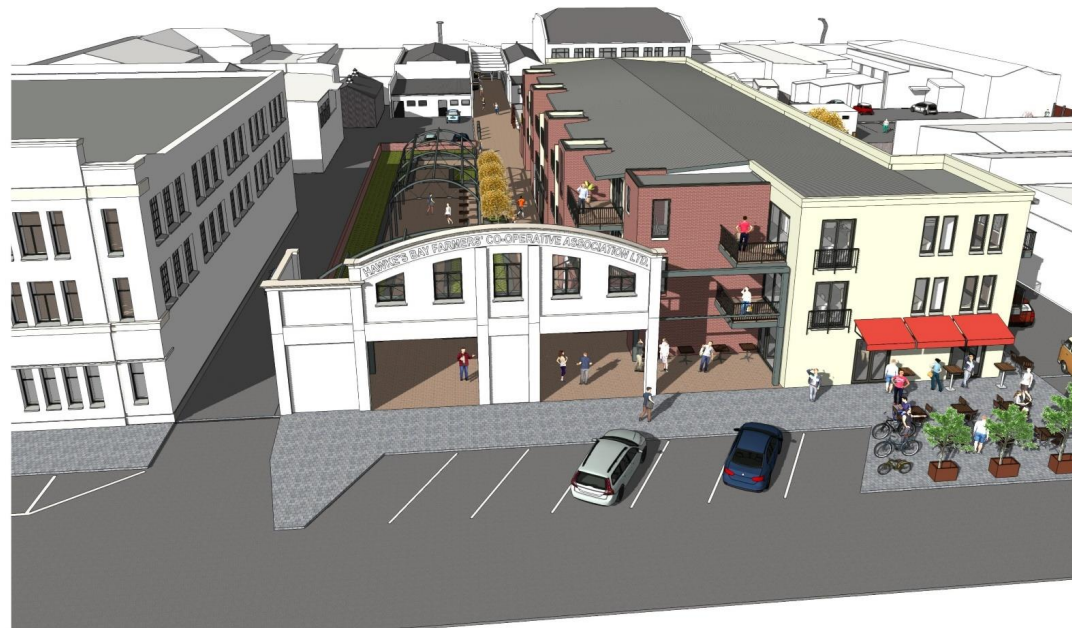
drawing
PA03

AERIAL VIEW

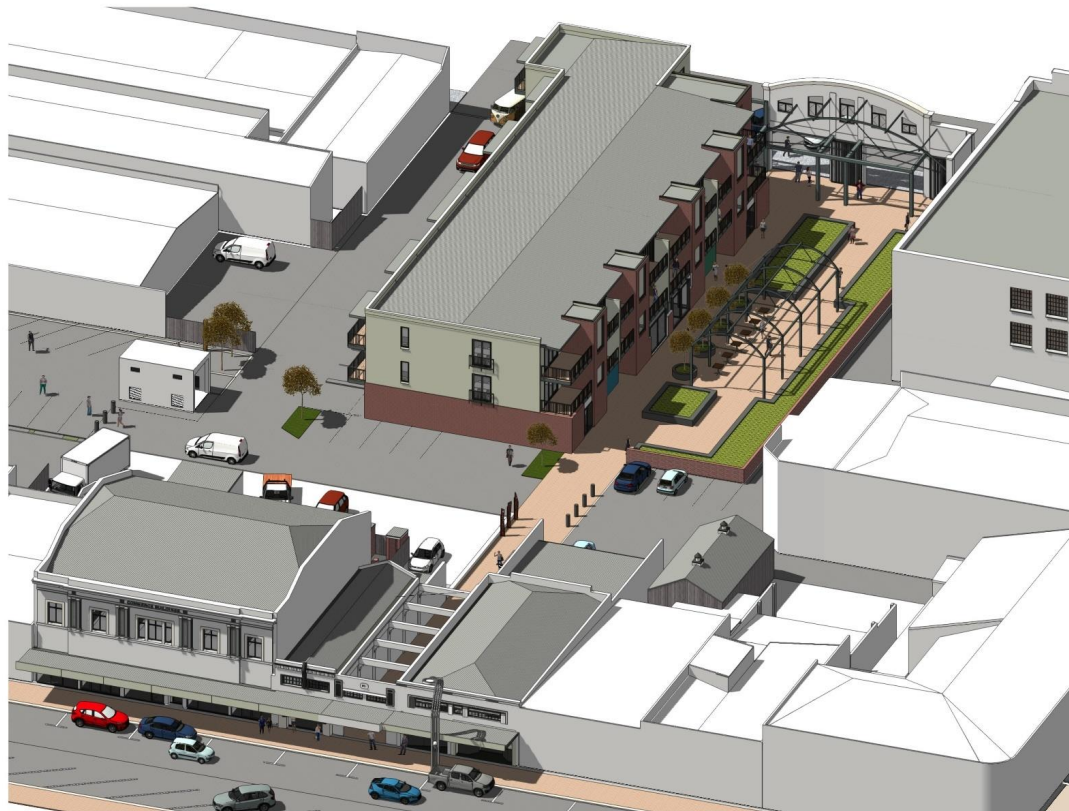
drawing
PA04

AXONOMETRIC VIEW

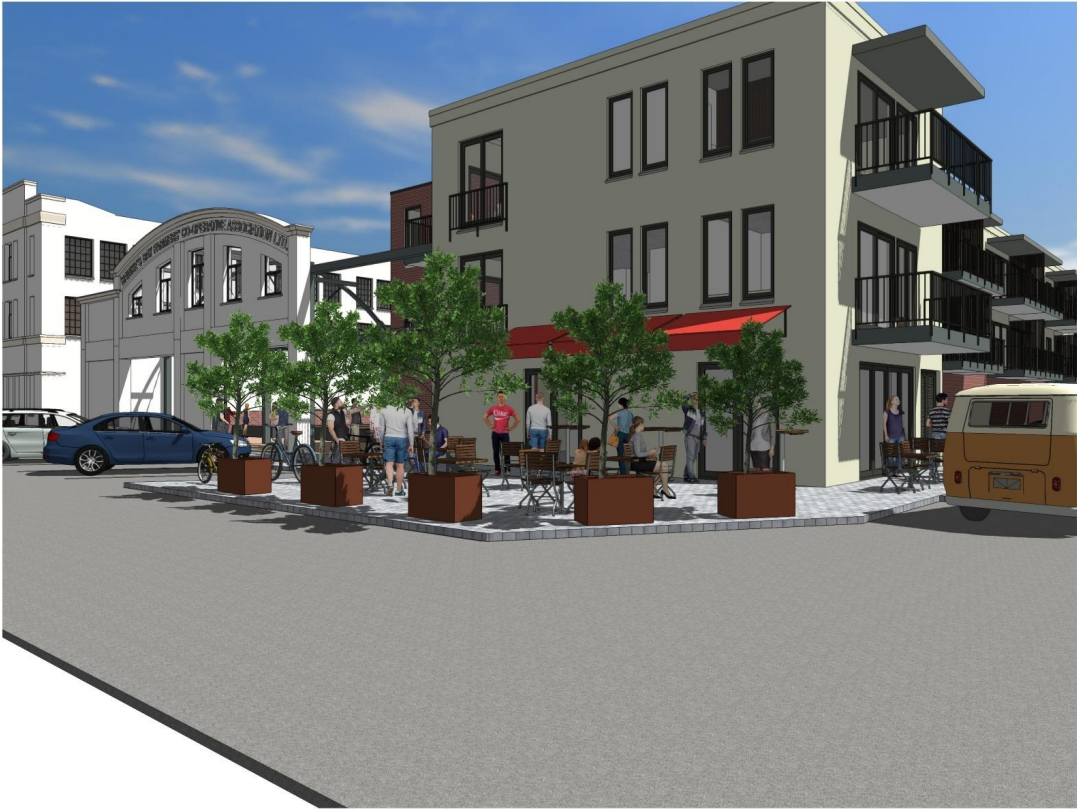
drawing
PA10

QUEEN ST VIEW

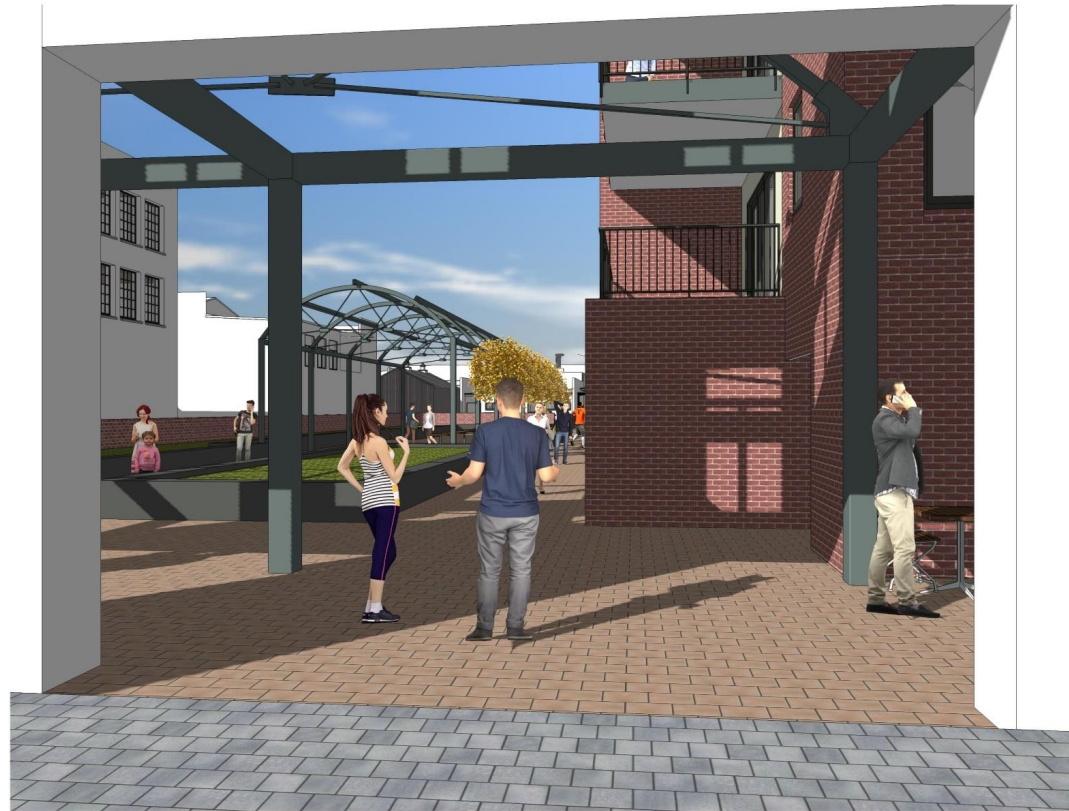
drawing
PA11

QUEEN ST LANEWAY ENTRY VIEW

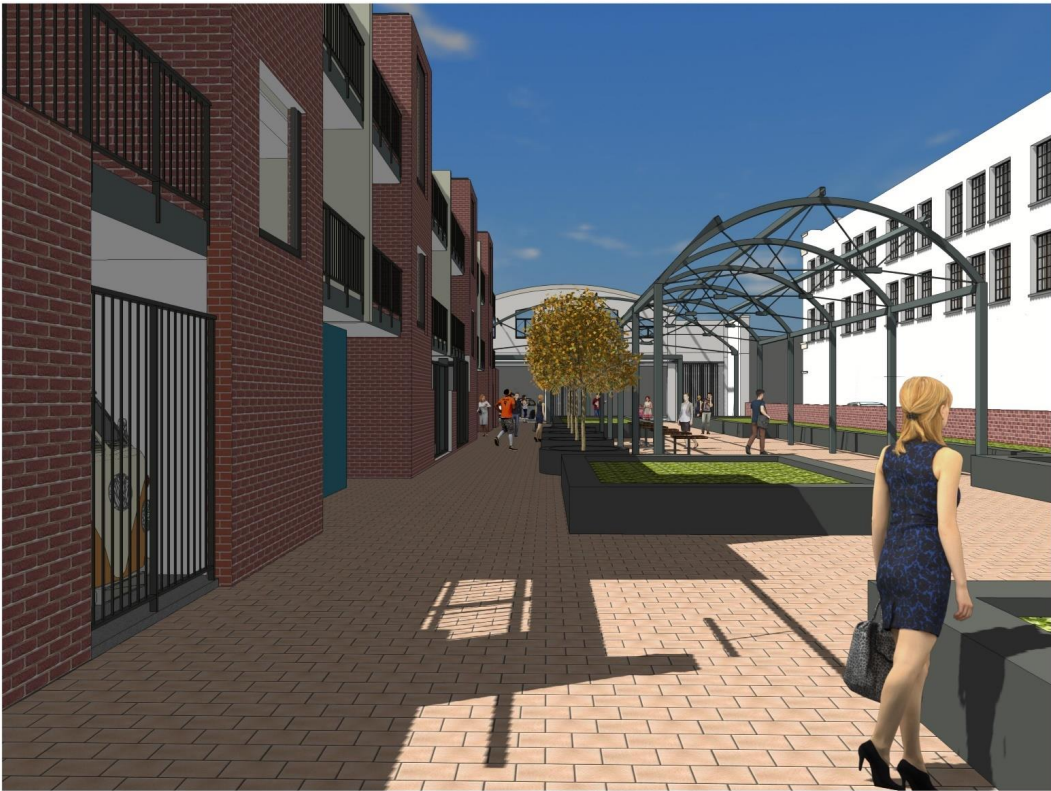
drawing
PA12

LANEWAY VIEW

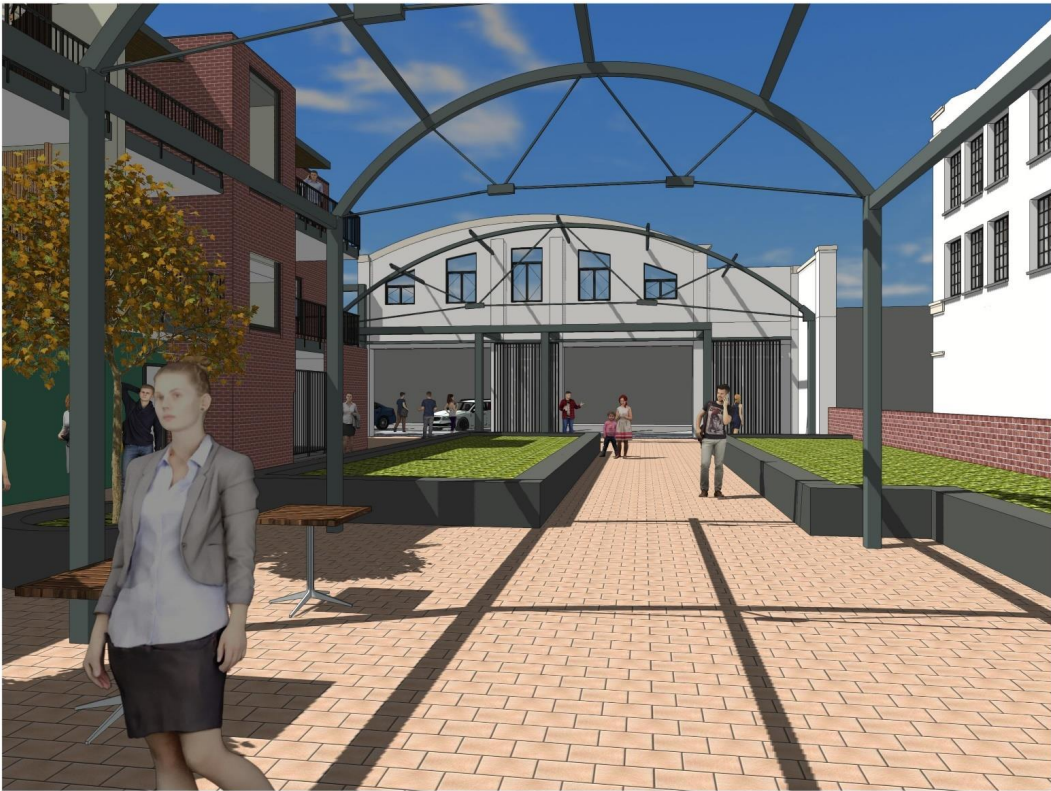
drawing
PA13

PARK VIEW

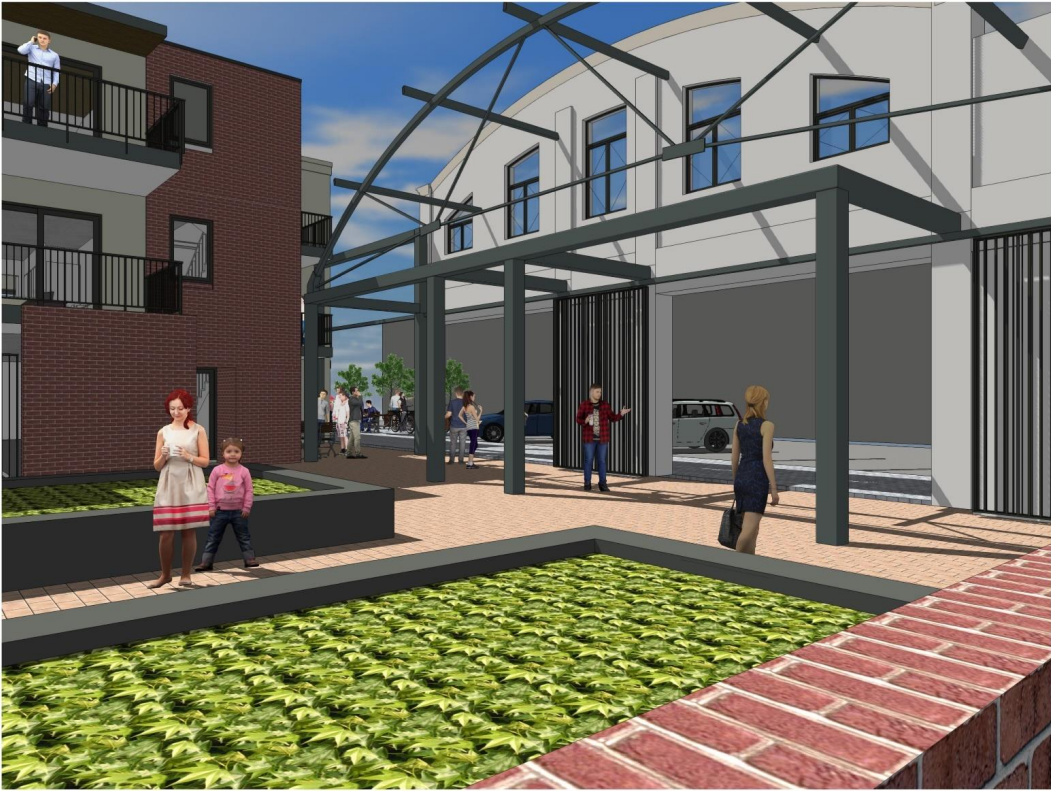
drawing
PA14

PARK FACADE VIEW

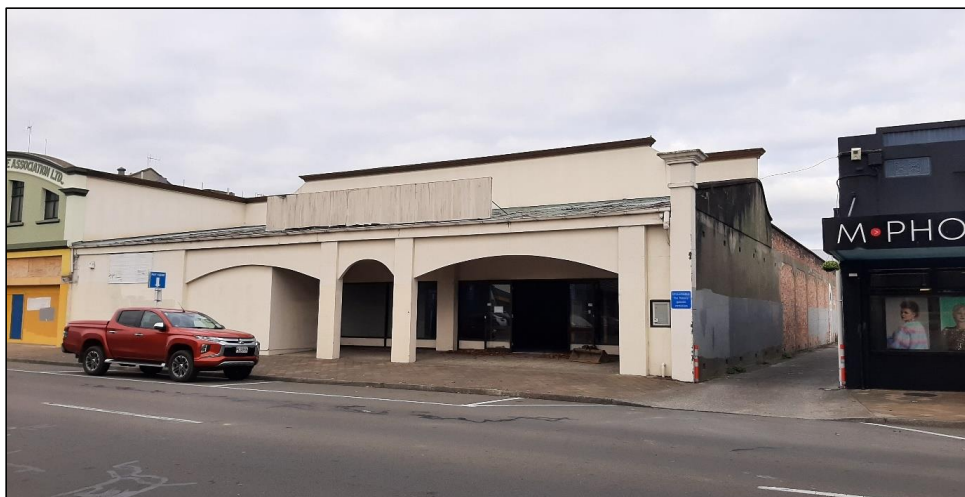
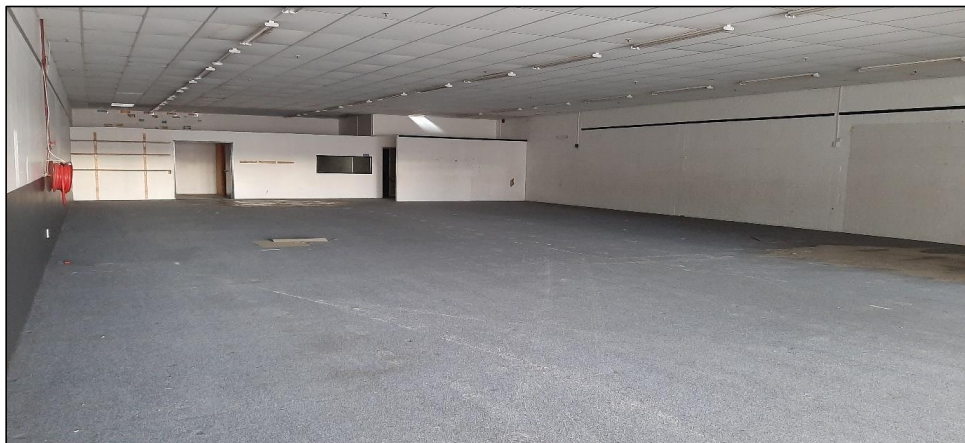
Top and Middle. Queen street facing building. **Bottom.** Queen Street facing showroom.

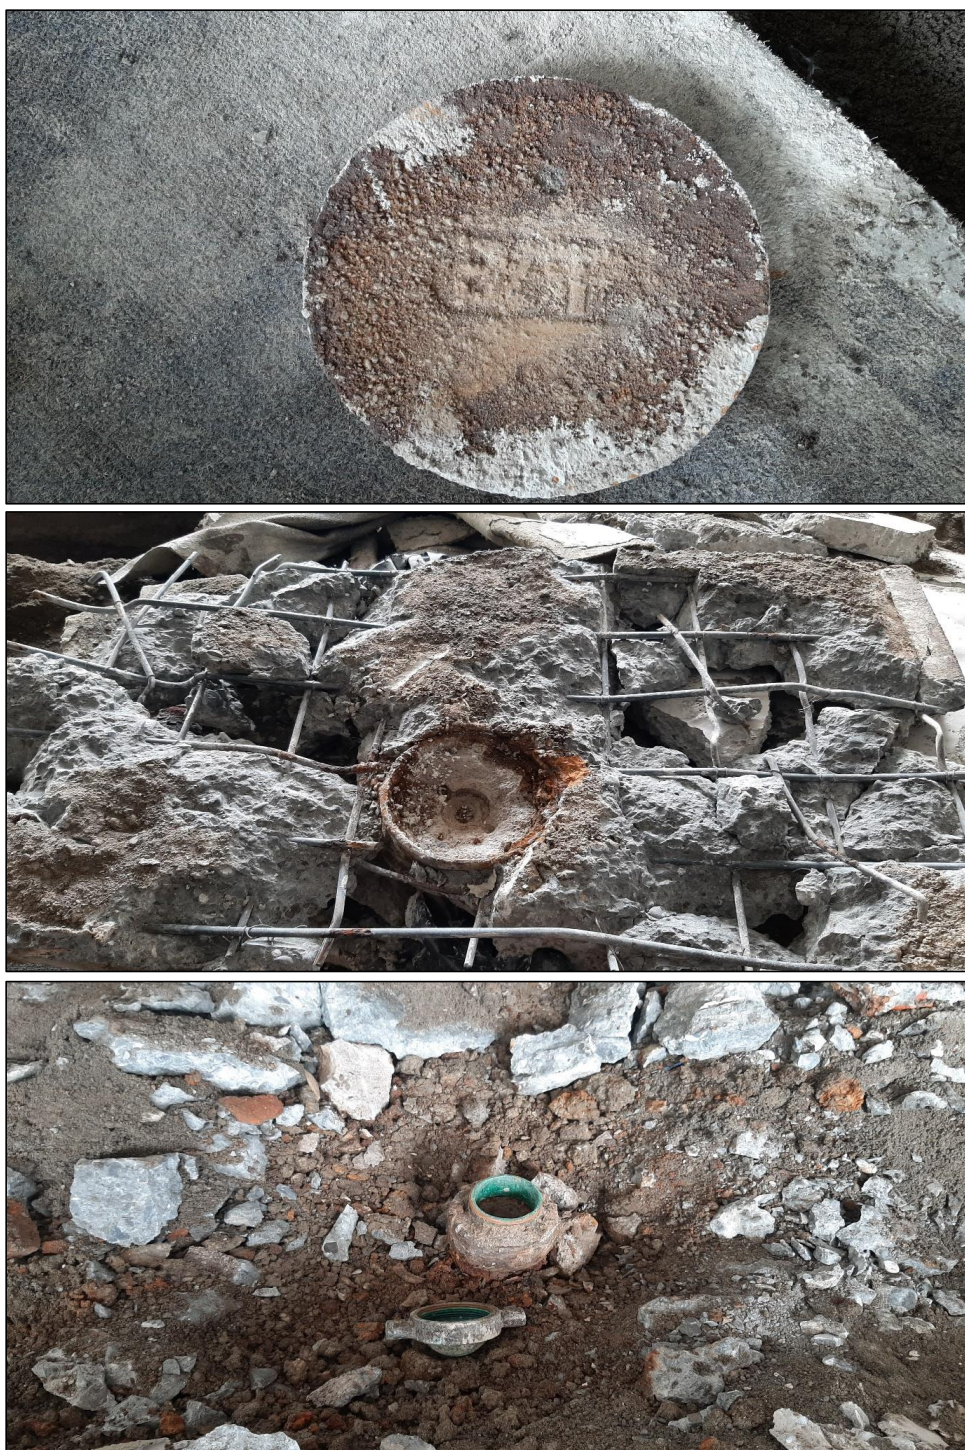
Above. Discovery of historic underground fuel tank.

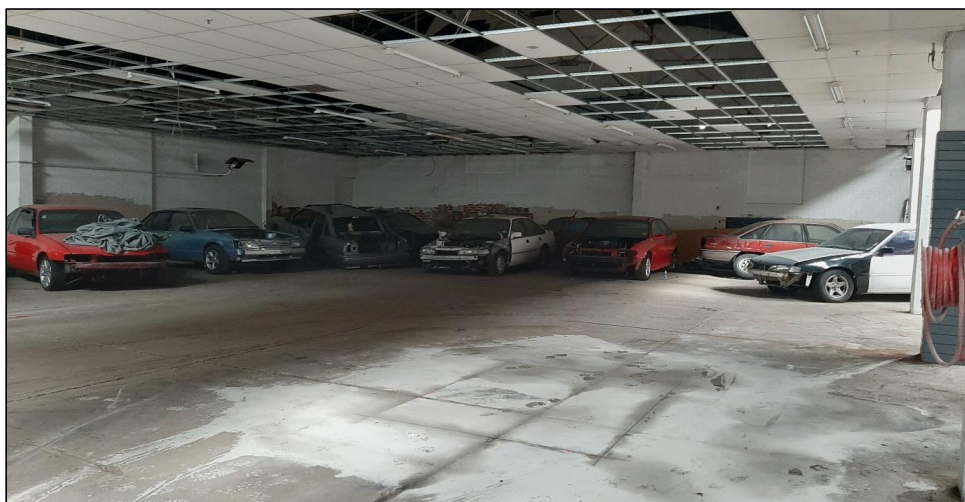
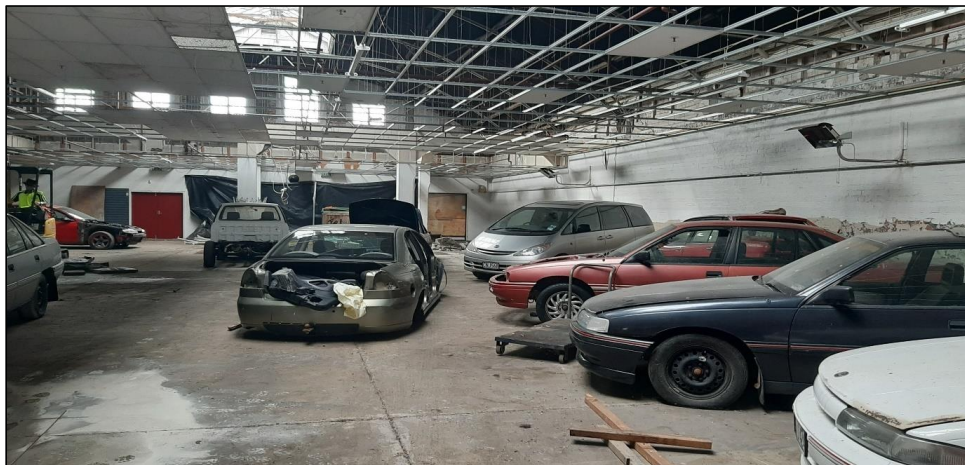
Top. Fill below concrete. **Middle and bottom.** Warehouse, currently used by a Holden collector.

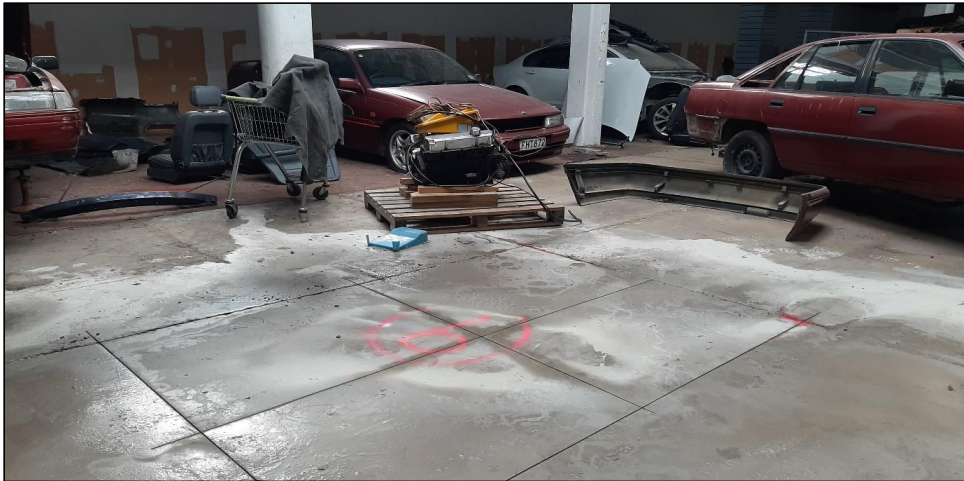
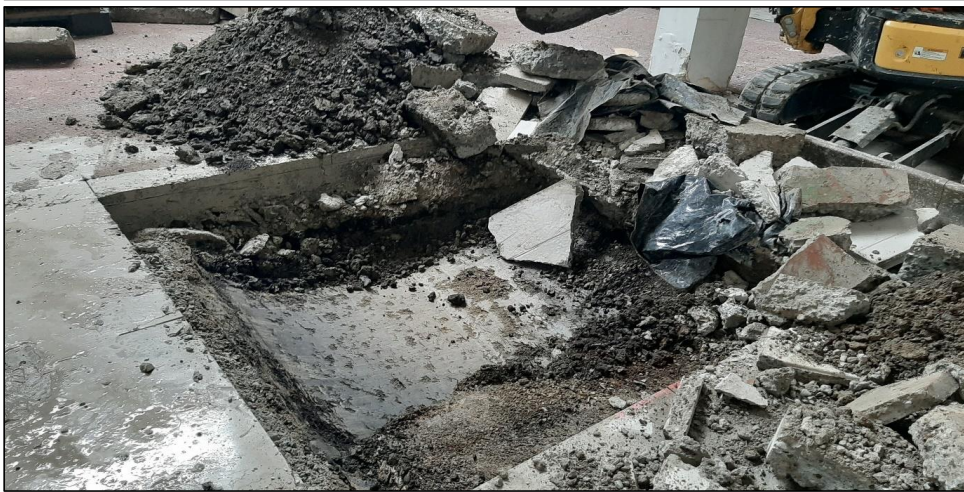
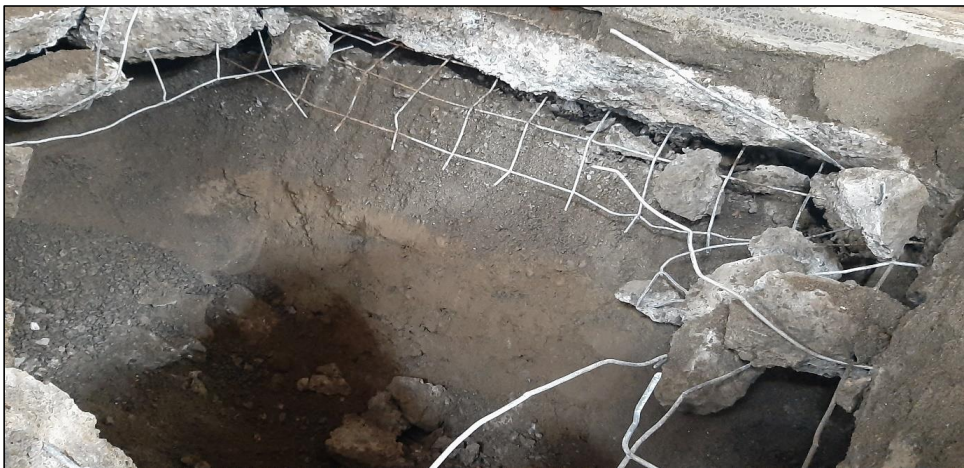
Top. Cut concrete. **Middle,** exposed soil, **Bottom.** TP4, deeper fill.

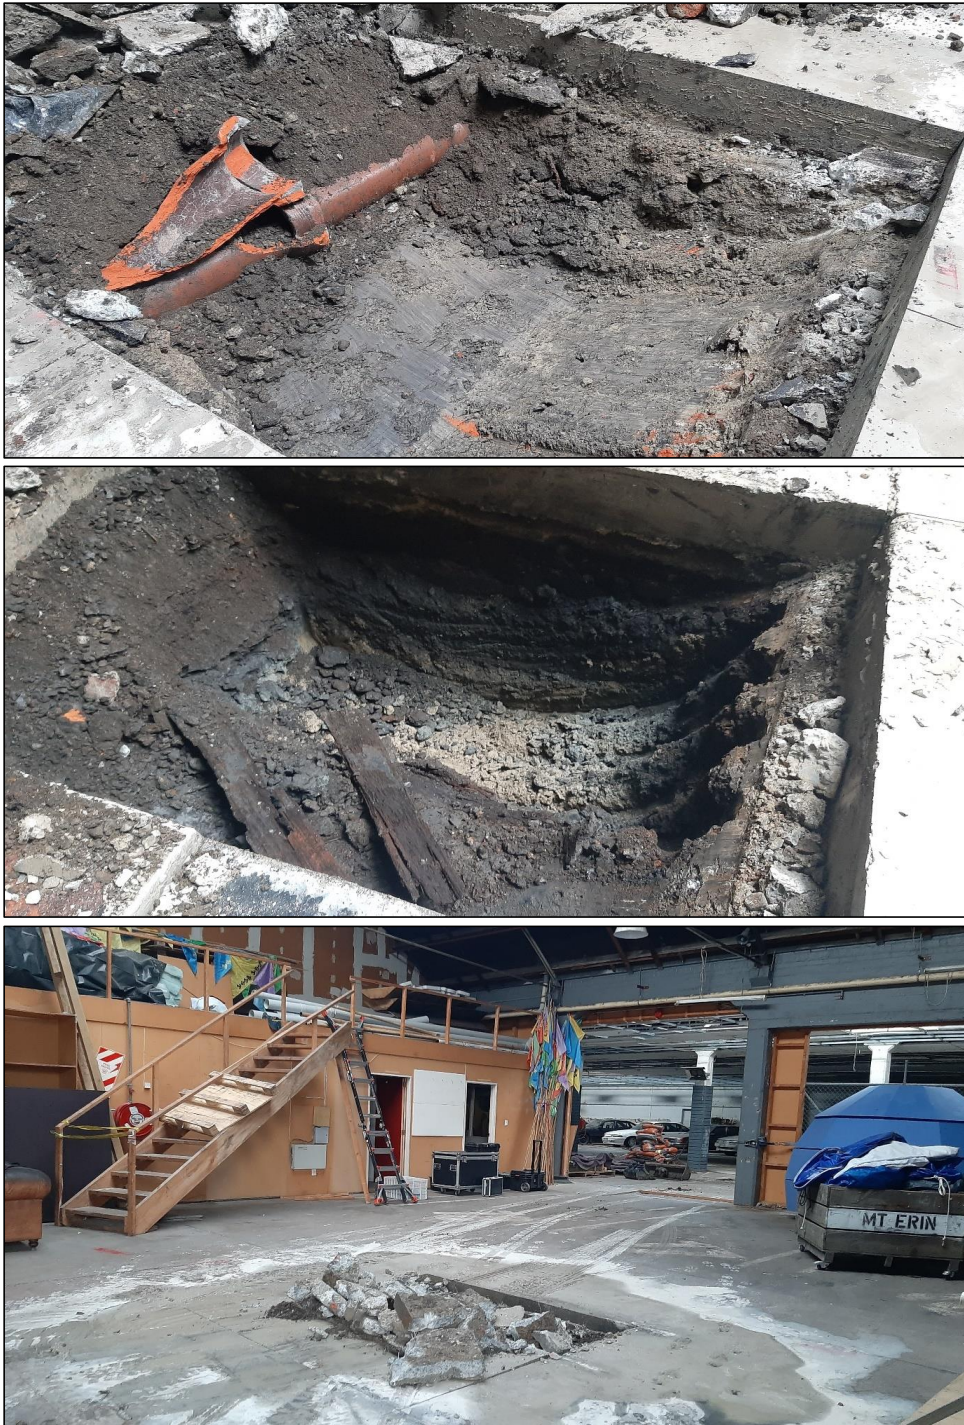
Top. Buried clay pipe. **Middle.** Fill material and underlying light brown silt. **Bottom.** TP11.

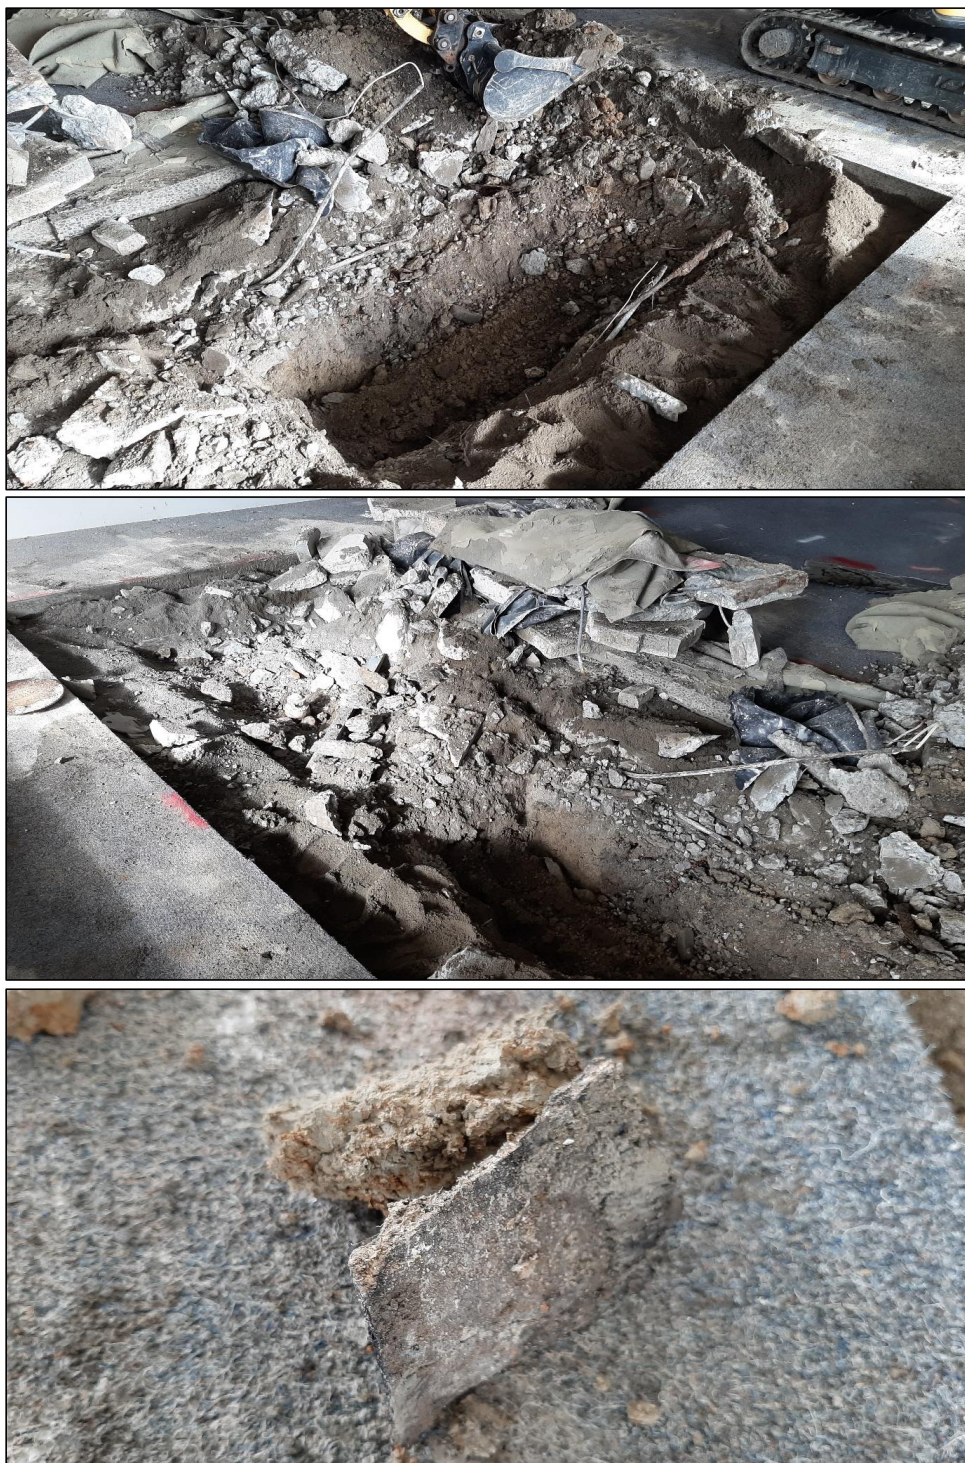
Top and middle. Excavated Pits. **Bottom.** Asbestos Containing Material.

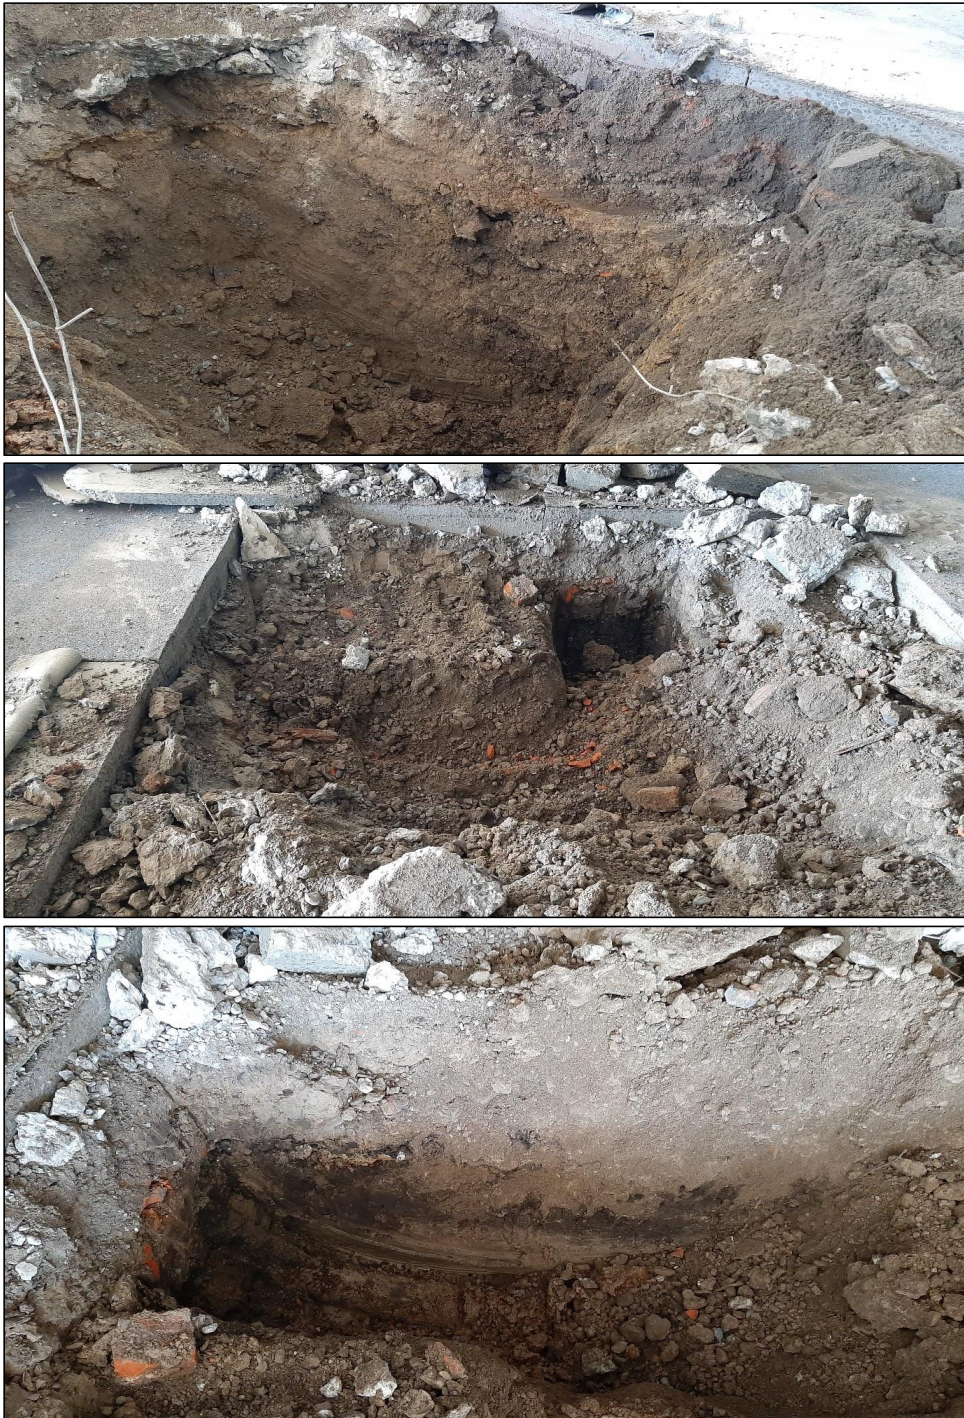
Above. Test pits showing fill material.

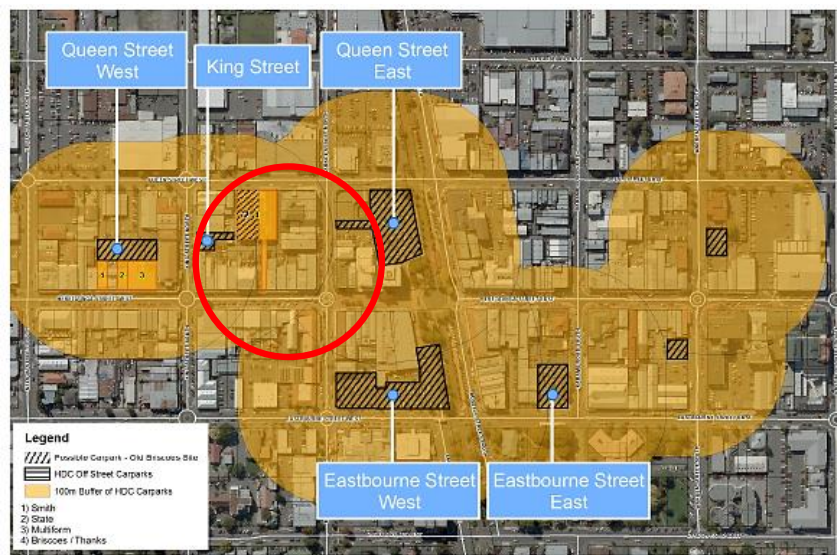
Figure 1 - Alternative locations of intended pedestrian links in 200 & 300 blocks in relation to the CBD off street carparks.

In response to this the Council engaged Urban Perspectives Ltd to provide an urban design report named “Hastings City Centre Parking & Pedestrian Linkages – Alternative Options Urban Design Report”, January 2014, (referred to throughout this report as the “Urban Design report”). The Urban Design report assessed four possible locations for new linkages in the west end retail area. The 200 Block was identified as one of the ideal locations to achieve this as shown in Figure 1:

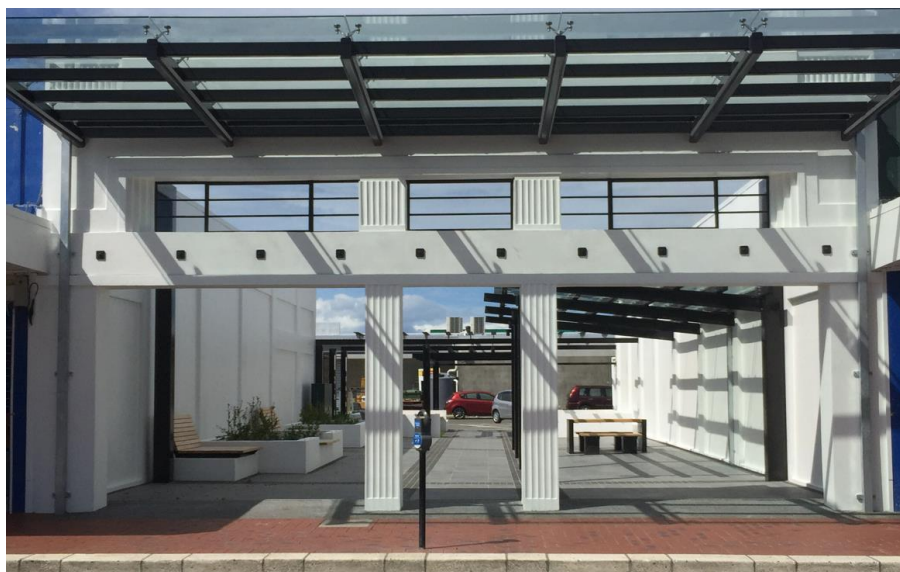
Figure 4 - Laneway from Heretaunga Street West view

The planting, which has matured since taking the photo in Figure 4 above, adds to the amenity of the space. The laneway and carpark beyond are surveyed by CCTV cameras. The laneway remains in excellent condition and has significantly increased the parking usage of King Street Carpark by 37%, as measured by the income of the carpark over a 12 month period (prior to Covid pandemic).

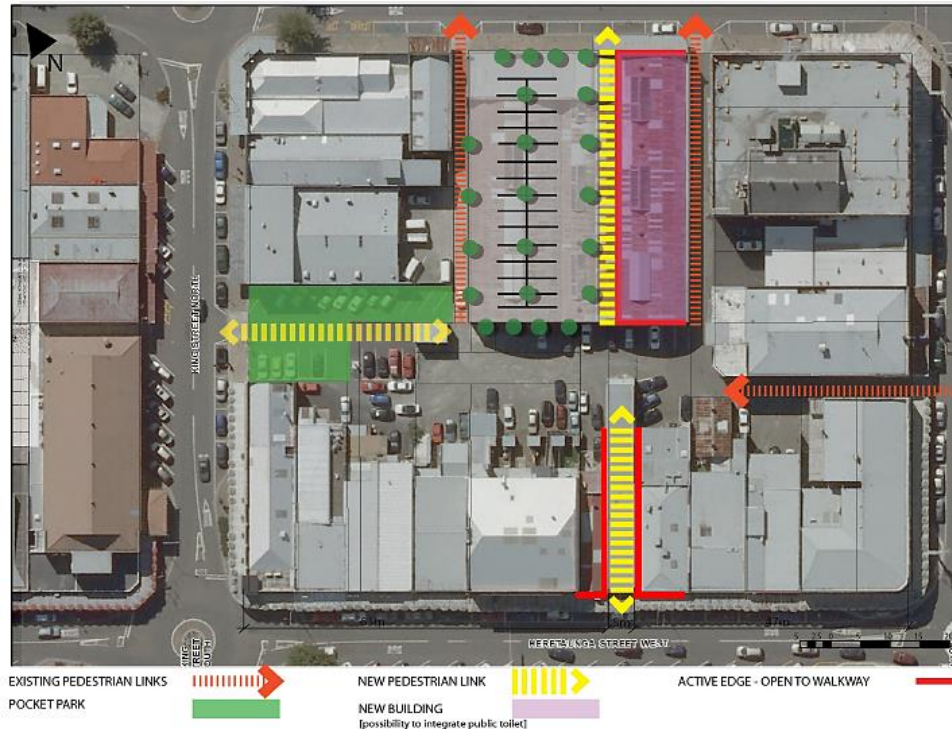
Figure 6 - linkage, parking and public space option, 2014 urban design report

The Urban Design report, which forms part of the resource consent application documentation, explored several options for the 200 Block. The 2022 concept proposal (which underpins the proposed redevelopment) is generally consistent with the options identified, in particular with Option 4 shown in Figure 6/page 9 of this report.

The Urban Design report, 2014, identified that securing a link through the Thanks building is critically important in relation to the possible redevelopment of the Former Briscoe's site (partly as carpark) and the associated potential to develop a pocket park. The Urban Design report stated that a link through the Thanks Building (former Envy Shoes) will be most effective if implemented as part of a wider project initiative integrating development possibilities for the entire block. Below is Option 4 for the 200 Block included in the Urban Design report, 2014.

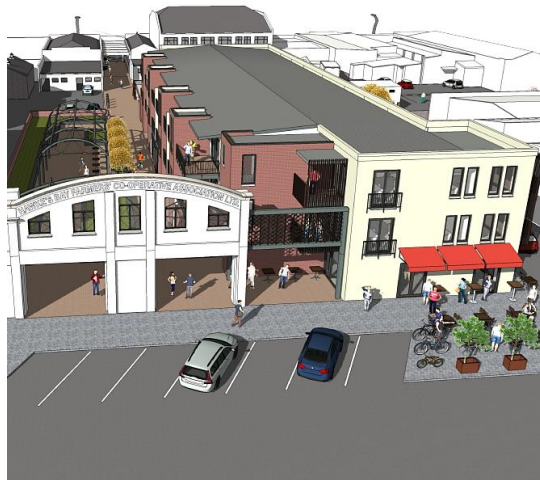
Figure 13 View from Queen Str West

Attention has been given to the interface with the adjoining roads and publicly accessible areas with the retained heritage façade and the ground level commercial tenancies within the apartment building providing active edges and spatial definition to the street, the laneway and adjacent park.

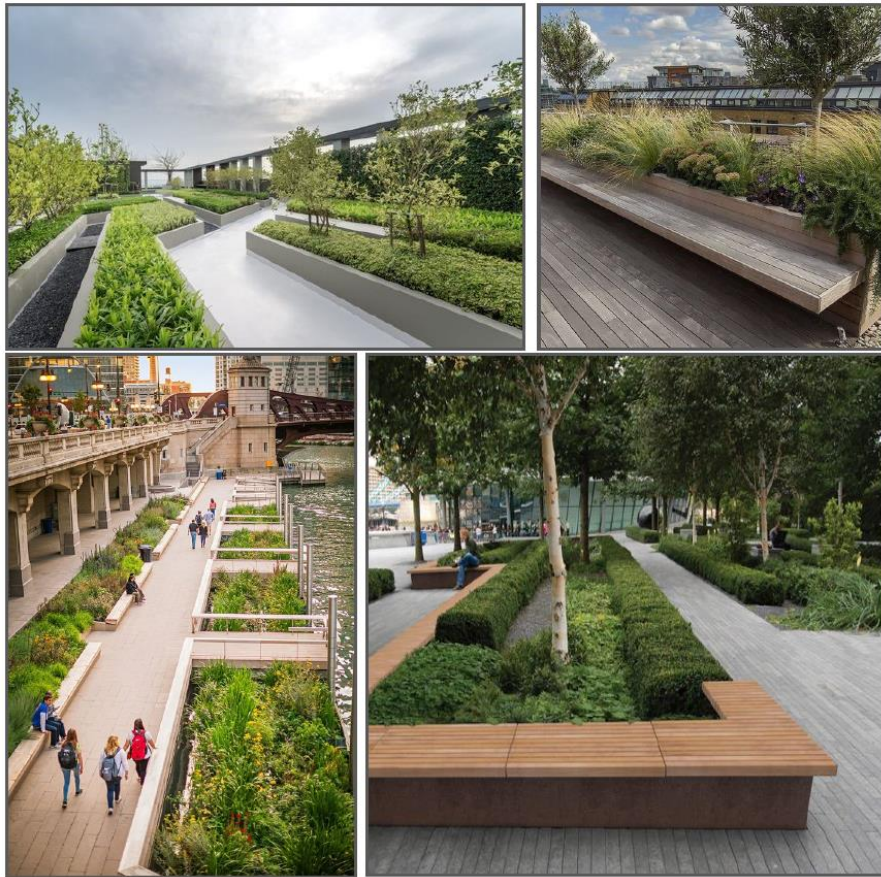
Figure 14 - Raised garden beds with seating, low shrubs with taller trees above eye line

The design layout of the new greenspace will have a linear structure and well defined routes to lead people through the site, with raised garden beds similar to the examples below (Figure 14).

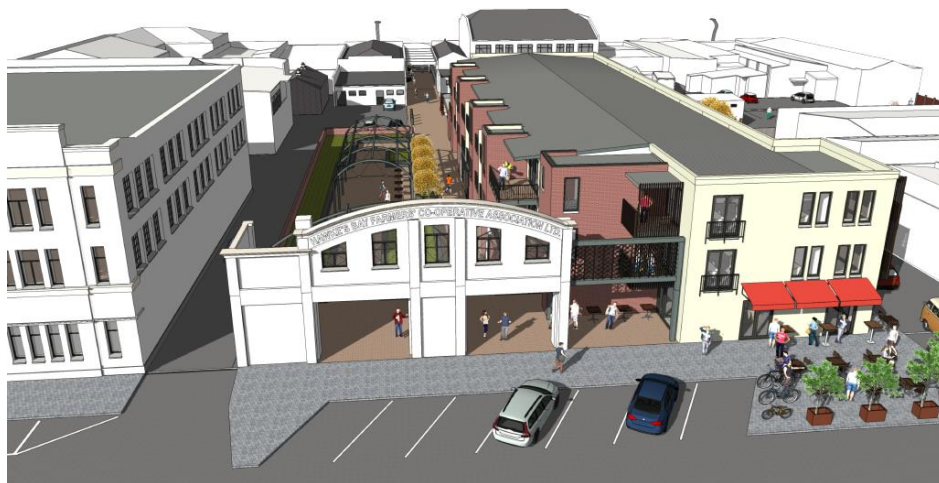
Figure 15 - Apartment balconies overlooking the greenspace and windows overlooking the street

To the south-east of the apartments is the new greenspace/park providing both an outlook for those living there as well as a shared outdoor living space space for residents and for those working and shopping in the CBD.

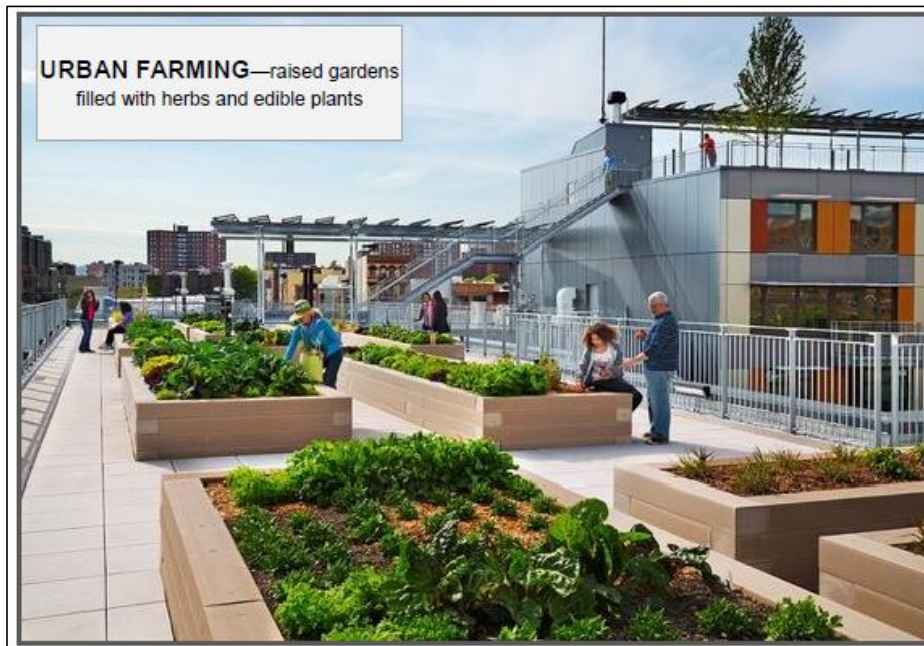
Figure 16 - Raised Community Garden bed

The proposed publicly accessible spaces (the laneway and park) are clearly defined, easily found and designed to encourage public use. The quality and aesthetics of the development as a whole will engender a sense of ownership and respect for the space. The public and the residents of the apartments will both have access to the park during the day, but in the evenings/night time the park (and the adjacent laneway) will be closed to the public and available to residents only, further promoting a sense of ownership. The raised garden beds will have areas that the residents can use for community gardens and to grow their own produce (see example below).

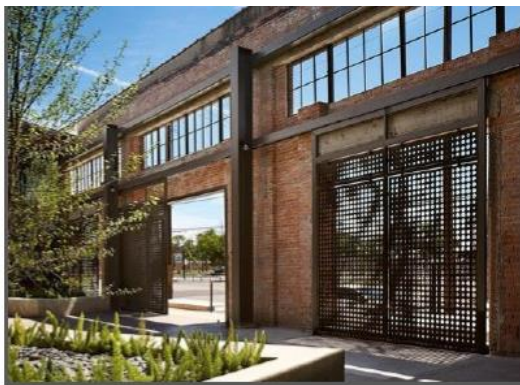
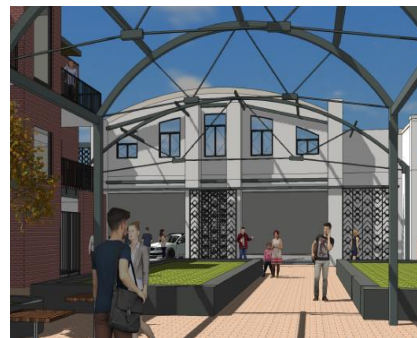
Figure 17 - Security gates examples

The park will be defined by a perimeter low brick wall with wrought iron screens above. Attractive transparent screen-like gates (see examples below) will sit behind the retained heritage façade that can be closed at night by either Recreation Services or security patrols (as they do for other parks in the district) at both ends of the park.

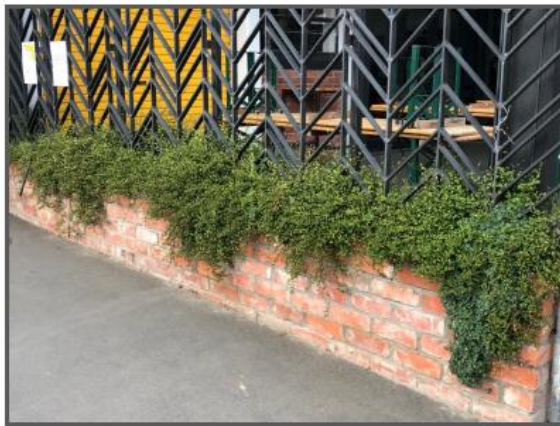
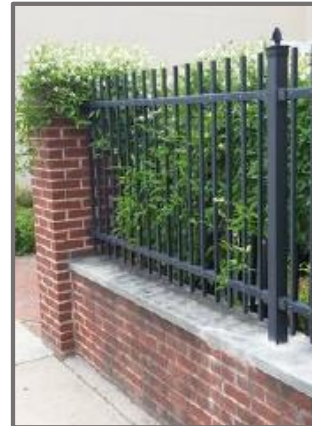
Figure 19 - Fencing styles (Brave Brewery, Hastings)

Fences will be a mix of brick and see-through wrought iron (design detail to be confirmed as part of the park's design) to allow durability and transparency similar to the examples below:
