Waiohiki Rd (Redclyffe) Bridge (ID 816)

Report – Stage 1 & 2

Part A: Feasibility Report

Part B: Options Report

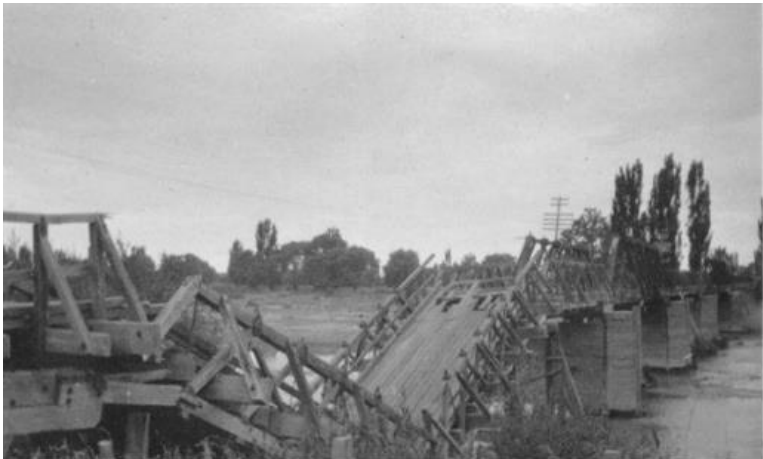
Figure 4: Original Bridge after 1931 Earthquake from NZSEE Paper³

The first Redclyffe bridge across Waiohiki Road was opened in June 1881². The one-lane bridge featured a passing facility at its center. A new bridge was planned in 1925 but was delayed for various reasons. During the 1931 Napier earthquake, the bridge was badly damaged, as depicted in Figure 4. It was repaired before the new reinforced concrete bridge was built in 1933 immediately downstream of the 'pre-1933 bridge, as shown in Figure 3.

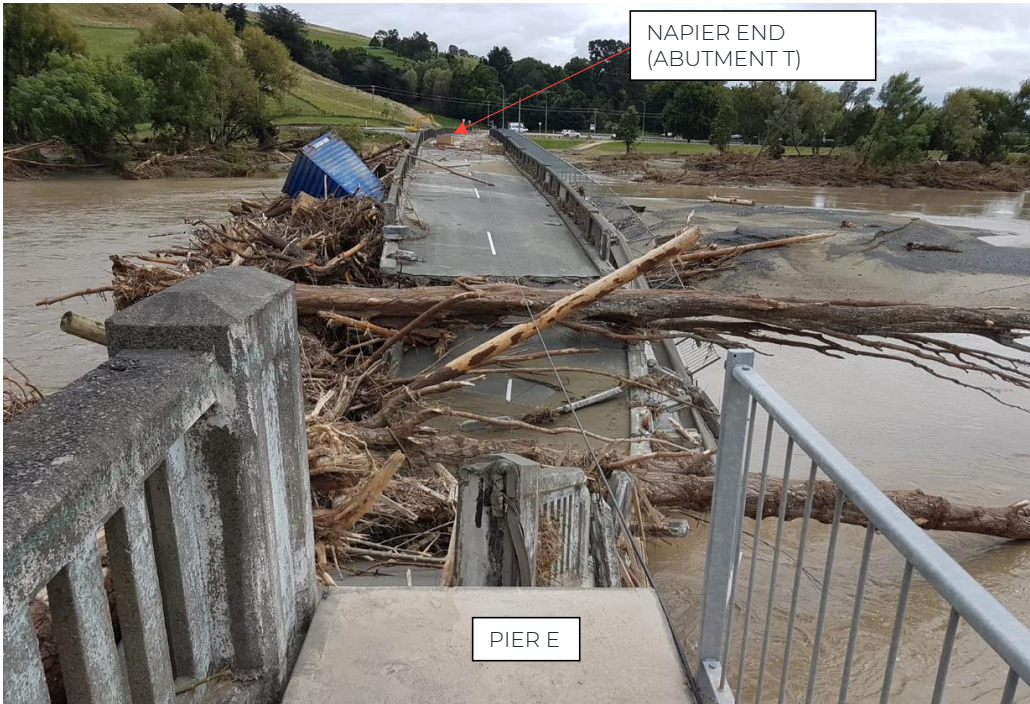
The bridge sustained severe damage due to the Cyclone over the period 13-14th February 2023. Spans between Pier E to Pier K collapsed and the alignment of the bridge from Pier K to Pier P shifted transversely. This resulted in the demolition of spans between Pier E to P (5 to 14). Refer Figure 5, Figure 6 and Figure 7 below. Abutment A to Pier E and Pier P to Abutment T was the only salvageable elements of the bridge

Figure 5: Redclyffe Bridge damage after Cyclone Gabrielle

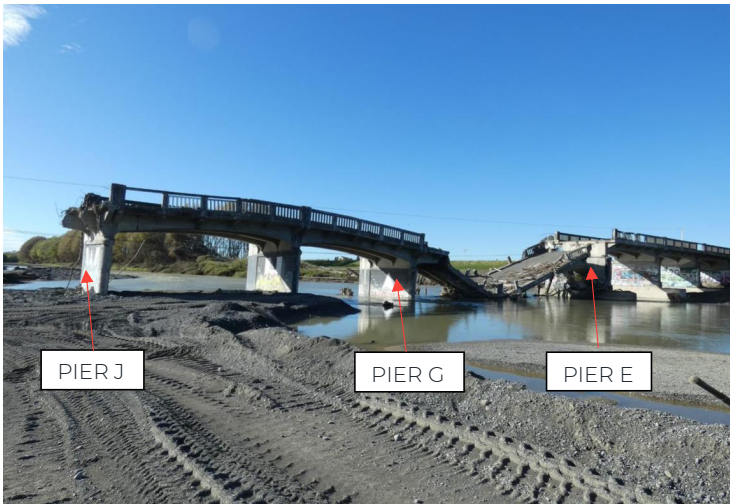
Figure 7: Redclyffe Bridge damage after Cyclone Gabrielle

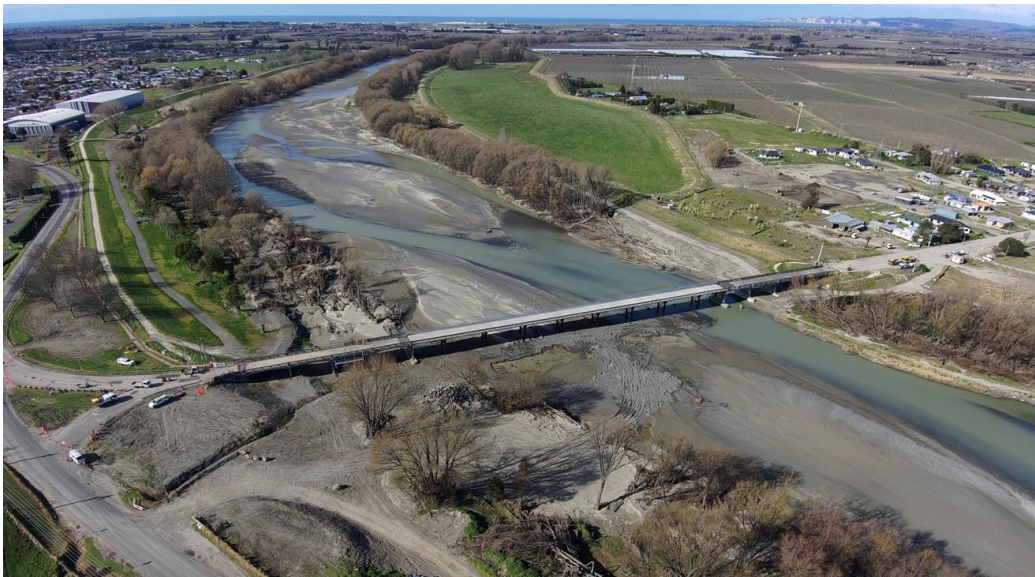
The staging bridge was completed and opened to the public on the 8th of August 2023⁴. Completed photos of the temporary bridge are shown in Figure 12 and Figure 13.

Figure 12: Aerial View of Completion of Redclyffe Staging Bridge – 4th August 2023

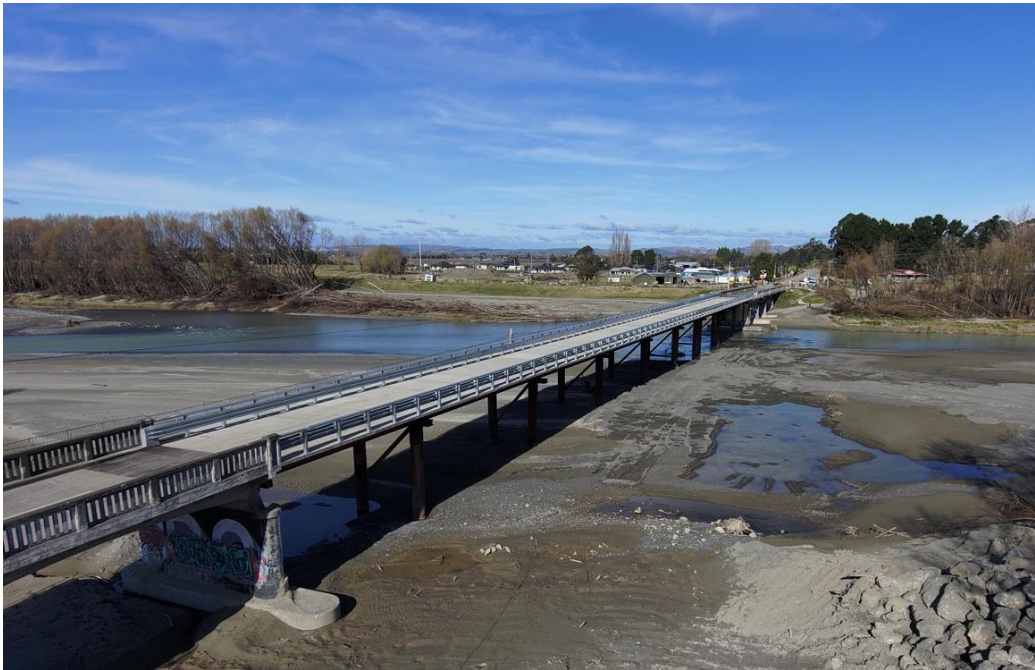
Figure 13: Elevation View of Completion of Redclyffe Staging Bridge (Napier end, Upstream) – 4th August 2023

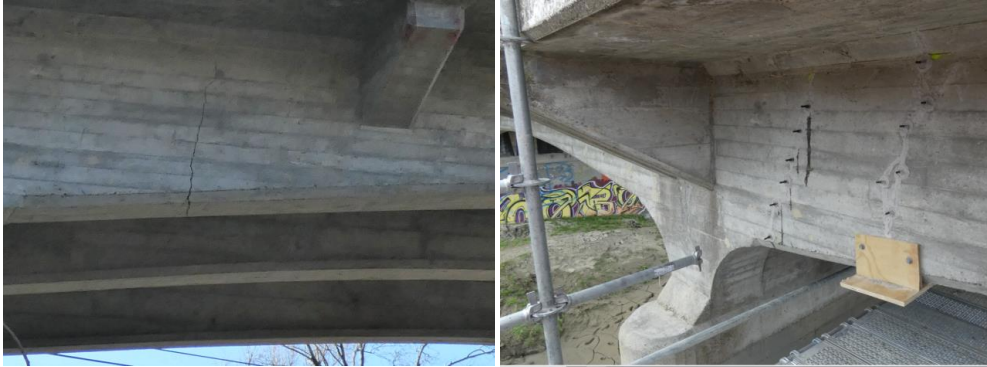
Cyclone Gabrielle caused significant transverse cracking in the super structure of at least one span that was retained. A repair was carried out with partial success. Before and after photos are shown in Figure 14. A detailed monitoring programme is in place for this bridge span and further work underway to review options increase the load limit.

Figure 14: Cracks in Beams of Existing Bridge (3rd span from Napier) Before (Left) and After (Right).

An 8-ton gross load limit and 30 km/h speed limit on the bridge are in place. Emergency vehicle and public busses are exempt from these load restrictions. The reasons for the restrictions are concerns around the existing bridge spans capacity to support heavier vehicles and driver comfort. The temporary staging bridge also strongly recommended a 30 km/h speed limit.

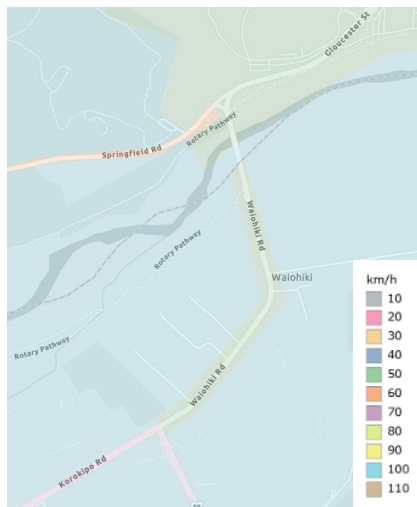
Figure 15: Speed limit around bridge (from <https://speedlimits.nzta.govt.nz/>). Yellow is 50km/h, Orange 60km/h, Purple 70km/h. Note – SH50 outside of view is 100 km/h limit.

The existing bridge has a 30km/h speed restriction. Waiohiki Rd has a speed limit of 50 km/h⁵ which was introduced in 2020, prior to this it was 70 km/h. On the Napier City Council side of the bridge, Springfield Rd has a 60 km/h speed limit and Gloucester Street 50 km/h introduced in November 2021⁶, previously was 100 km/h and 70 km/h respectively. These speed limits are shown graphically in Figure 15 below. It is recommended that any proposed replacement bridge be designed for a design speed of at least 50 km/h.

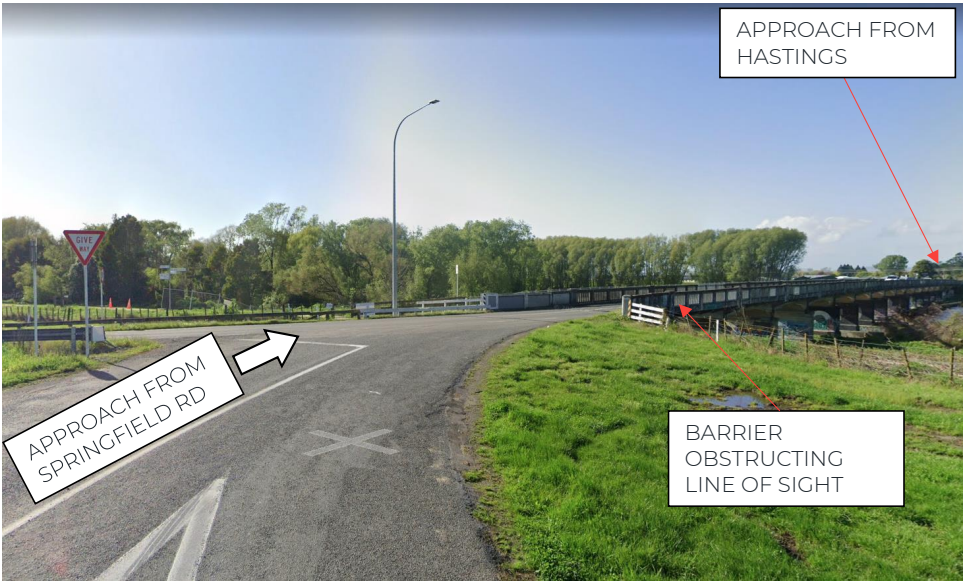
Figure 17: Approach from Springfield Rd turning on Redclyffe Bridge

Past investigation has identified that sight visibility is a problem approaching from the north when turning from Springfield Rd into Waiohiki Rd to cross Redclyffe bridge as shown in Figure 17. Replacing the barrier system to allow greater visibility was likely to reduce the lane width and require significant deck strengthening. No improvement has been implemented at this time.

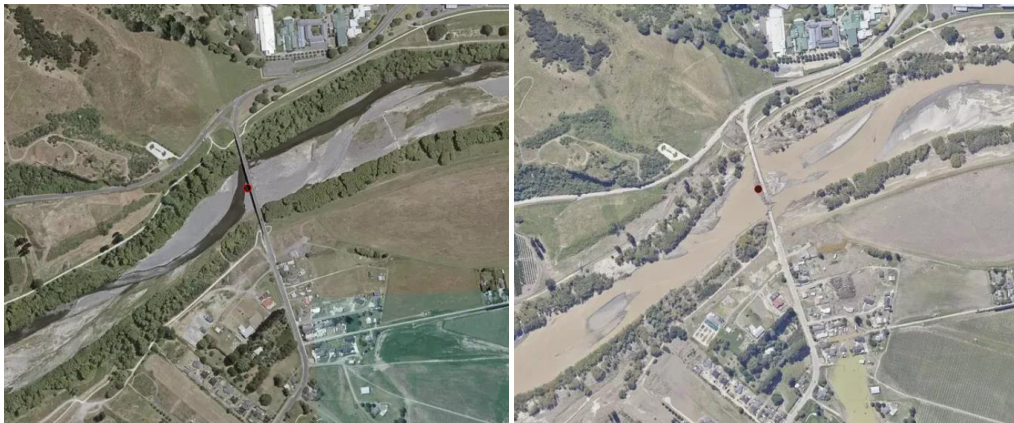
The Tūtaekurī River before and after Cyclone Gabrielle at Redclyffe bridge is shown in Figure 20. Due to torrential rains from the cyclone, the river burst its banks at numerous locations along the watercourse, overtopping and damaging stopbanks, destroying portions of the original Redclyffe Bridge and flooding the surrounding areas causing widespread damage.

Figure 20: Redclyffe Bridge pre Cyclone Gabrielle (Left) and post Cyclone Gabrielle (Right)
(source LINZ GIS)

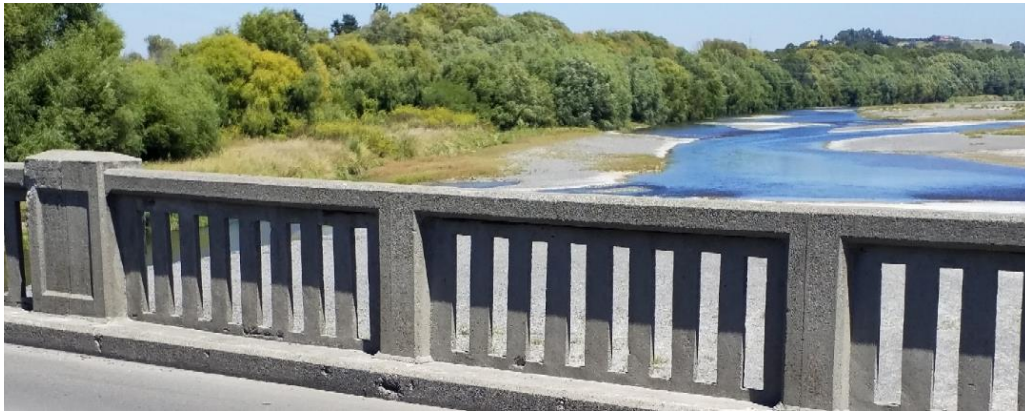
The following images demonstrate the observed flood levels during the events of Cyclone Gabrielle. Correlating a previous inspection photo (see Figure 21) with an aerial photo taken immediately after Cyclone Gabrielle (see Figure 22) indicates the peak flood level reached approximately 14.5 to 15.5mRL (NZVD 2016). Debris and sediment on the bridge deck suggests that some blockage occurred at the bridge site and the maximum water level overtopped the bridge in some locations.

Figure 21: Redclyffe Bridge Location pre flooding Bridge Inspection taken April 2019 (Upstream)

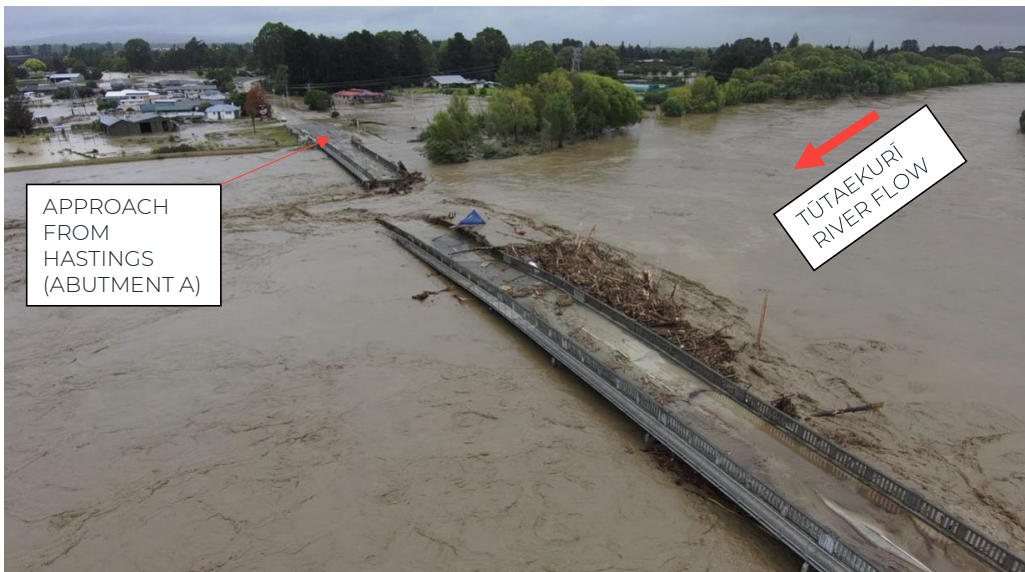
Figure 22: Redclyffe Bridge Location Aerial View following Cyclone Gabrielle:

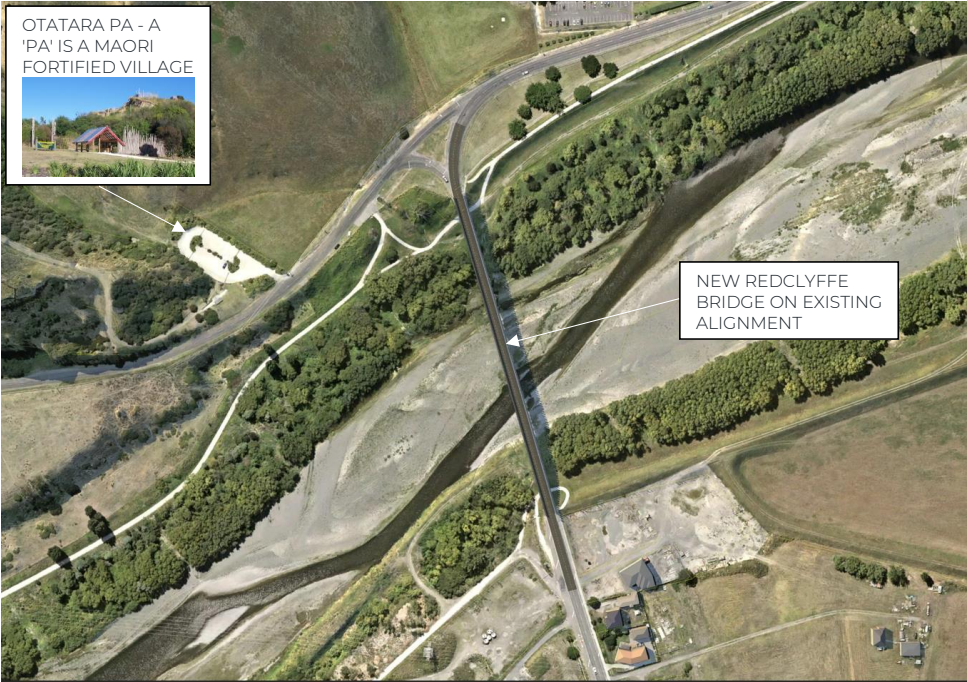
The existing bridge would be demolished, and the replacement bridge built in its place as shown below in Figure 24.

Figure 24: Option 2A: Replace Bridge along the Same Alignment

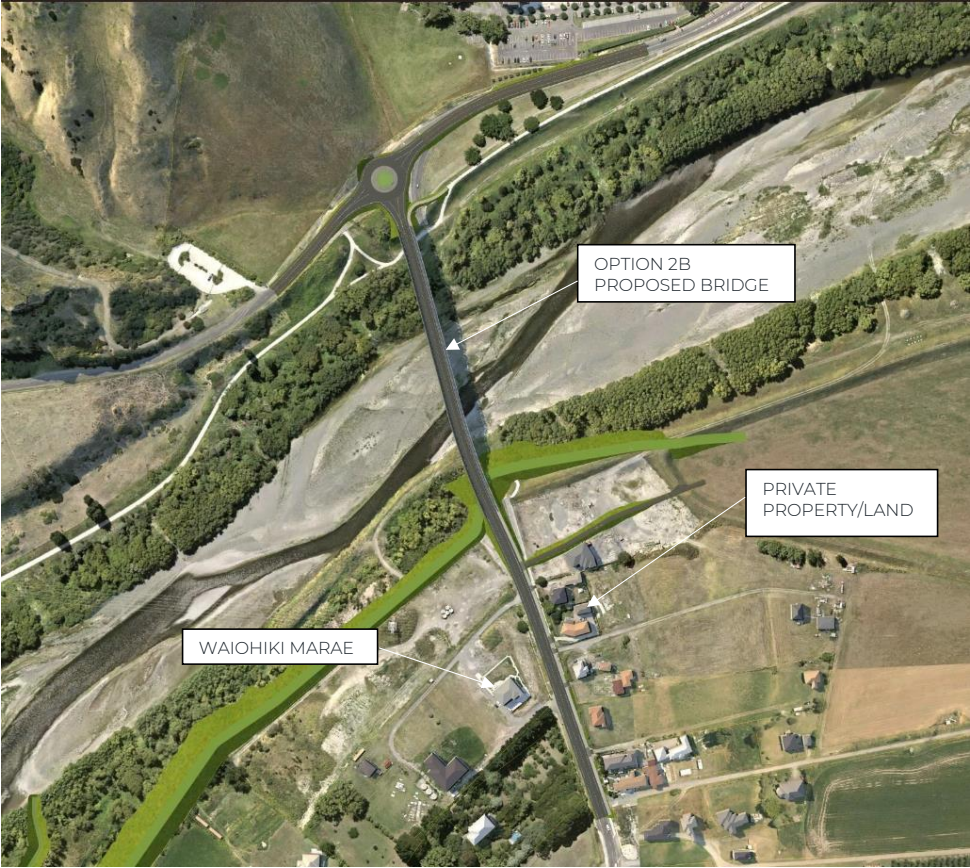
Note that several figures show repair of the upstream true right stop bank by Hawke's Bay Regional Council, this is indicative only.

Figure 25: Option 2B: Replace Bridge Upstream of Existing Bridge next to Existing Bridge

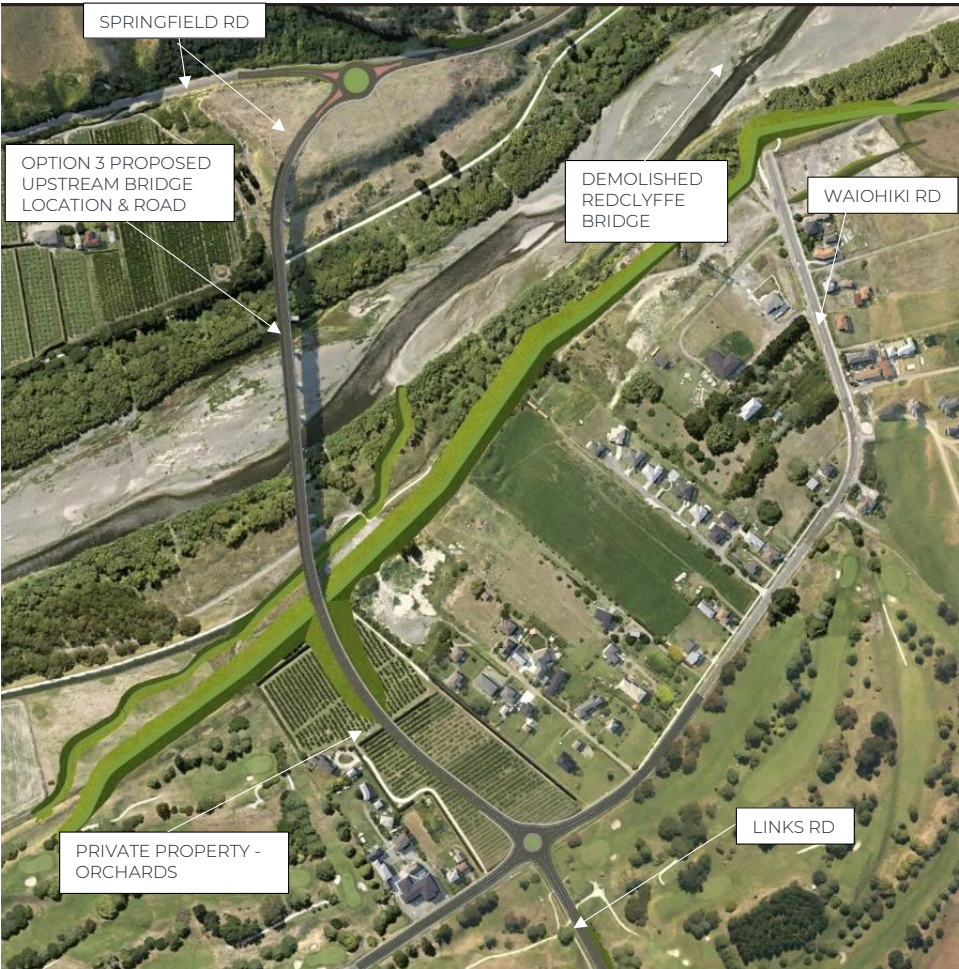
The alternate bridge replacement location is approximately 600m upstream of the original structure. The replacement structure will be approximately 400m long, an approximately 1km new road extension via Links Rd, where it will link into Springfield Rd and then Gloucester St at the existing bridge.

Figure 27: Option 3 Alternate Bridge Replacement Location Overview

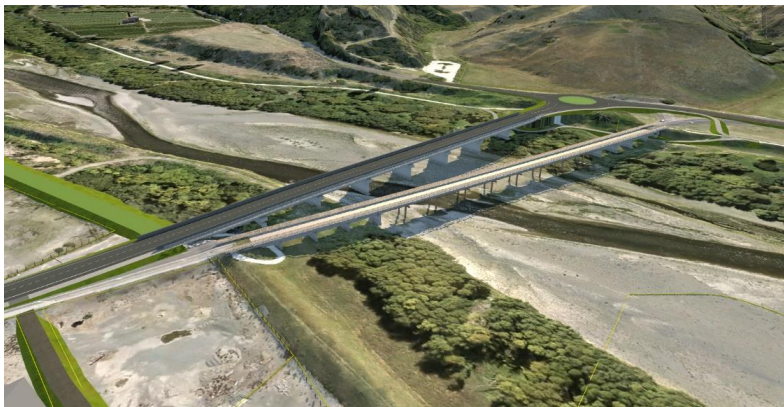
Figure 29: Option 2C Position in Relation to Existing Staging Bridge

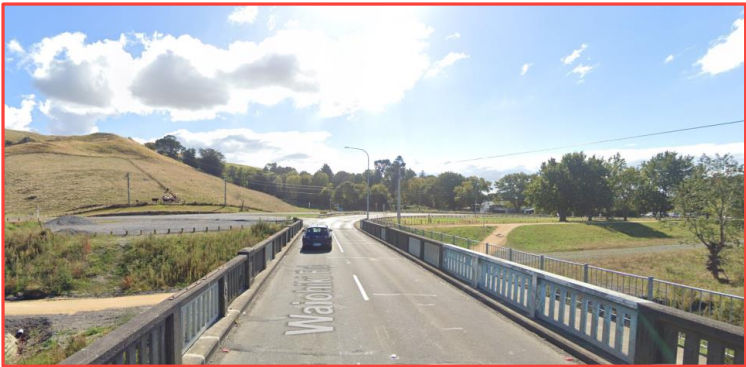
Figure 2: North embankment (image from Google Streetview; captured April 2024)

The north and south embankments are vegetated with grass and longitudinally sloped at grades of less than 20° (see Figures 2 and 3 below).

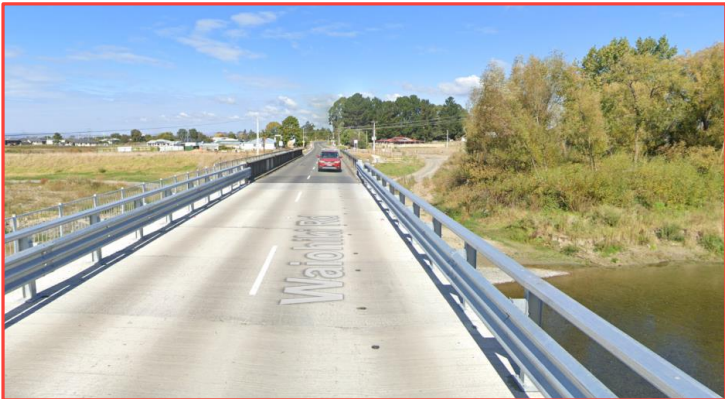
Figure 3: South embankment (image from Google Streetview; captured April 2024)

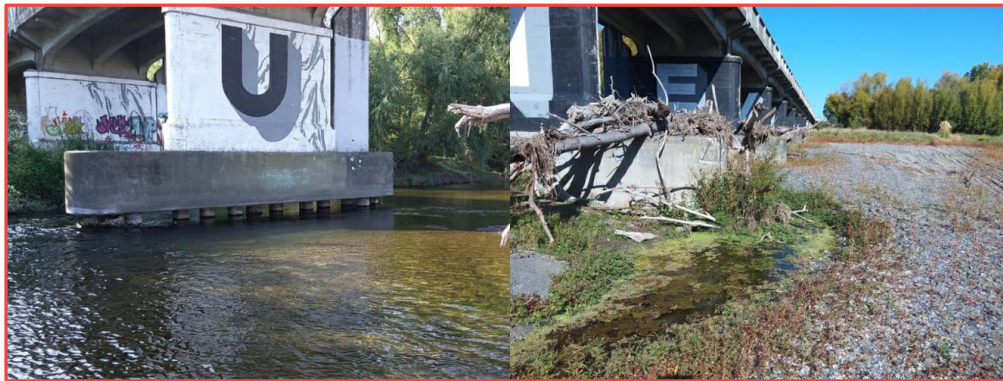
We also note potential historical scour of piles within the river migrating river channel recorded in pre-cyclone bridge inspection (see Figure 4 below).

Figure 4: Potential scour around piers prior to 2023 Cyclone event.

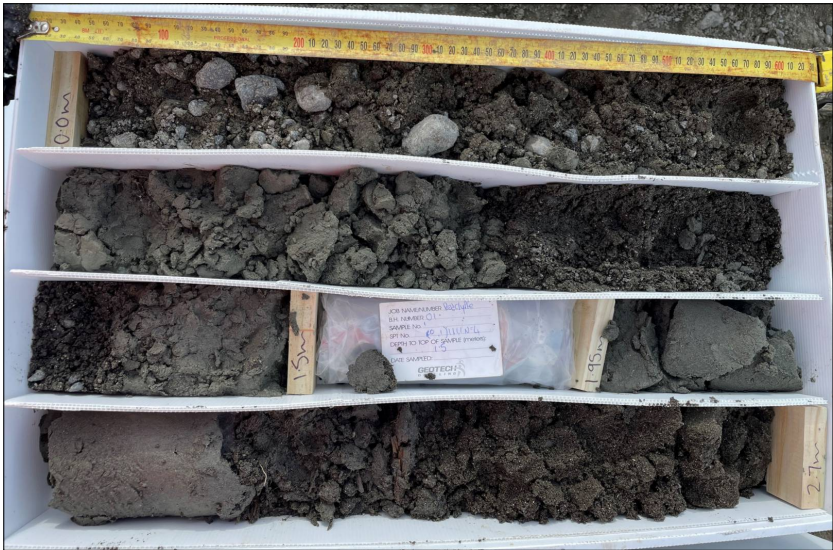
Photo BH01.1
0.00 m to 2.70 m BGL

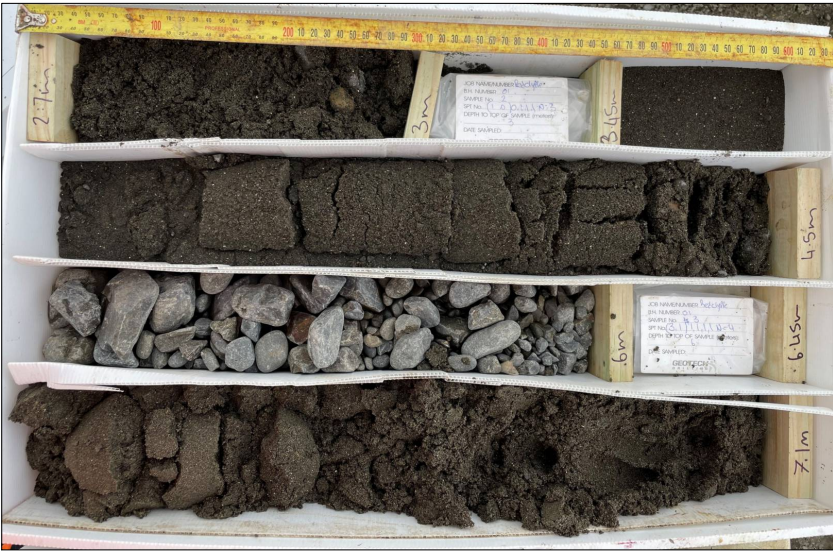
Photo BH01.2
2.70 m to 7.10 m BGL

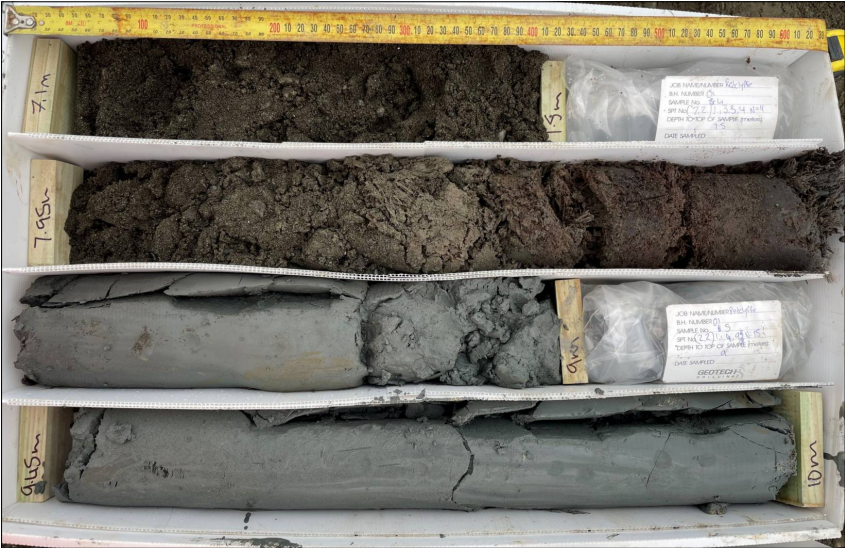
Photo BH01.3
7.10 m to 10.00 m BGL

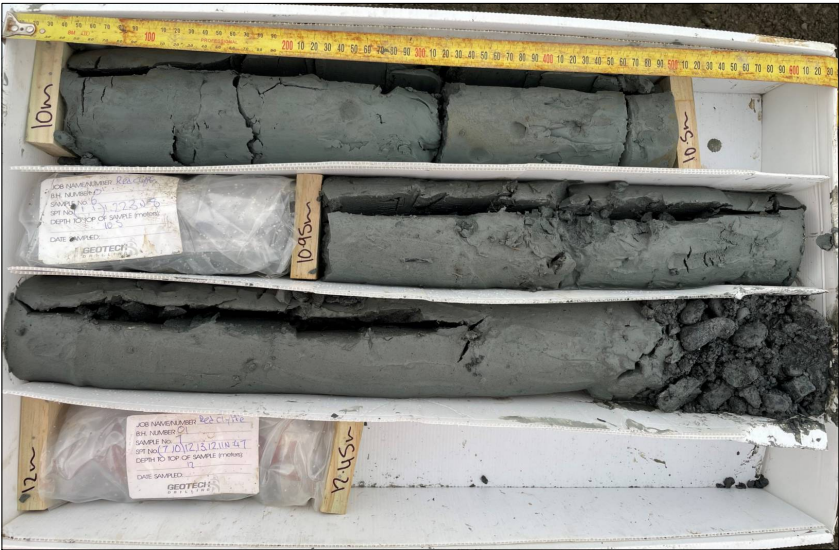
Photo BH01.4
10.00 m to 12.45 m BGL

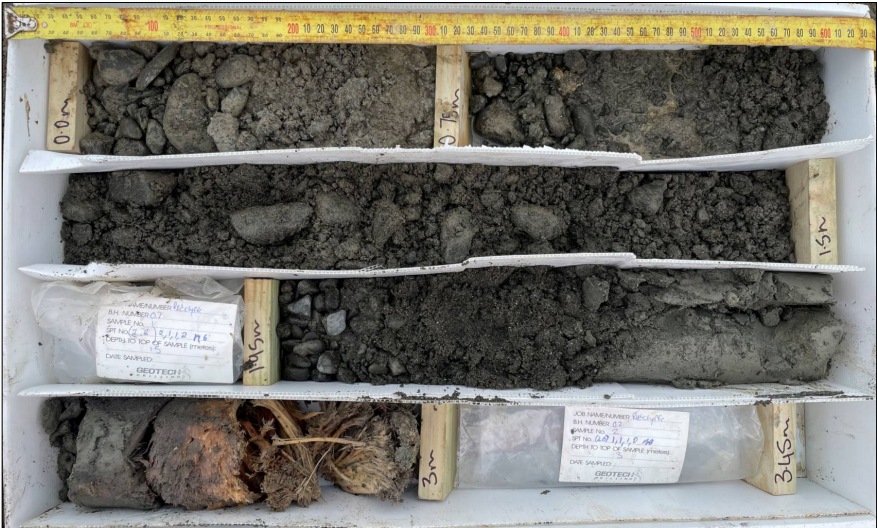
Photo BH02.1
0.00 m to 3.45 m BGL

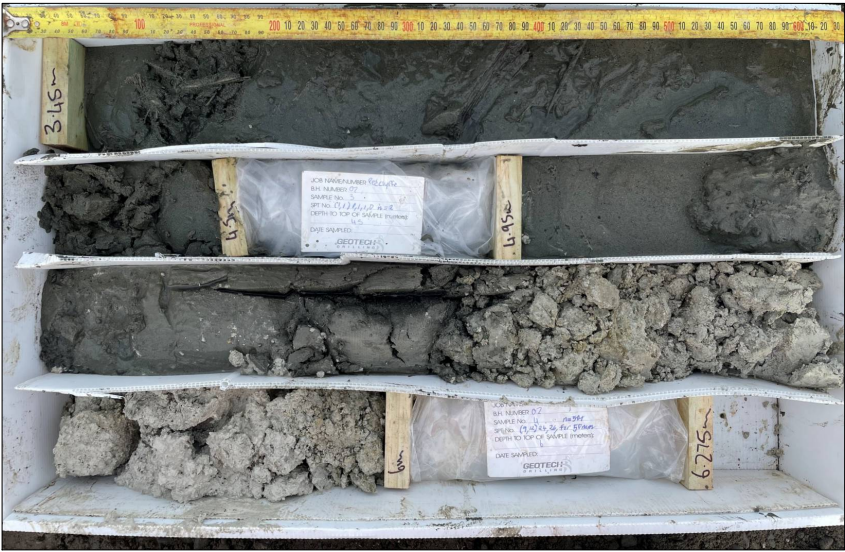
Photo BH02.2
3.45 m to 6.275 m BGL

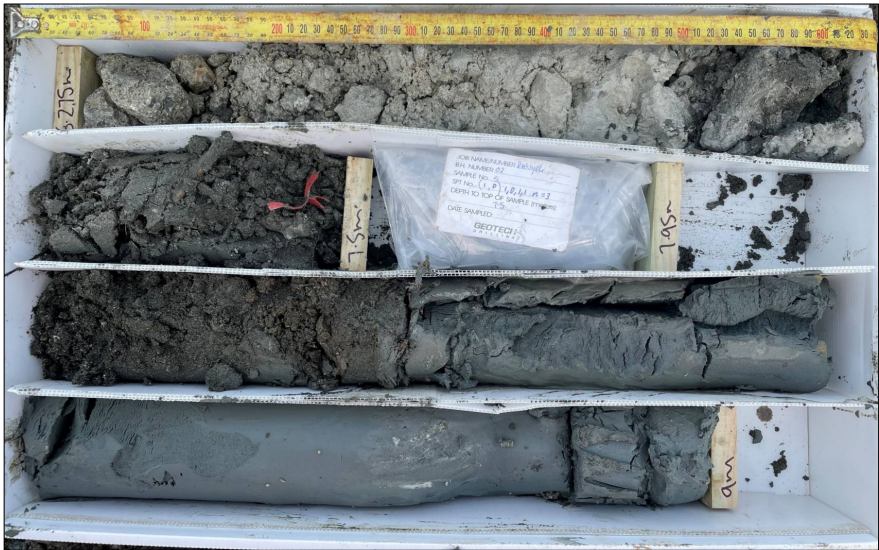
Photo BH02.3
6.275 m to 9.00 m BGL

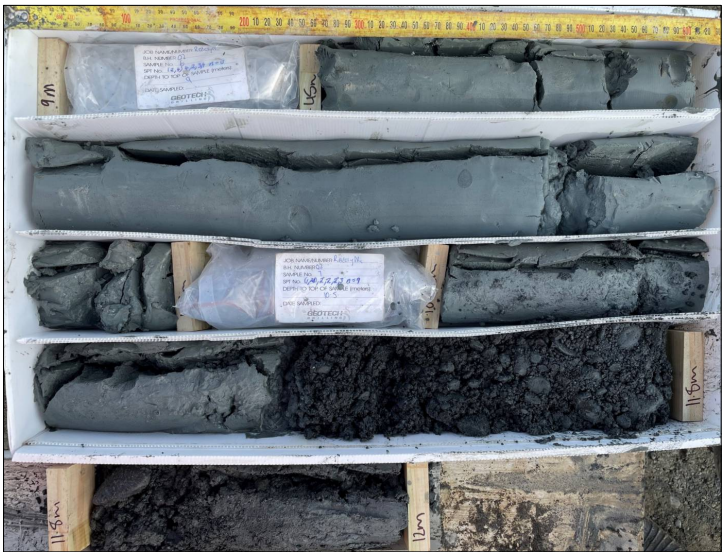
Photo BH02.4
9.00 m to 12.00 m BGL

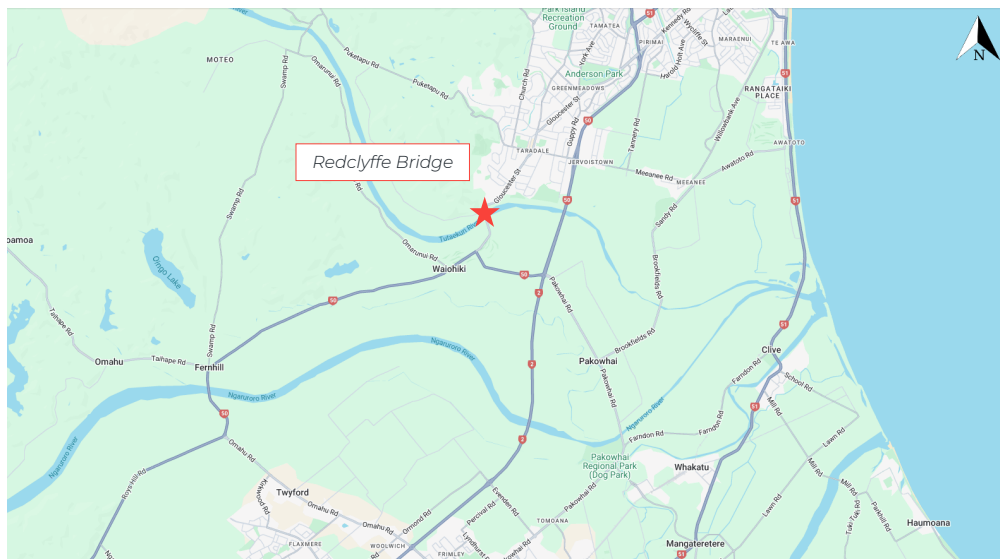
Figure 1-1: Redclyffe Bridge

Waiohiki Road “Redclyffe” Bridge connects Waiohiki and adjacent suburbs to the western side of Napier. The bridge has an important strategic function within the regional road network¹ carrying approximately 8,000 vehicles per day. The bridge also forms part of the detour route when the State Highway 2 Expressway between Links Road (SH50) and Meanee Road is closed. The location of Redclyffe Bridge is shown in Figure 1-1.

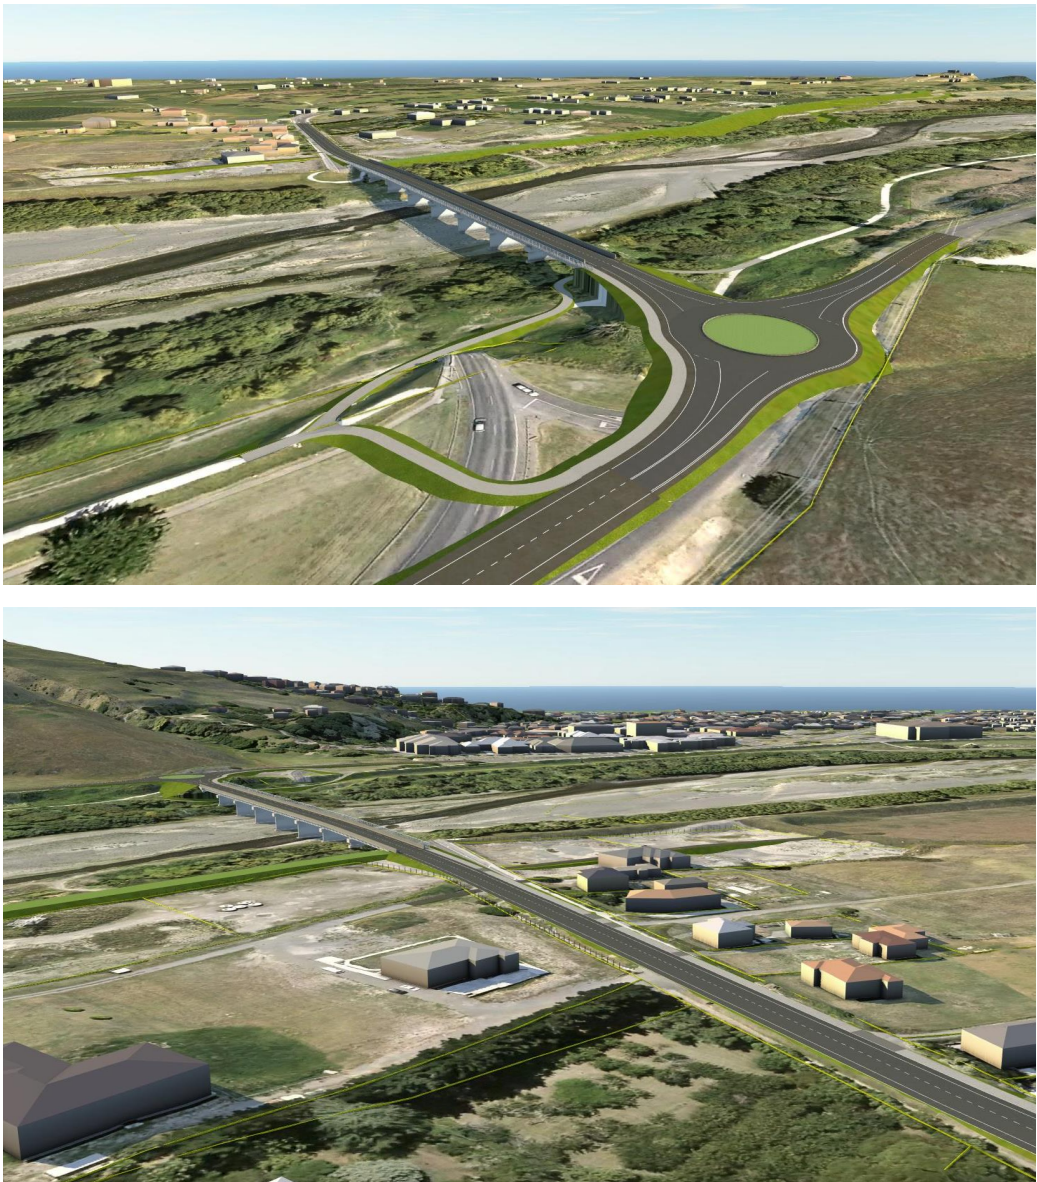
Option 3 – Alternate Bridge Replacement location (Links Road)

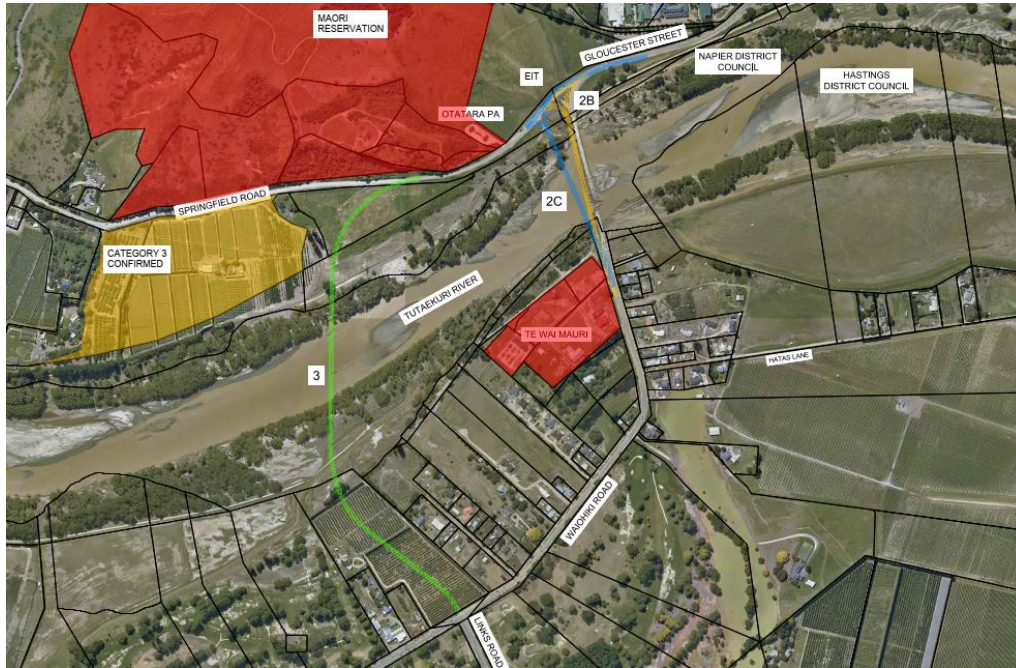
Figure 4: Aerial View of Alignment Options

Part A Feasibility of the Waiohiki Road (Redclyffe Bridge) report was first completed on the 10th of August 2023 highlighting 2x preferred options, 2B & 2C shown in Figure 4. This report required further Hydrology, Hydraulic, Geometric and Property Investigations to recommend a single preferred engineering alignment.

Engagement resumed with Community and Mana Whenua on the 23rd of July 2025 based on the three alignment options 2B, 2C and 3 (refer Figure 4) with clear communication of the preferred engineering alignment but highlighting the need for further non engineering based investigations, as outlined in Section 6.

- Option 1: Do Nothing (Maintain Existing Temporary Crossing)
- Option 2A: Replace Bridge on the Existing Alignment
- Option 2B: Replace Bridge Immediately Upstream and Parallel to Existing Bridge
- Option 2C: Replace Bridge Immediately Upstream and Skewed to Existing Bridge
- Option 3: Alternate Bridge Replacement Location (Links Road)
- Option 4: Non-bridge Alternative
