### **COUNCIL MEETING**

**Meeting Date: Tuesday, 5 March 2019**

**SUBJECT:** CAPE KIDNAPPERS HAZARD MANAGEMENT

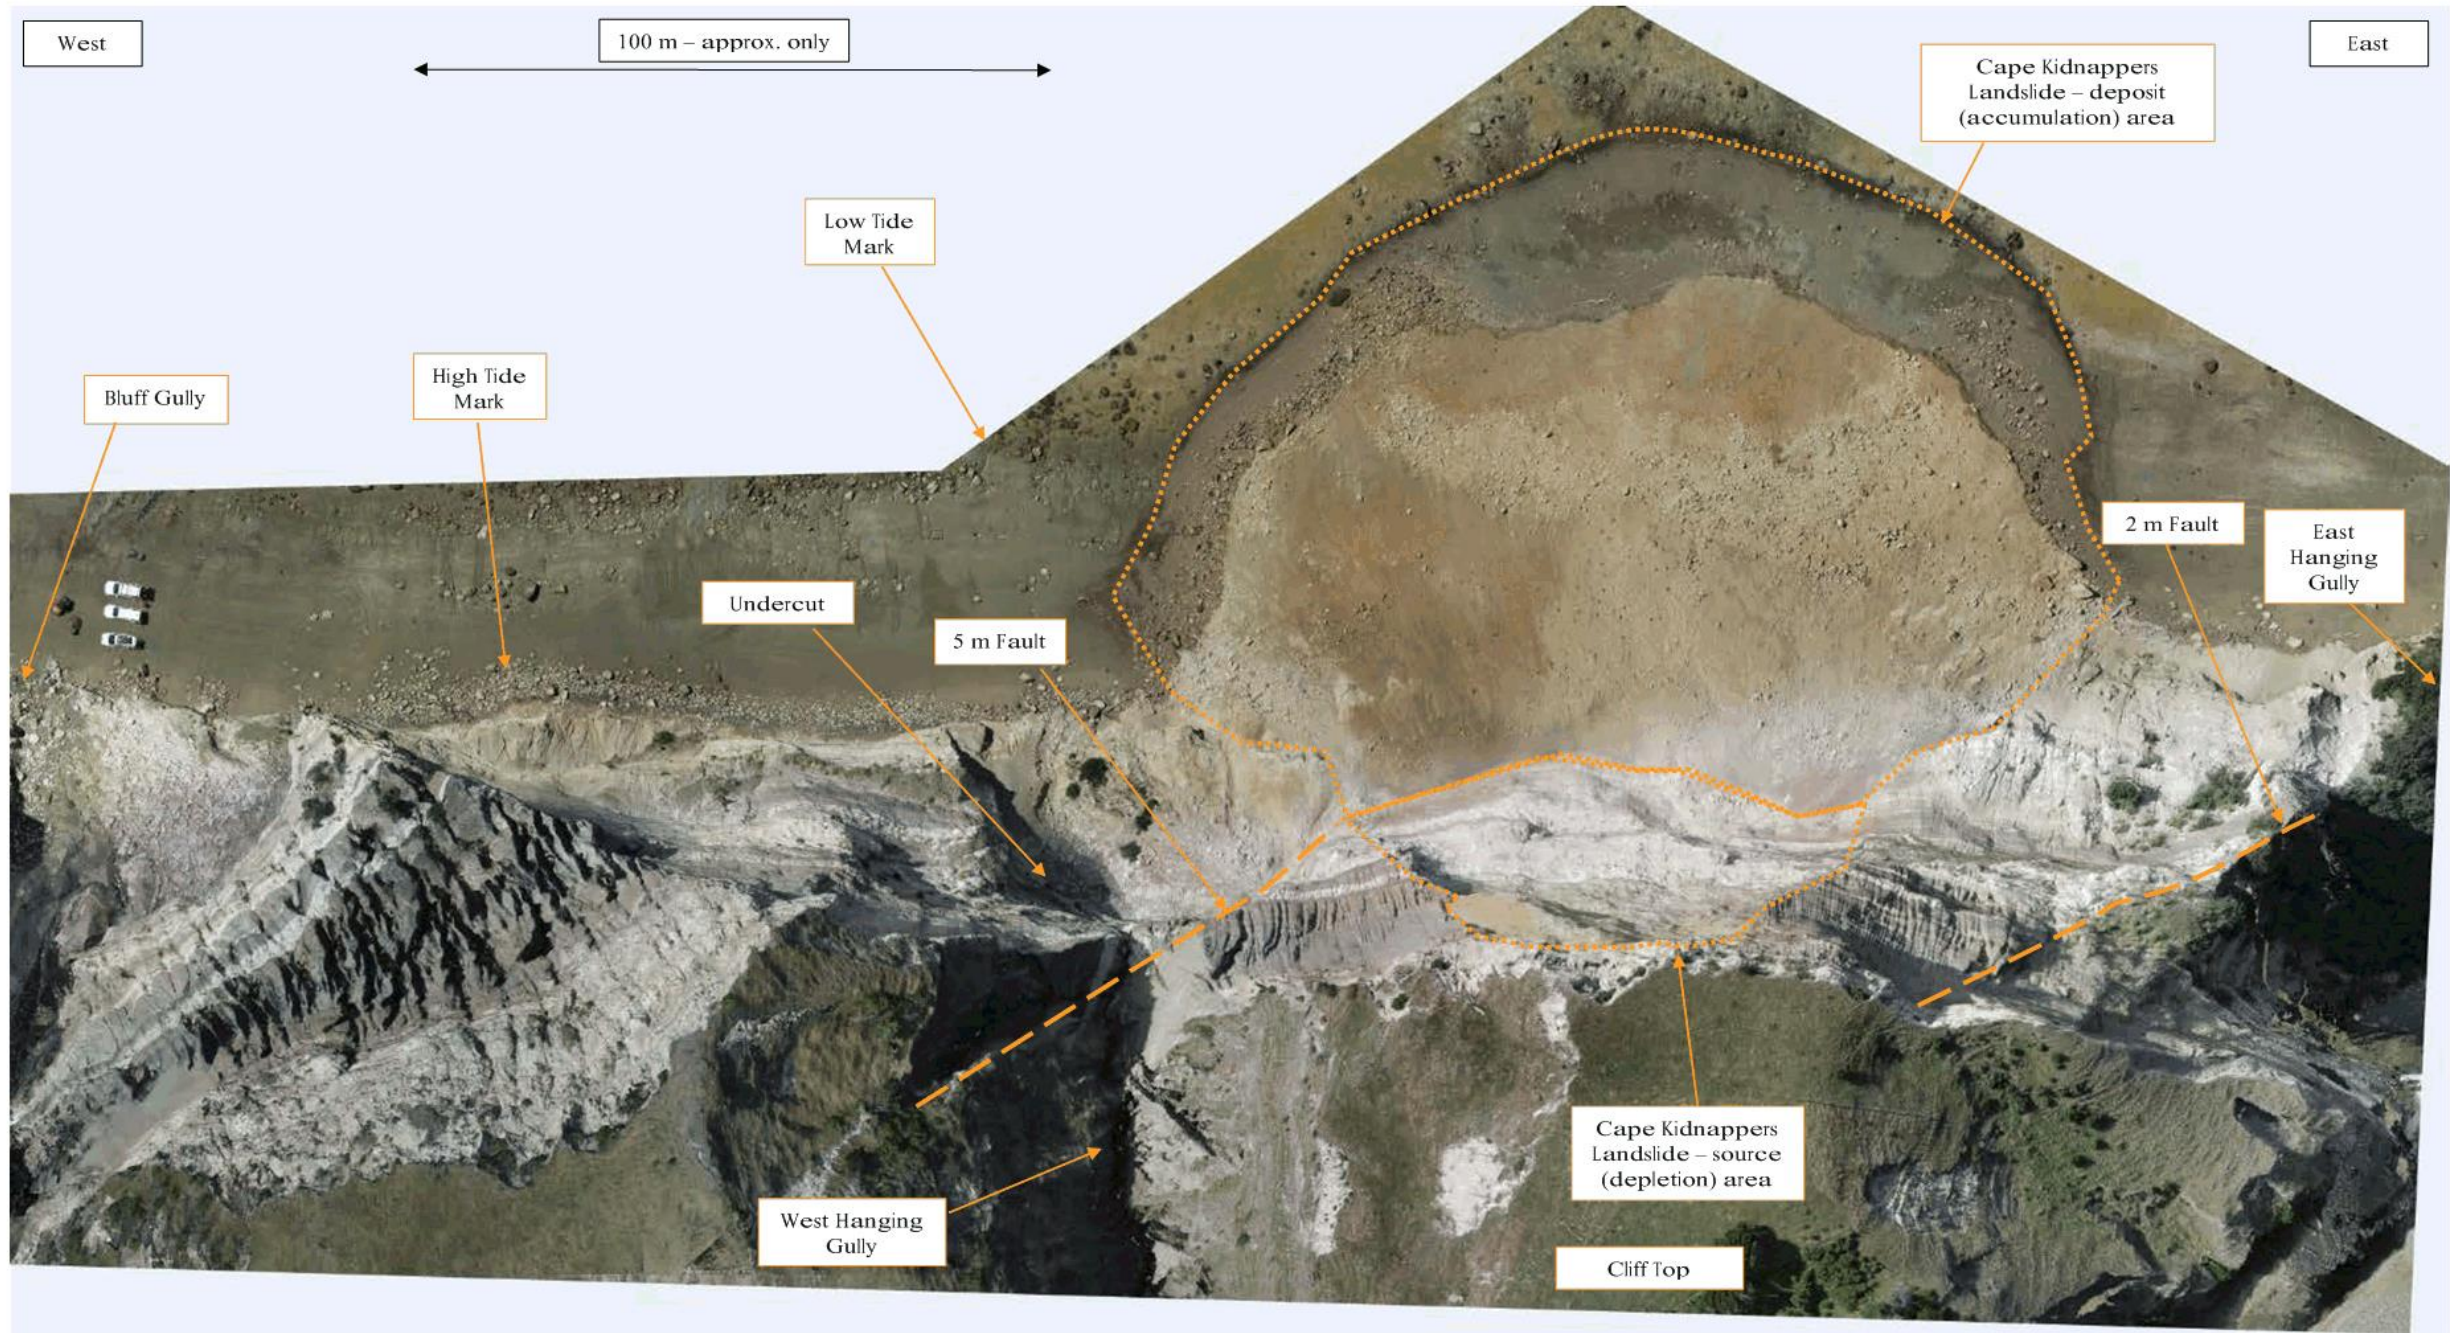
Figure 2-3: Cape Kidnappers Landslide orthophoto (taken at low tide, 25 January 2019)

An orthophane (elevation) of the CKL is presented as Figure 2-2 and an orthophoto (plan) as Figure 2-3.

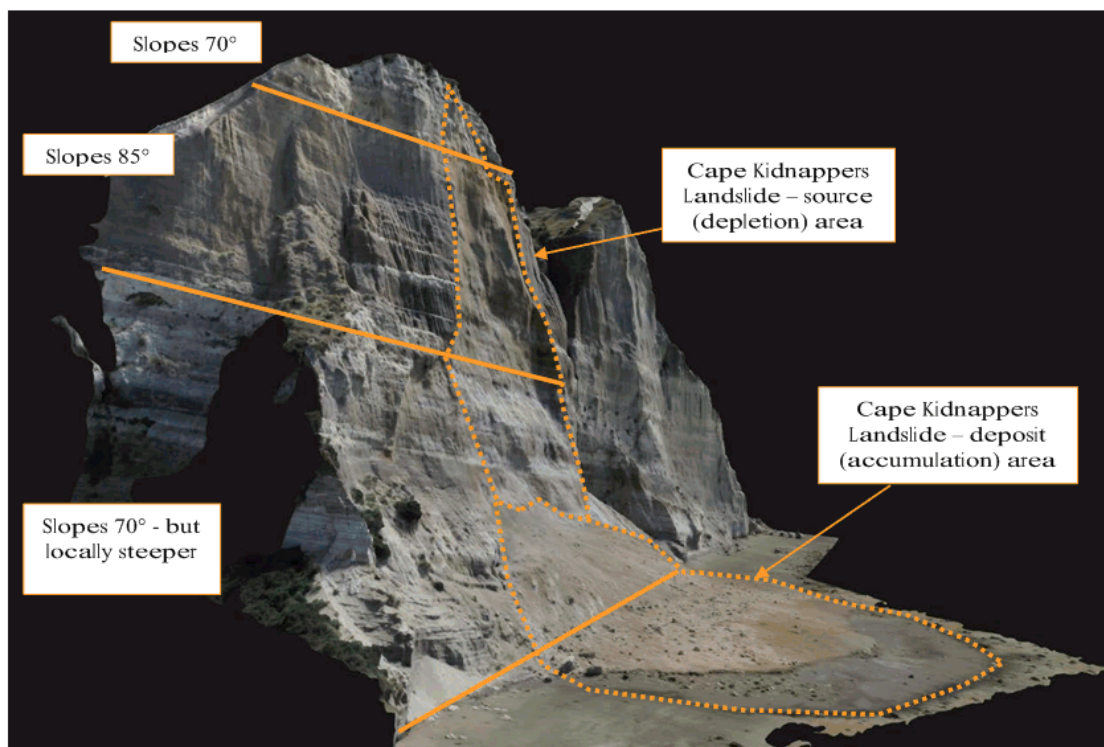
Figure 2-4: Schematic cliff section at the landslide location (25 January 2019)

The cliff on which the landslide occurred broadly strikes east-west and has a northerly (facing) aspect. The cliff is roughly 130 m high. Prior to the landslide, the cliff had an overall slope angle of around 75°. The cliff section did not appear to have been a uniform slope angle however (refer Figure 2-4). The section is judged as primarily controlled by geotechnical properties of the cliff forming materials (refer subsequent section), with secondary influences of coast and slope forming processes. Below mid-height, below the rockfall source area, the cliff sloped typically at 70°. Above this, within most of the landslide source area, the cliff appeared to slope more steeply at 85°. The top 20 m or so of the cliff, which includes the upper part of the landslide source area and the area above it, slopes at 70°. The cliff face is free of vegetation. The cliff top is grassed.

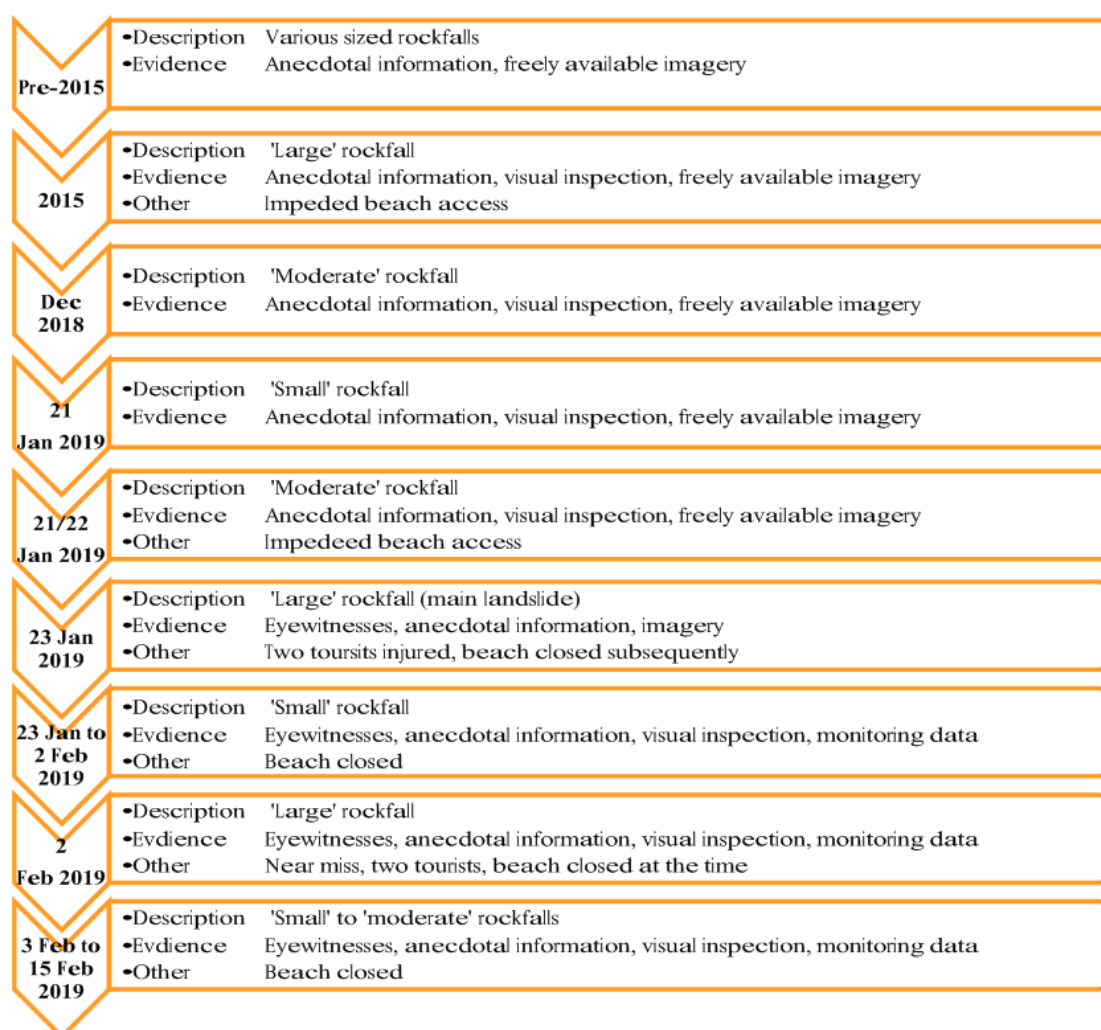
Figure 4-1: Provisional timeline for the Cape Kidnappers Landslide

A timeline for the CKL is still being developed. What is clear, is that the immediate landslide location has been subject to previous landsliding. Landsliding has continued post the 23 January 2019 (refer subsequent Section).

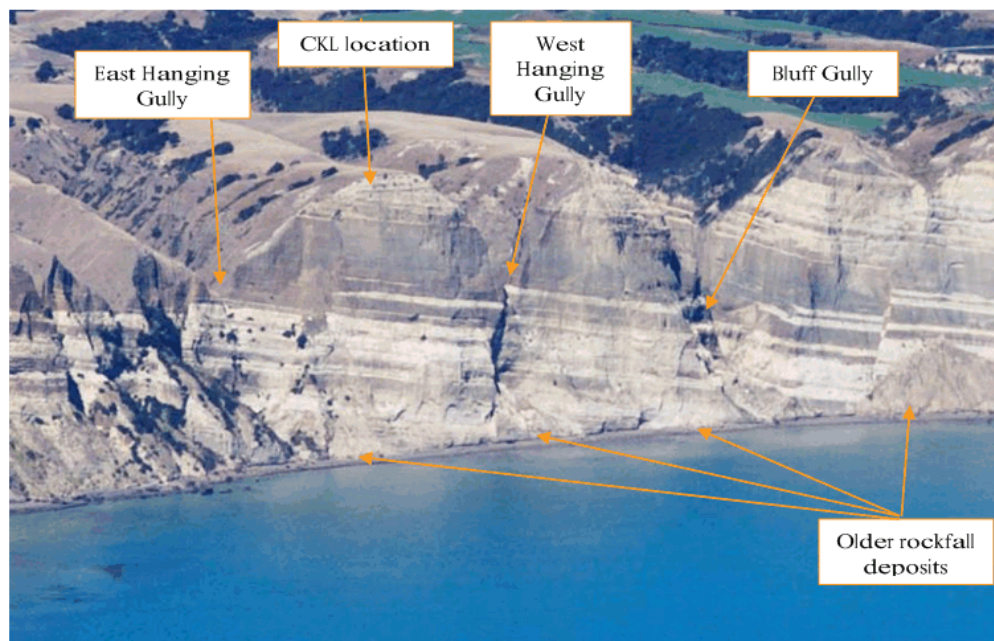
Figure 4-2: The CKL location in March 2015

An image of the cliff from March 2015 is shown below as Figure 4-2. This image is taken before the 2015 landslide occurred.

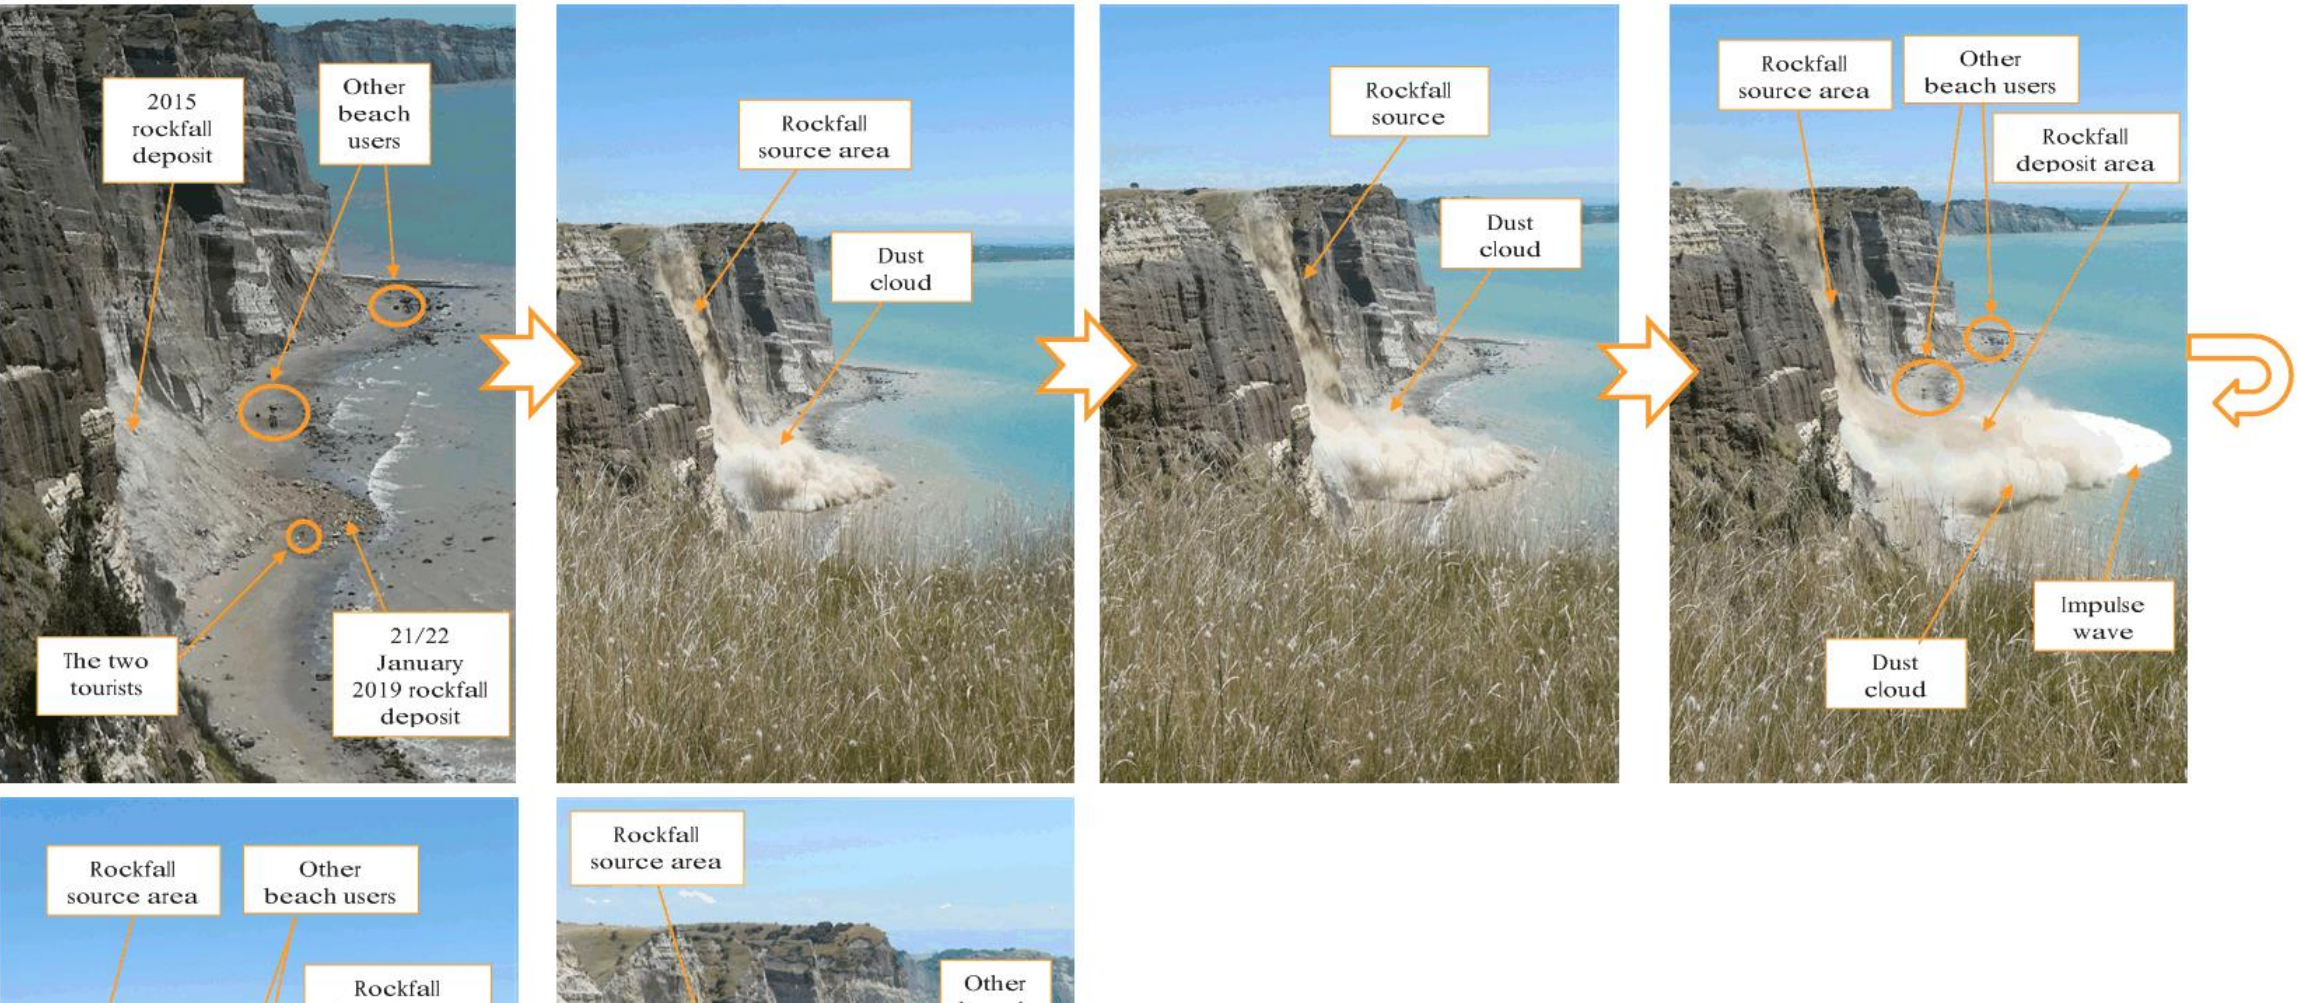
Third party images of the 23 January 2019 landslide are shown below in Figure 4-4. Key features are marked on the images. A video of the latter parts of the CKL can be found at <https://twitter.com/AnushaBradley/status/1087917915779878912/video/1>.

Based upon the work completed to date, the CKL of 23 January 2019 would be described as a 'rock fall'. Anecdotal information suggests toppling may have occurred locally. The rockfall deposit suggests the material was dry to moist. The velocity of the landslide would have been very rapid to extremely rapid based upon site characteristics and observations (such as the impulse wave generated).

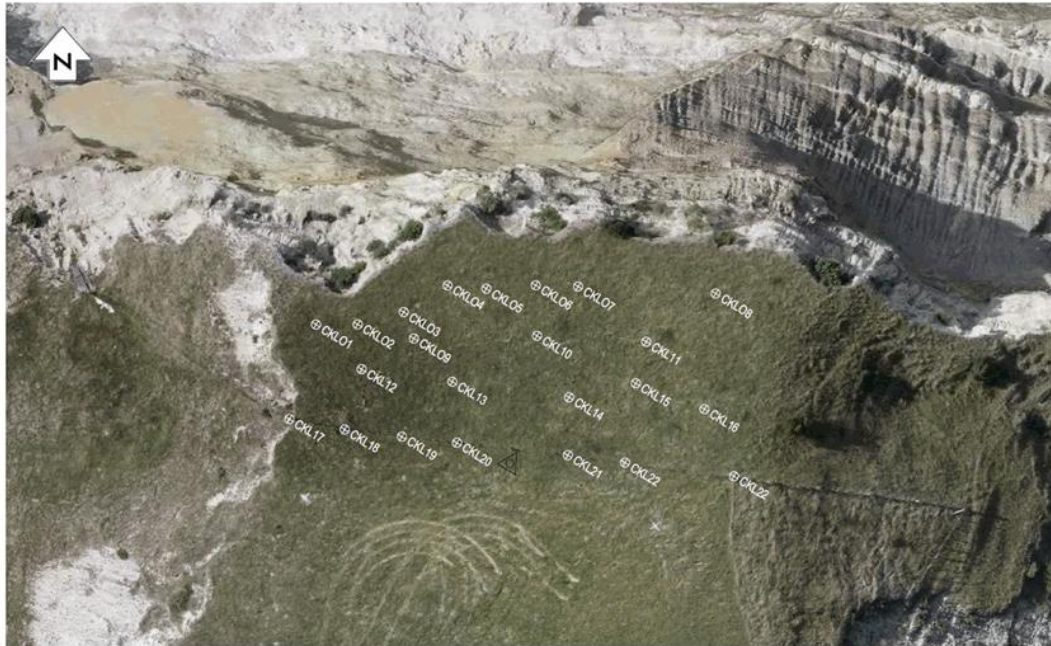
Figure 5-1: Locations of the survey monitoring points located at the cliff top, above the CKL location (5 February 2019)

The locations of the monitoring points are shown in Figure 5-1. Three rows of survey points were installed at approximately 5, 10 and 15 m distance from the cliff edge.
