PRE-CIRCULATED APPLICANT EVIDENCE

2. PRE-CIRCULATED APPLICANT EVIDENCE FOR CRAGGY RANGE TRACK REMEDIATION HEARING ON 11 JUNE 2019

Stage 2 Remedial Emergency Works: Landscape and Visual Effects Assessment
Prepared for Hastings District Council

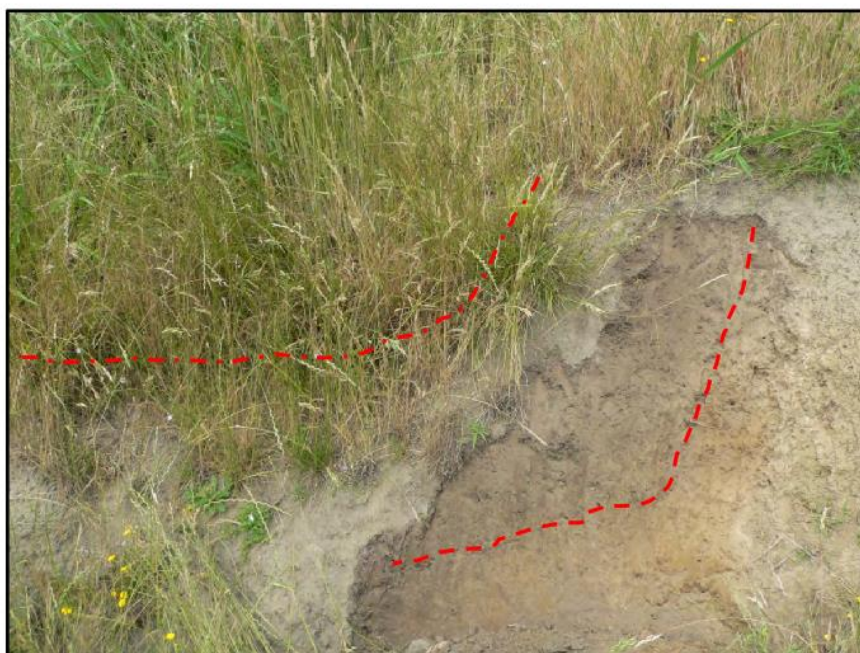
Example of a potential pit profile identified in track cut as highlighted by red dash.

Within the track bank cuts several potential archaeological profiles were noted. These were of a size and shape that would be consistent with pits (see photograph below). Unfortunately the extreme long grass made identifying further evidence of these potential pits in the ground surface difficult. Further, the location of these potential features on apparent gully slopes could be considered unusual for pits, however they have been identified in similar locations in other areas in Hawke's Bay so cannot be ruled out on this basis alone.

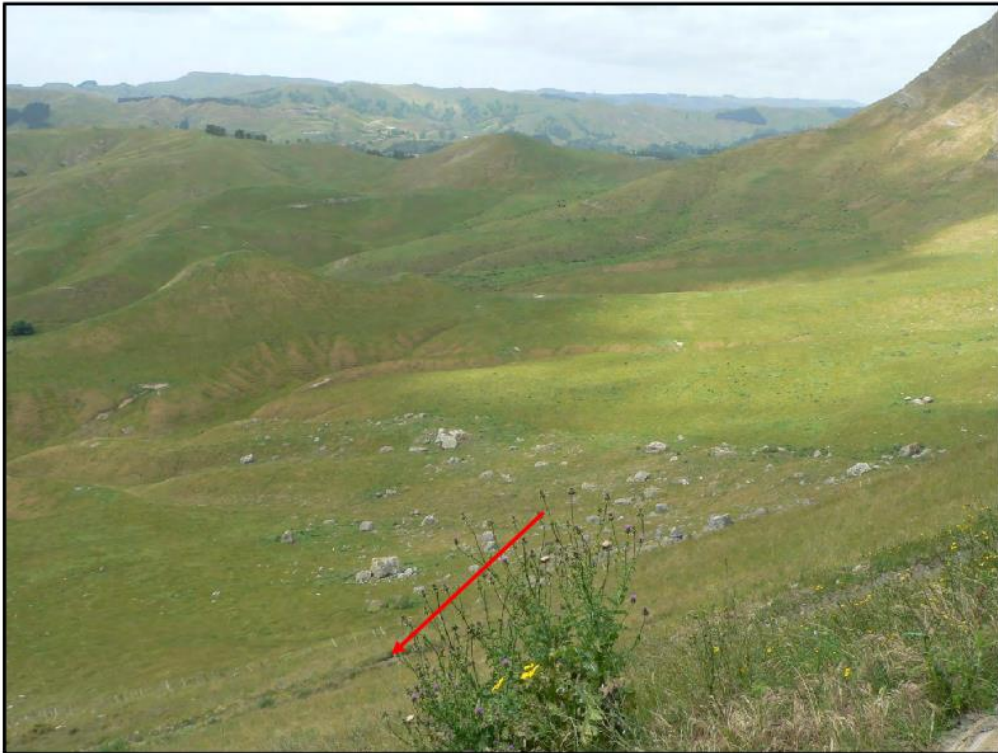
Location identified as represented by recorded sites V21/180 and V21/182 location in relation to the track (red arrow).

There are numerous recorded archaeological sites in the wider area, including V21/180 and V21/182, the ArchSite polygons of which lie between 0 m and < 50 m of the track cut. Recorded site V21/180 refers to a single raised rim pit, whilst V21/182 refers to an occupation area featuring numerous pits, drains and house sites. This is the *kainga* site that was noted during the site visit.

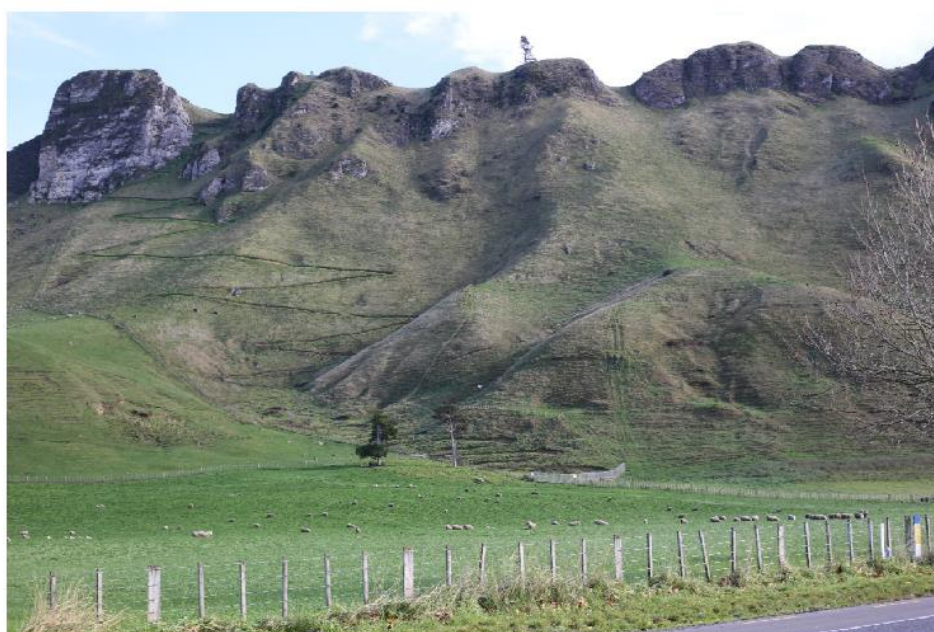
Figure 1 – Photo of installed track (June 2018)

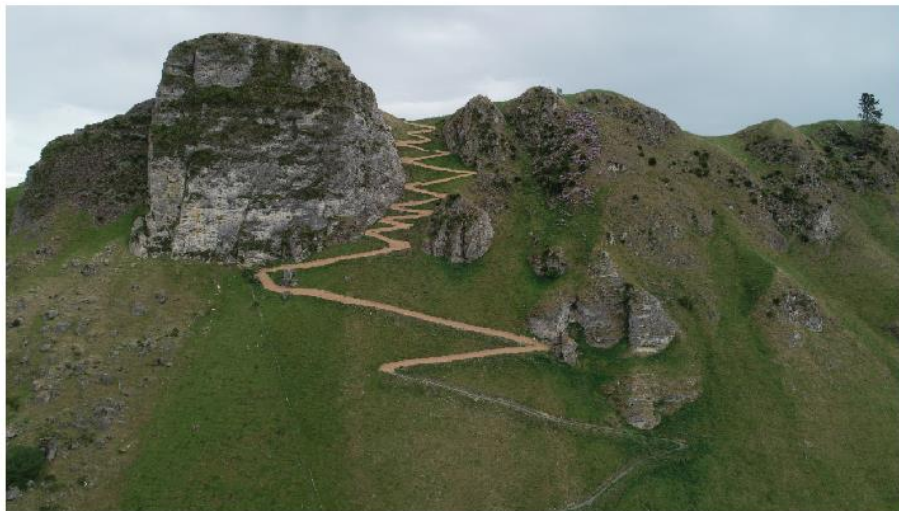
Figure 2 – Photo of remediated upper section of the track (November 2018)

- 1.5 Hastings District Council Acting Chief Executive considered this recommendation and concluded that the first stage of the remediation works affecting the upper 500m of the track could proceed as emergency works without a resource consent under s330 of the RMA.³ These works were carried out in early November 2018 and a retrospective consent, including a landscape and visual effects assessment was undertaken in December 2018.

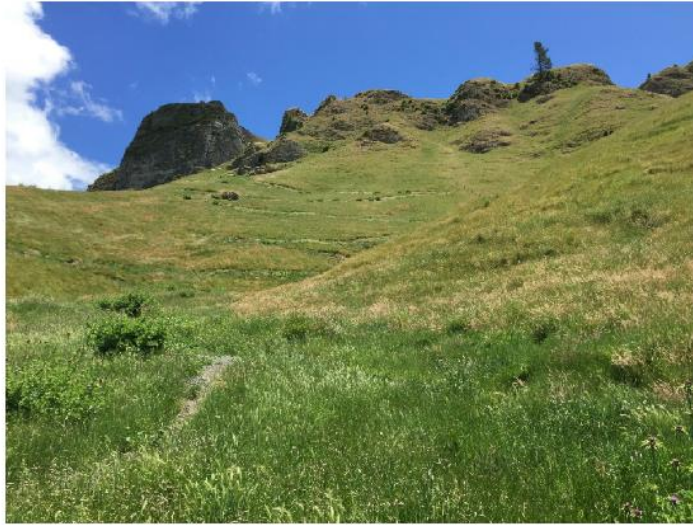
Figure 11 – Existing track amongst long grass

Tall pasture on both the upper and lower edges of the track had masked its presence in many places and the previously prominent zigzag had disappeared along many stretches (Figure 11). Weeds, especially thistles, dock, dandelion were also present, especially on track edges and on the side-cast material of the middle and lower track sections (Figure 12 and 13). Flat weeds were also becoming established on the actual track surface.

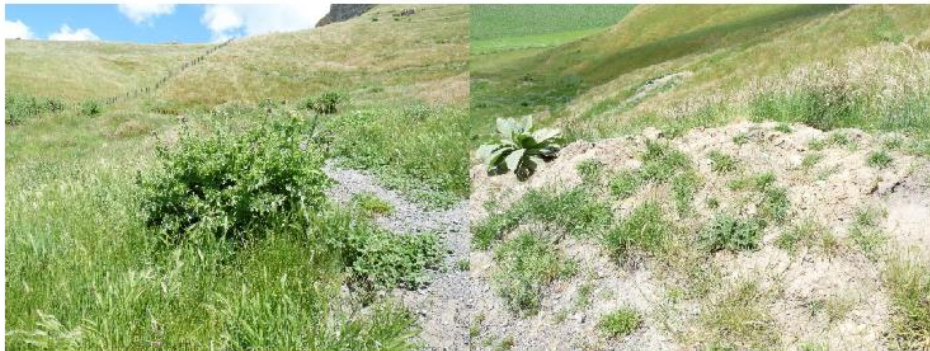
Figures 12 and 13 – Weed Species

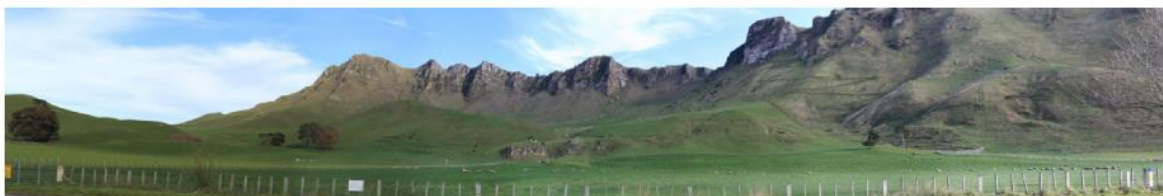
Figure 14 – Panorama looking west of eastern escarpment, including track (July 2018)

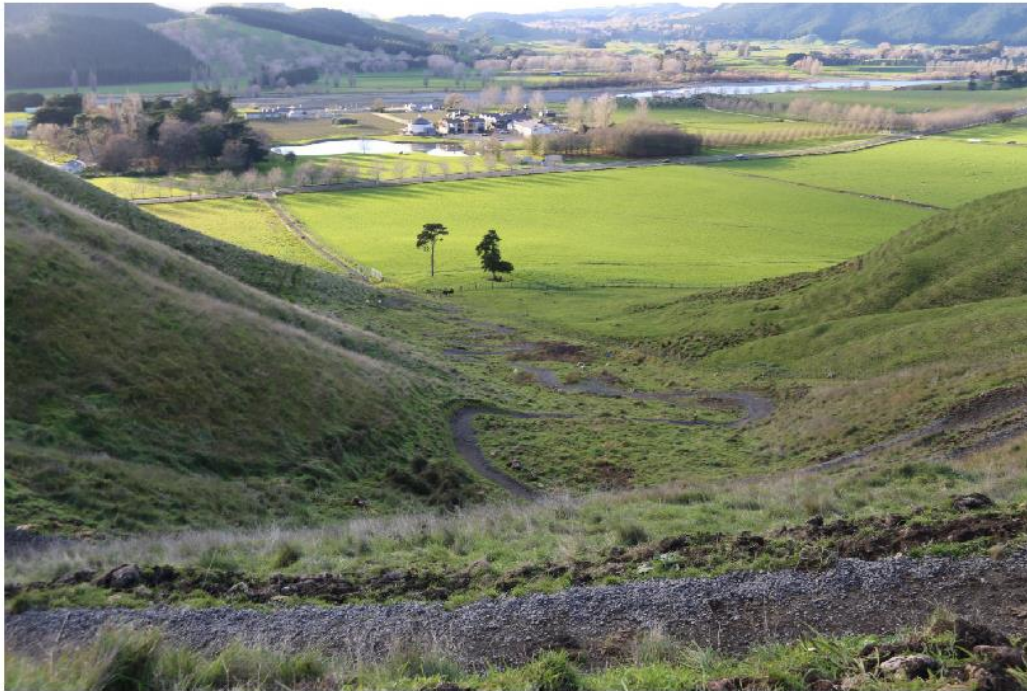
Figure 15 - View from Section C of the existing track, of eastern visual catchment

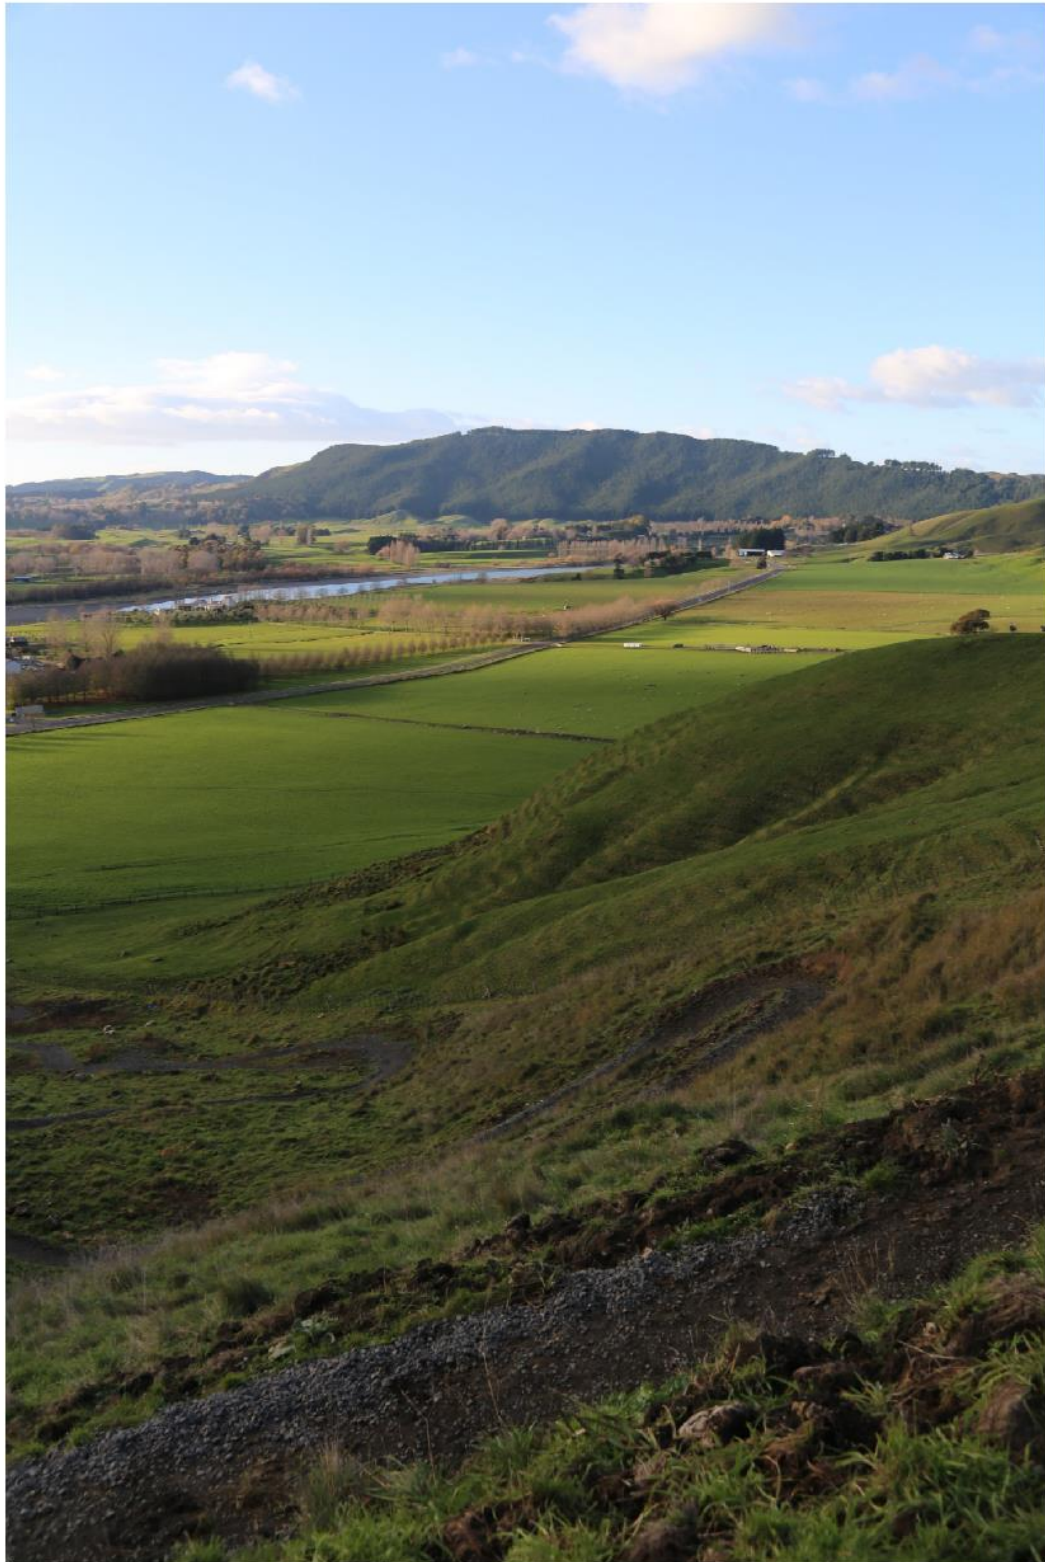
Figure 17 - View from Section C of the existing track, of southern visual catchment

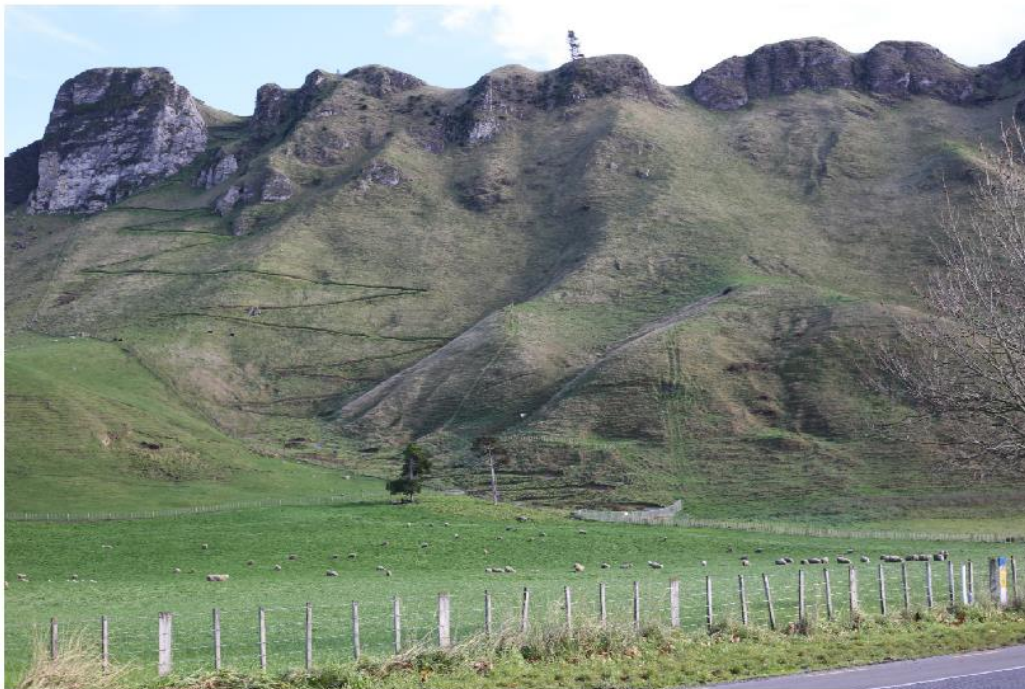
Figure 19 - View from Waimarama Road looking west at track

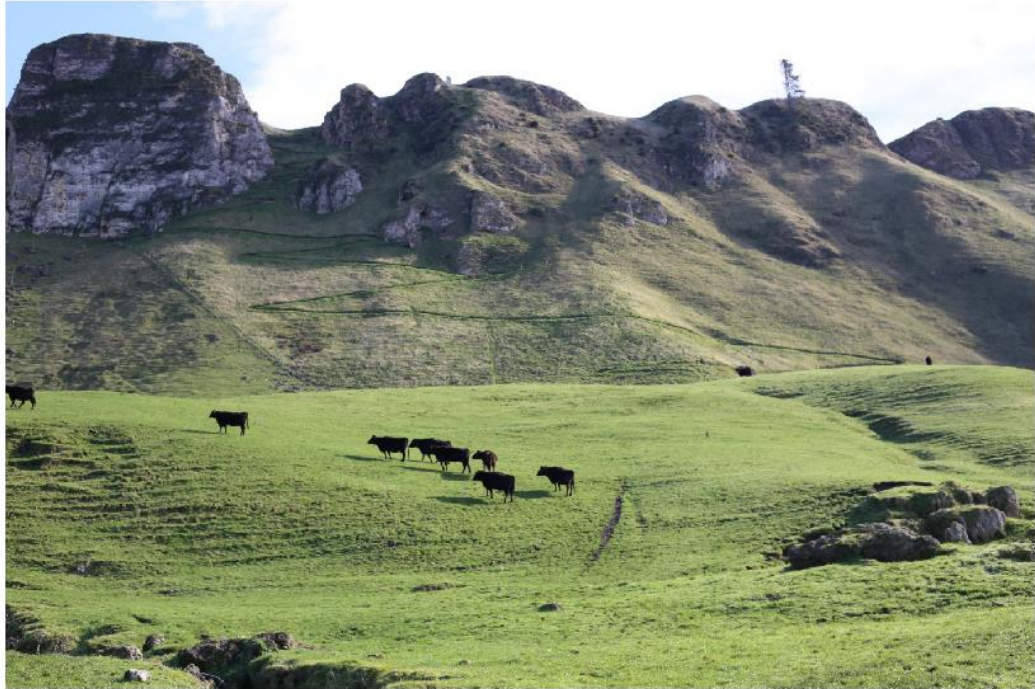
Figure 20 - View from Wellwood Farms property looking northwest at track.

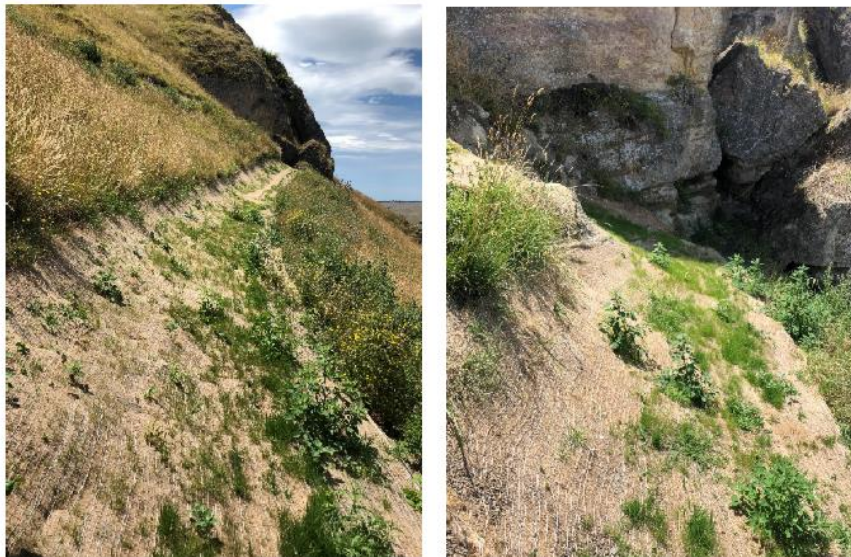
Figure 21 – View of Section D of track – January 2019

- 9.6 Existing remediation of Section D portion of the track demonstrates the integration of the landform. Photographs taken in early January 2019⁷ (Figure 21) show the level of growth on the remediated section of the track (Section D) demonstrates the rapid grass and weed growth through the matting. Complete reinstatement of the pre-track landform is not possible from a construction perspective but over time the establishment of the ryegrass mix and invasion of surrounding pasture will ensure the track alignment will not be visible.

As with Section D, the upper section of the track, the introduction of the BioCoir matting on Sections B and C will be a temporary measure, however this will accentuate the alignment of the track on the eastern escarpment. This is a temporary measure which will begin biodegrading at 6 months and will continue to degrade amongst dominating grass cover over a period of up to 5 years. Recent examples of growth on the remediated section of the track (Section D) demonstrates the rapid grass and weed growth through the matting.

Examples of the remediated Section D portion of the track demonstrate the integration of the landform. This approach provides a successful remediation of the natural landform, recognising that complete reinstatement of the pre track landform is not possible from a construction perspective. Over time the integration of the ryegrass mix and long term invasion of surrounding pasture cover will ensure the track alignment will not be visible.

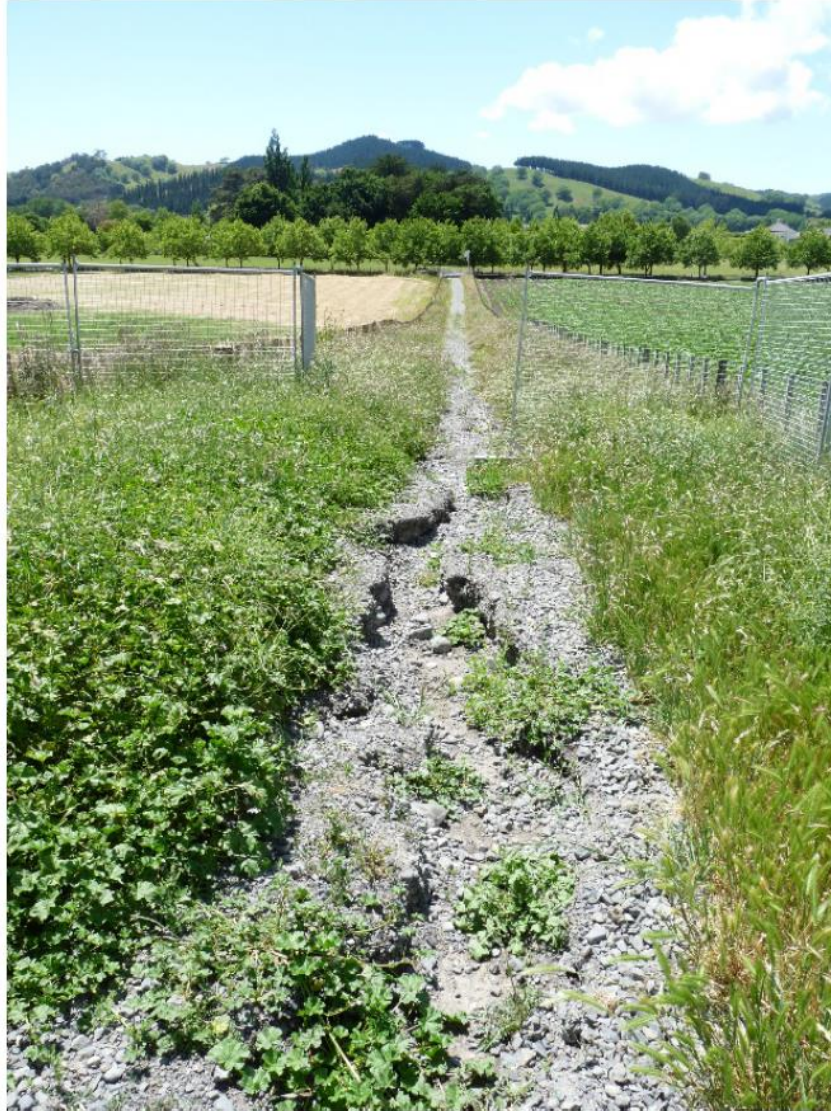
Figure 22 - View of Section A track condition (October 2018)

Section A of the track will not require BioCoir matting due to the flat gradient. A silt dominated topsoil will be placed on the site and seeded with a productive pasture mix dominated by ryegrass (Refer to Appendix 4). This will see this area visually integrate within 1-2years with a dominant pasture cover in three years.
