Te Hui o Te Kaunihera ā-Rohe o Heretaunga
Hastings District Council
Council Meeting

DRAFT STATEMENT OF PROPOSAL

PROPOSED SPEED LIMIT
AMENDMENTS TO THE
SPEED LIMITS BYLAW 2012

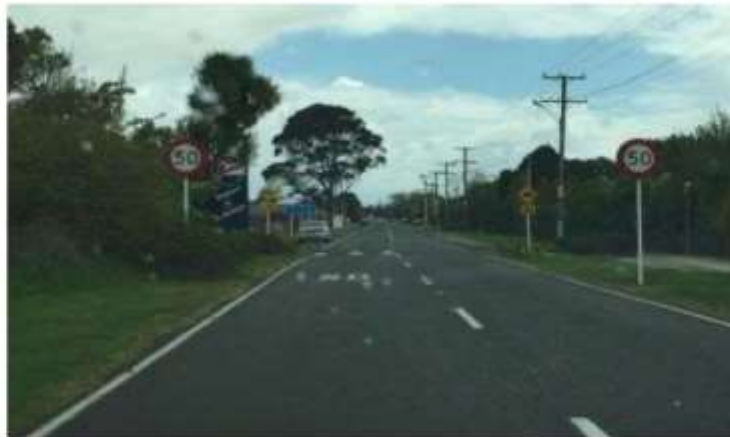
Entering Te Awanga from the south

Note, the image above shows the starts of the 50km/h speed limit and the speed hump immediately behind it with a 20km/h advisory speed. Even if the speed limit is reduced to 80km/h it is likely that vehicles will enter the lower speed area at a speed greater than 50km/h. Due to the limited separation between the speed limit change point and speed hump it is proposed to extend the 50km/h section approximately 30m to the south (providing better offset from the speed limit change and the speed hump).

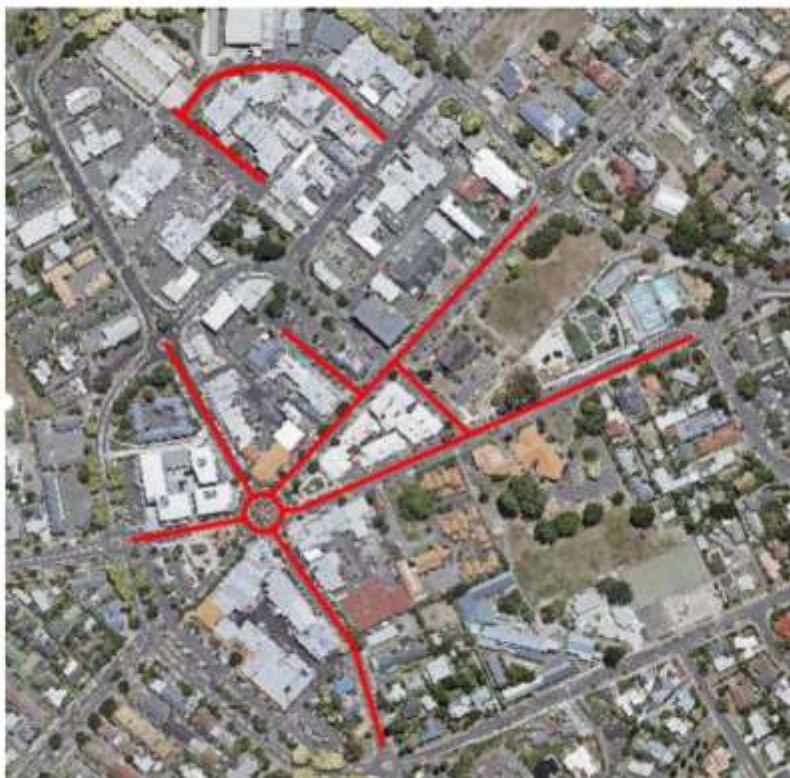
17 Proposal 17: Havelock North CBD

The speed limit review for the Havelock North CBD area was undertaken following a public request to consider the introduction of a 30km/h speed limit zone. The Havelock North Business Association have indicated their support for this proposal.

- The speed limit be reduced from 50km/h to 30km/h across the CBD area as indicated above.

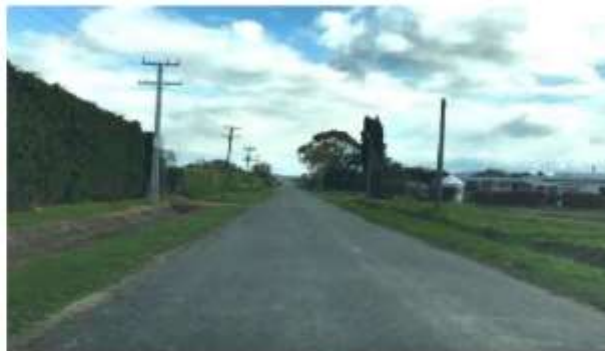
Typical layout of Jarvis Road

The existing speed limit along this road is 100km/h for most of its length with the exception of the first 110m from the Omaha Road intersection which is 70km/h. The 85th percentile speed is slightly below the calculated safe speed of 80km/h which suggests that compliance with an 80km/h speed limit will not be an issue. Given the width of the road and roadside hazards in the form of ditches and culverts (see below), the speed limit on Jarvis Road is proposed to reduce to 80km/h to be closer to the Safe And Appropriate Speed.

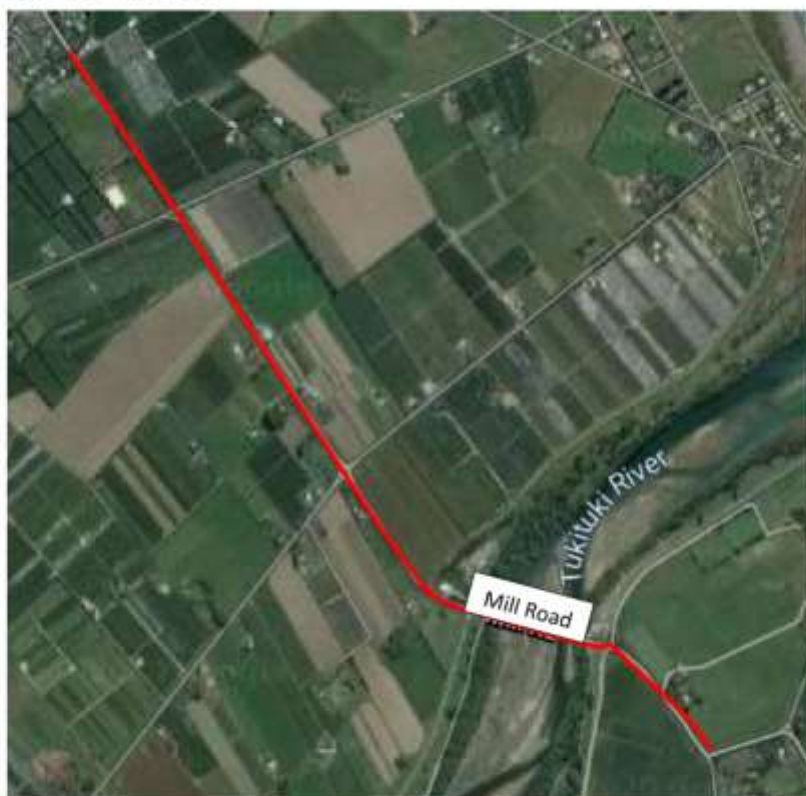
25 Proposal 25: Mill Road

This section of Mill Road, from Clive to Tuki Tuki Road, is currently 100km/h and is being identified as a top ten percent site for Death and Serious Injury Crashes.

- The speed limit be reduced from 100km/h to 80km/h on Mill Road between the existing 50km/h speed limit signs and Tuki Tuki Road.

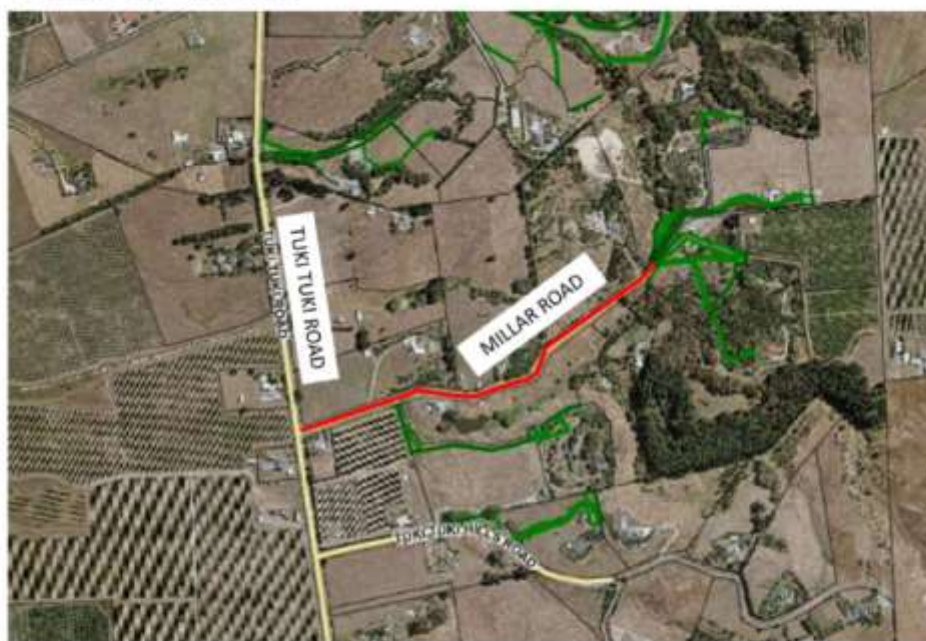
26 Proposal 26: Millar Road

Millar Road has been reviewed due to the proposed change to the speed limit on Tuki Tuki Road (from 100km/h to 80km/h)

- Reduce the speed limit on Millar Road from 100km/h to 80km/h for its entire length.

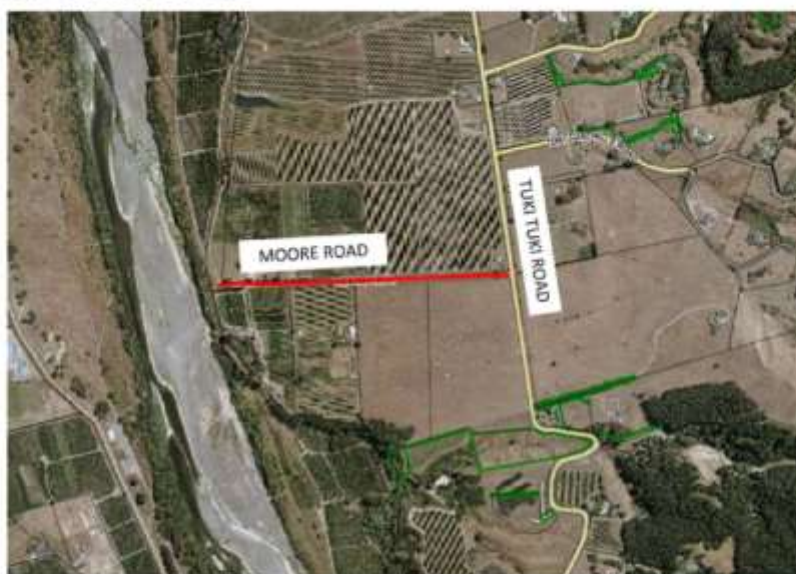
27 Proposal 27: Moore Road

Moore Road has been reviewed due to the proposed change to the speed limit on Tuki Tuki Road (from 100km/h to 80km/h)

- Reduce the speed limit on Moore Road from 100km/h to 80km/h for its entire length.

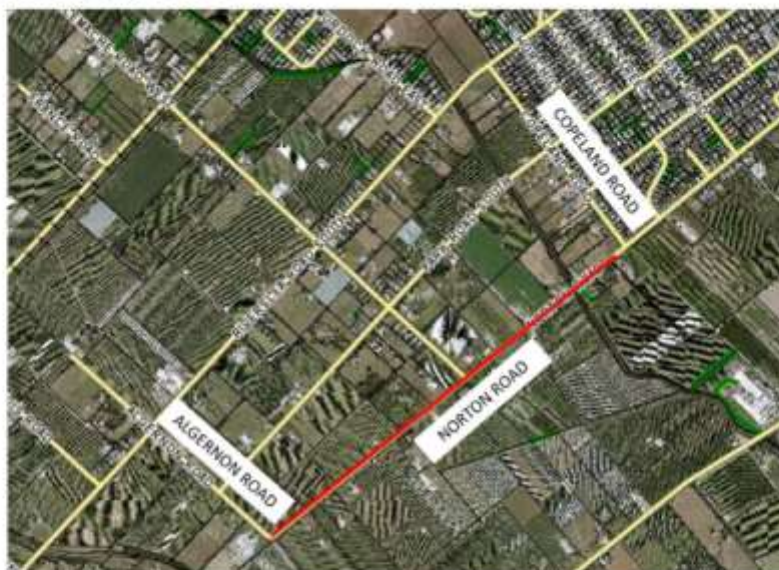
28 Proposal 28: Norton Road

The public request to review the speed limit on Norton Road, between Algernon Rd and Copeland Road, forms part of the broader speed limit review for the Longlands area.

- The speed limit be reduced from 100km/h to 80km/h along Norton Road from Algernon Road to the existing 50km/h speed limit signs 90m west of Copeland Road.

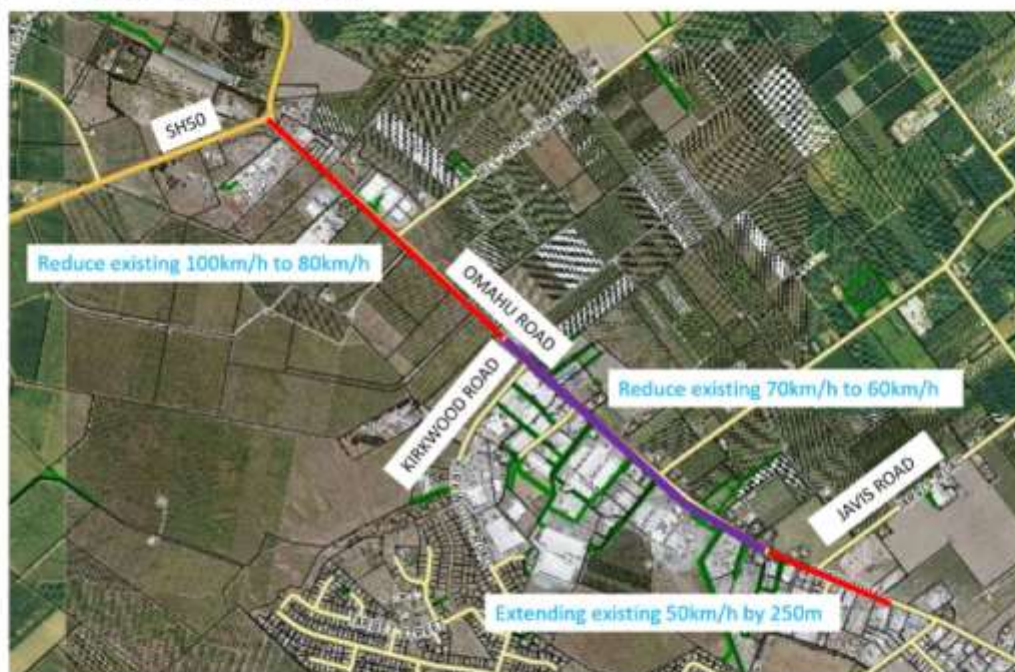
29 Proposal 29: Omaha Road

This section of Omaha Road was selected for the speed review for two reasons, to review the section identified as being in the top ten percent of sites for Death and Serious Injury reductions and a request to extend the existing 50km/h speed limit.

- The 50km/h speed zone to be extended from its existing position approximately 250m east of Jarvis Road to the start of the existing flush median 250m west of Jarvis Road.
- A speed limit of 60km/h be implemented on Omaha Road from a point 90m west of Kirkwood Road to a point 250m west of Jarvis Road.
- The speed limit be reduced from 100km/h to 80km/h on Omaha Road from the intersection with SH50 to the existing 70km/100km/h speed limit change point approximately 90m west of Kirkwood Road.

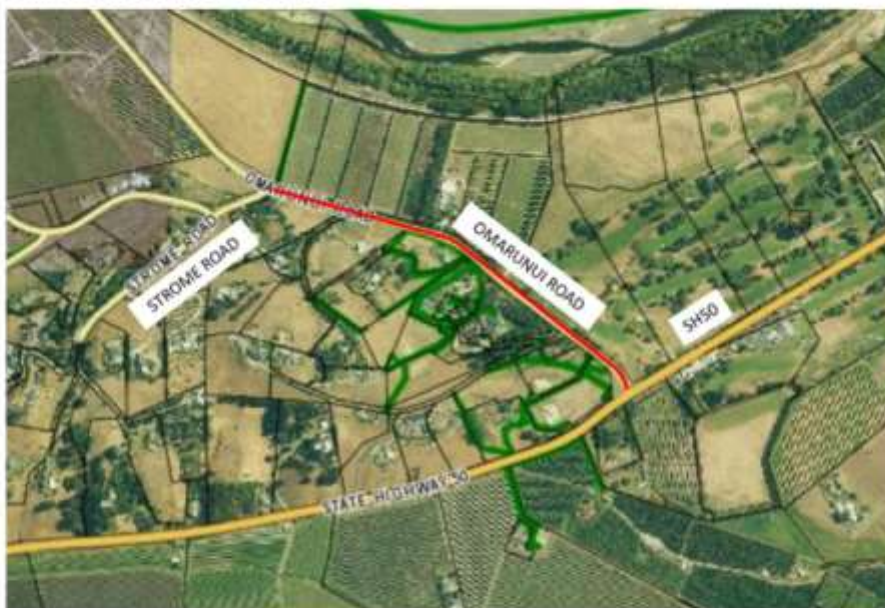
30 Proposal 30: Omarunui Road

This section of Omarunui Road, between SH50 and Strome Road, is currently 100km/h with adjacent land uses being residential lifestyle before becoming more rural north of Strome Road.

- The speed limit be reduced from 100 to 80km/h on Omarunui Road between Strome Road and SH50.

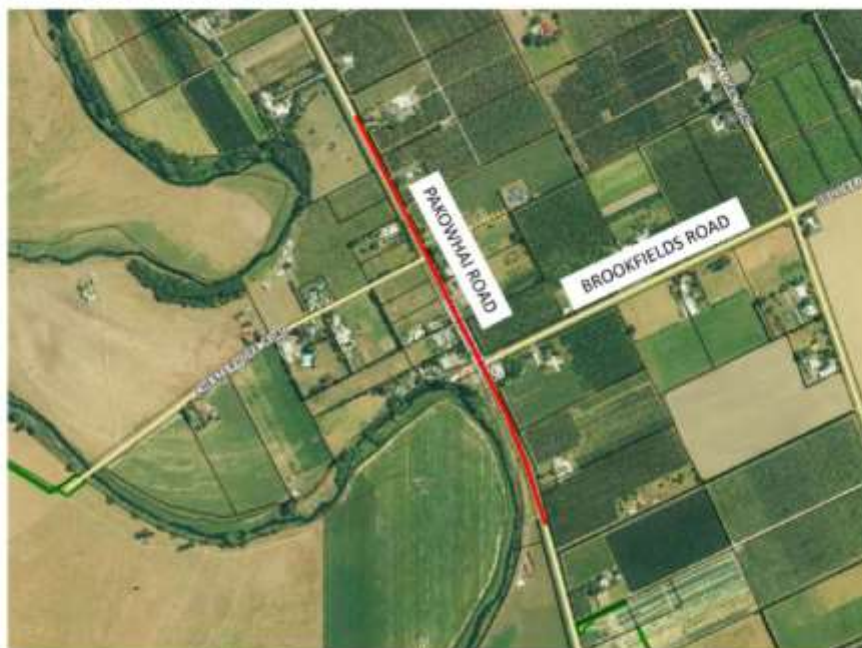
31 Proposal 31: Pakowhai Road

This section of Pakowhai Road, between 240m south of Brookfields Road to 640m north of Brookfields Road, is currently 60km/h following its change as part of the wider Pakowhai Road speed limit reductions in 2014. Traffic counts and observations suggest that this speed limit is rarely adhered to by road users and following the completion of the Whakatu Arterial Link (Te Ara Kahikatea), the strategic importance of this route for commuters and the broader industry has increased.

- The speed limit be increased from 60km/h to 80km/h for the section of Pakowhai road from 240m south to 640m north of Brookfields Road.

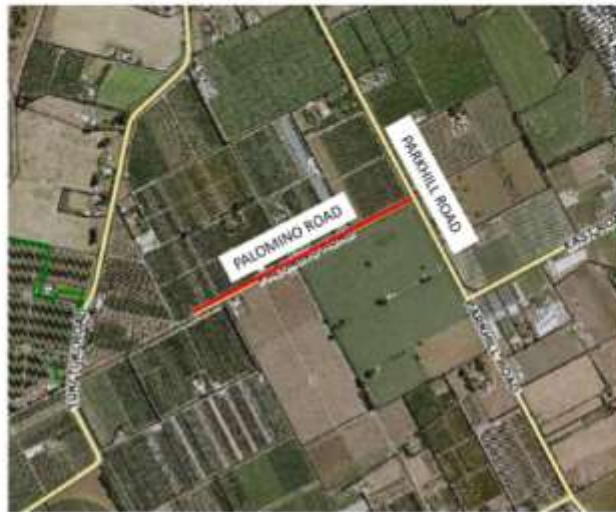
32 Proposal 32: Palomino Road

Palomino Road has been reviewed due to the proposed change to the speed limit on Parkhill Road (from 100km/h to 80km/h)

- The speed limit be reduced from 100km/h to 80km/h for the entire length of Palomino Road.

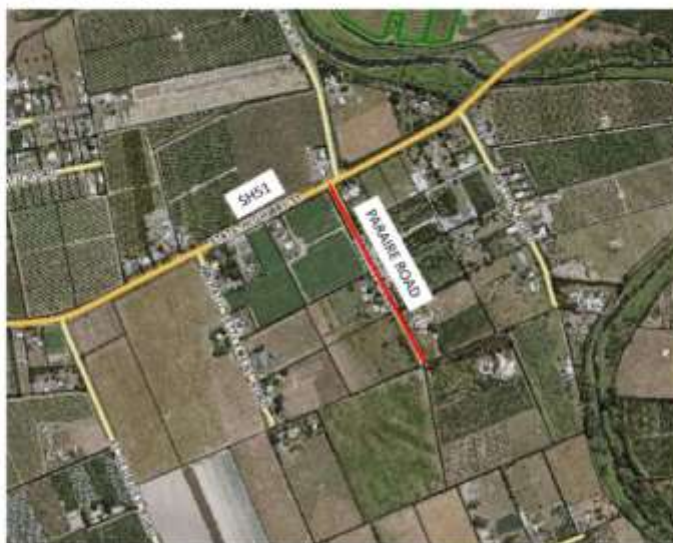
33 Proposal 33: Paraire Road

Paraire Road is one of the three roads that are all parallel no exit roads that intersect with SH51 in proximity to the Waipatu settlement. The request to review the speed limit on Paraire Road relates to the NZTA speed limit review on SH51.

- The speed limit on Paraire Road be reduced from 80km/h to 60km/h along the entire length of the road.

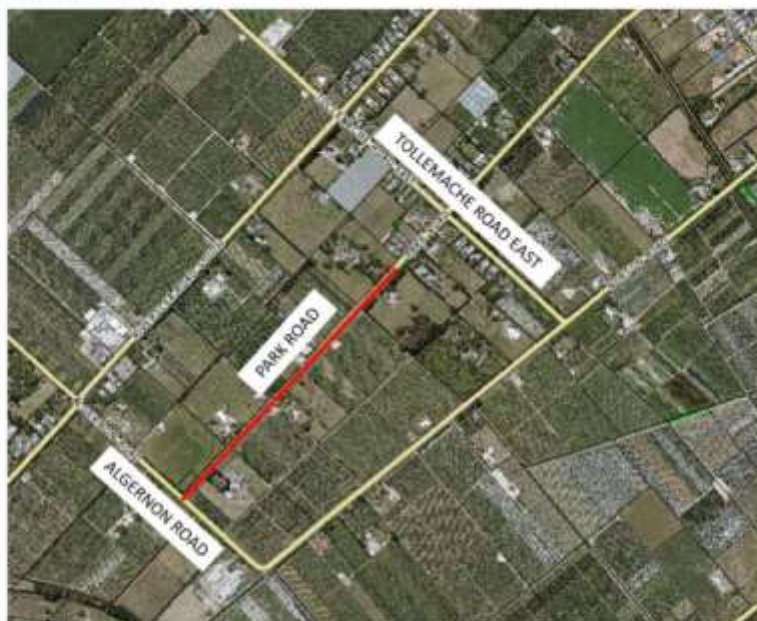
34 Proposal 34: Park Road

The request to review the speed limit on Park Road, between Algernon Road to 200m West of Tollemache Road East, is a part of the broader speed limit review for the Longlands area.

- The speed limit be reduced from 100km/h to 80km/h along Park Road from the intersection with Algernon Road to the existing 70km/h speed limit signs 200m west of Tollemache Road East.

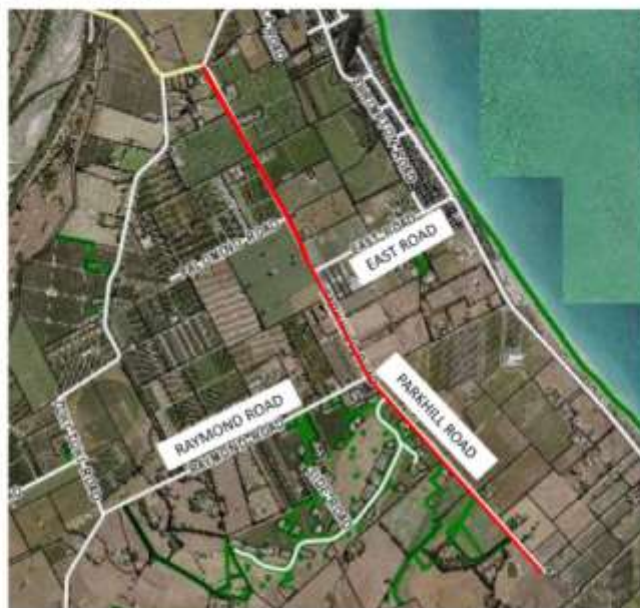
35 Proposal 35: Parkhill Road

The speed limit review on this section of Parkhill Road is a part of the speed review in the surrounding road network and more specifically the review on East Road and Haumoana Road.

- The speed limit be reduced from 100 to 80km/h on Parkhill Road from Haumoana Road through to the end of the road south of Raymond Road.

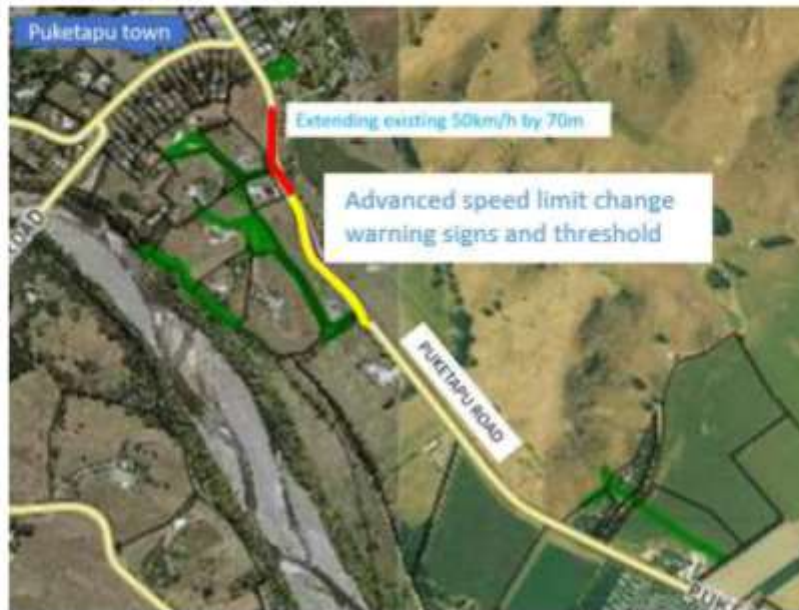
36 Proposal 36: Puketapu Road

The speed limit review on this section of Puketapu Road, south of the township, is a part of the broader speed limit review for the Puketapu area.

- The 50km/h speed limit zone be extended from the existing 50/100km/h signs to the south by 70m.

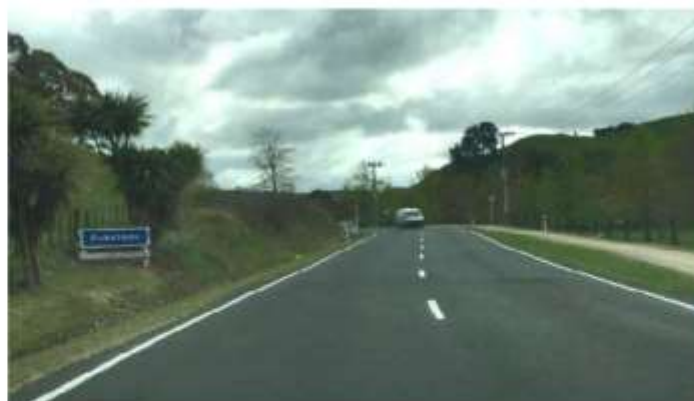
The section of Puketapu Road south of the township is classified a Primary Collector (with the same characteristics as Dartmoor Road), with a low collective and low personal risk and an Infrastructure Risk Rating band of medium. The current location of the change from 50 to 100km/h is on a curve, see below. It is recommended to combine speed limit signs with the Puketapu place name sign to provide a threshold treatment to allow a greater buffer prior to vehicles reaching the township. This requires an extension of the 50km/h speed limit by 70m to the south.

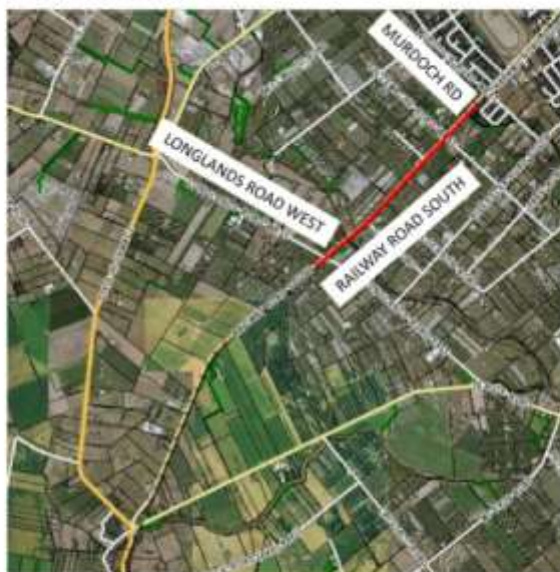
37 Proposal 37: Railway Road South

This section of Railway Road South has been reviewed due to it being identified as a top ten percent site for Death and Serious Injury reductions through a lowering of travel speeds.

- The speed limit be reduced from 100km/h to 80km/h on a section of Railway Road South from the 50km/h speed limit 50m south of Murdoch Road through to 250m south of the intersection with Longlands Road.
- The Rural Intersection Advanced Warning Signs speed limit on Railway Road South at Longlands Road be reduced from 100/70km/h to 80/60km/h.

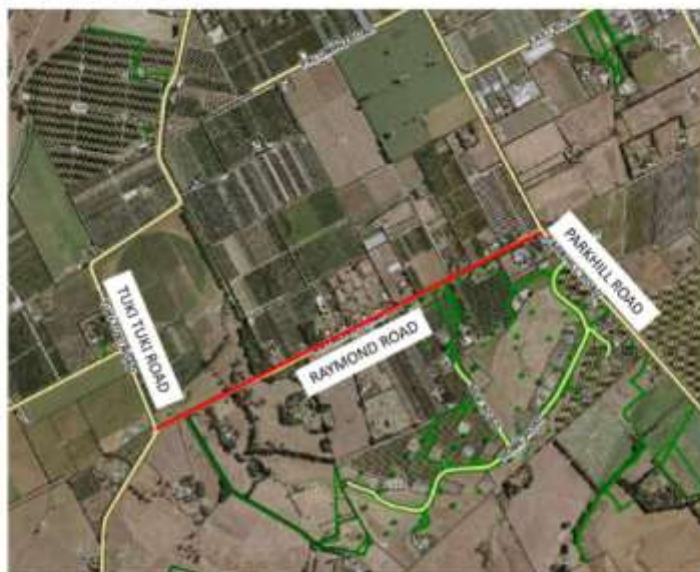
38 Proposal 38: Raymond Road

The speed limit on Raymond Road was requested to be reviewed by residents in the community. It also ties in to the broader speed limit review associated to Tuki Tuki Road and Parkhill Road that it connects to. Speed limit changes across this area are proposed to achieve a more consistent solution for road users.

- The speed limit be reduced from 100km/h to 80km/h on the whole length of Raymond Road. The 50km/h courtesy speed zone in front of the school will remain in place.

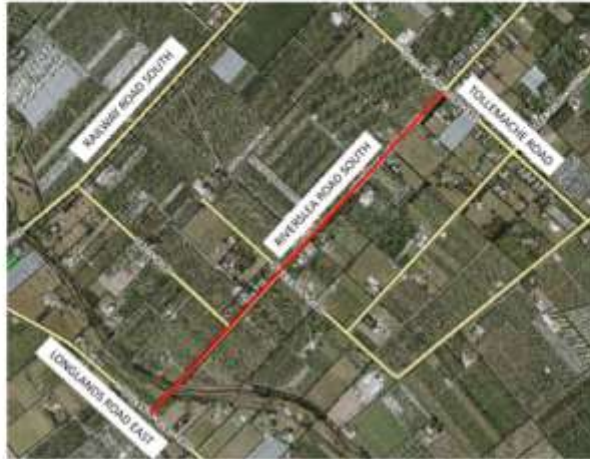
39 Proposal 39: Riverslea Road South

This section of Riverslea Road South has been reviewed due to it being identified as a top ten percent site for Death and Serious Injury reductions through a lowering of travel speeds.

- The speed limit be reduced from 100km/h to 80km/h from the existing 50km/h speed limit signs south of Tollemache Road through to Longlands Road East.

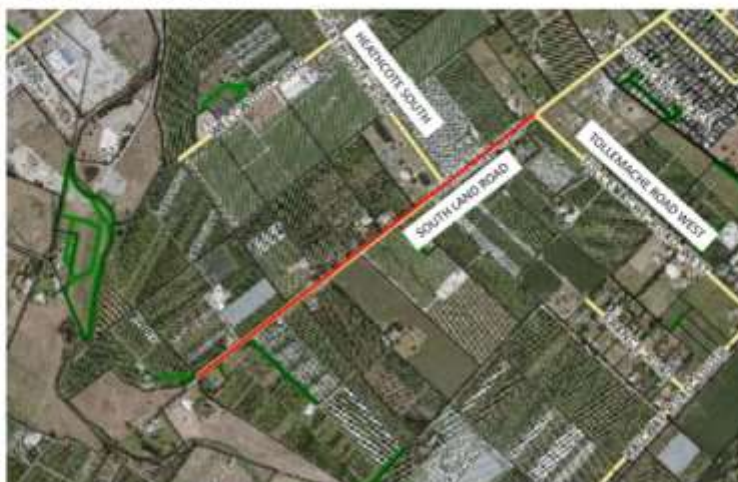
40 Proposal 40: Southland Road

This section of Southland Road is currently 100km/h with an approximately 380m length to the east, between Tollemache Road and Heathcote Road, being identified as a top ten percent site for Death and Serious Injury reductions.

- The speed limit be reduced on Southland Road from 100km/h to 80km/h from the 50km/h signs near Tollemache Road to its western extent.

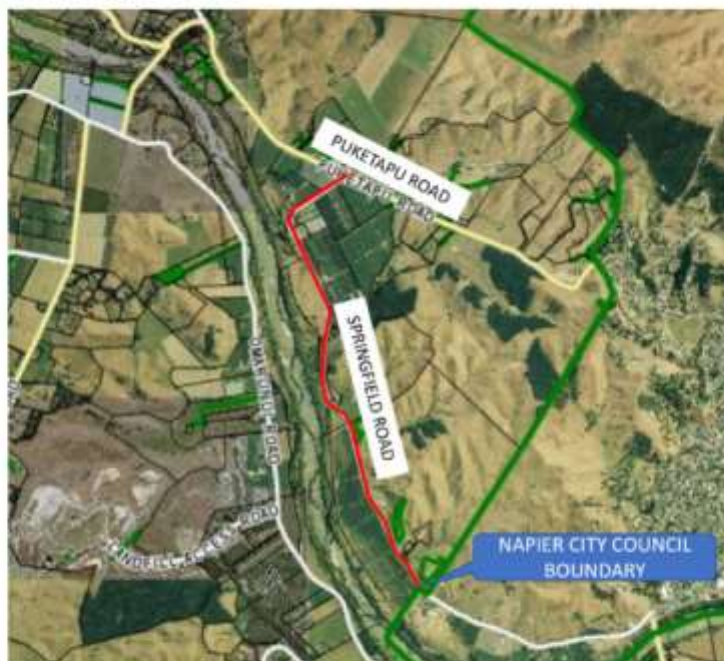
41 Proposal 41: Springfield Road

The speed limit review on this section of Springfield Road, from Puketapu Road to Napier City Council boundary, is a part of the road network speed limit review following Napier's proposal to reduce the remaining extents of Springfield Road to 80km/h.

- The speed limit be reduced from 100km/h to 80km/h on Springfield Road between Puketapu Road and the boundary with Napier City.

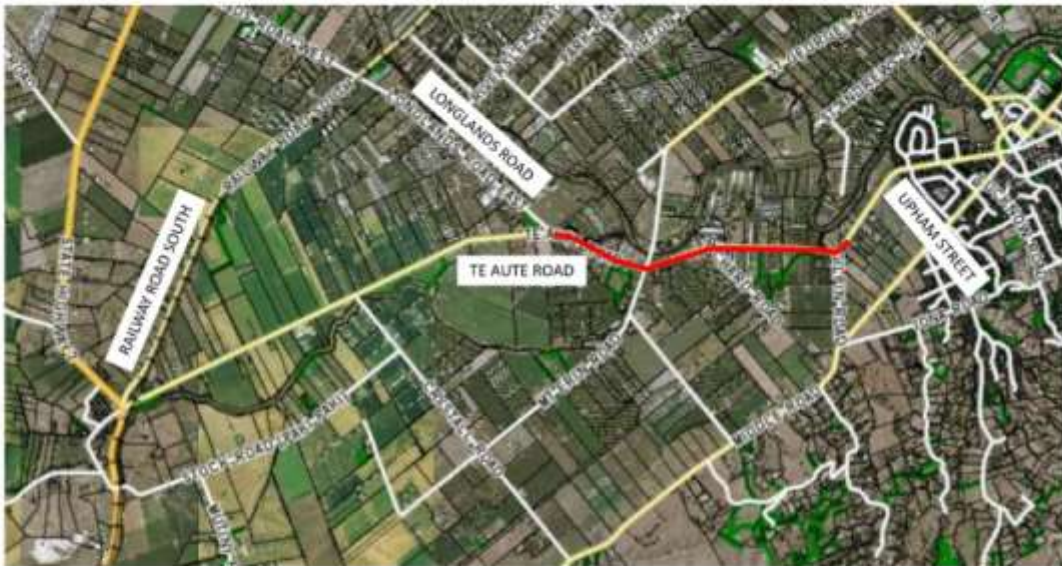
42 Proposal 42: Te Aute Road

This section of Te Aute Road, between Longlands Road East and a point 230m east of Gilpin Road, is currently 100km/h and has been identified as a top ten percent site for Death and Serious Injury reductions through a lowering of travel speeds.

- The speed limit be reduced from 100km/h to 80km/h on Te Aute Road between Longlands Road East and the 50km/h speed signs east of Gilpin Road.

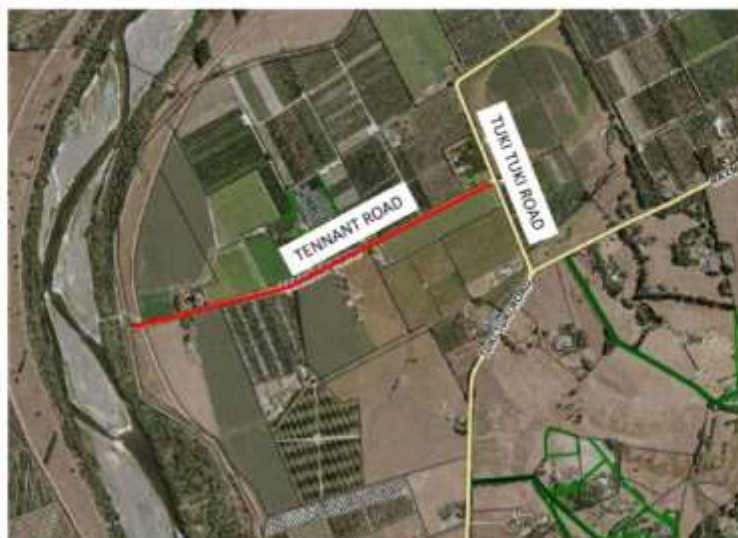
43 Proposal 43: Tennant Road

Tennant Road has been reviewed due to the proposed change to the speed limit on Tuki Tuki Road (from 100km/h to 80km/h)

- Reduce the speed limit on Tennant Road from 100km/h to 80km/h for its entire length.

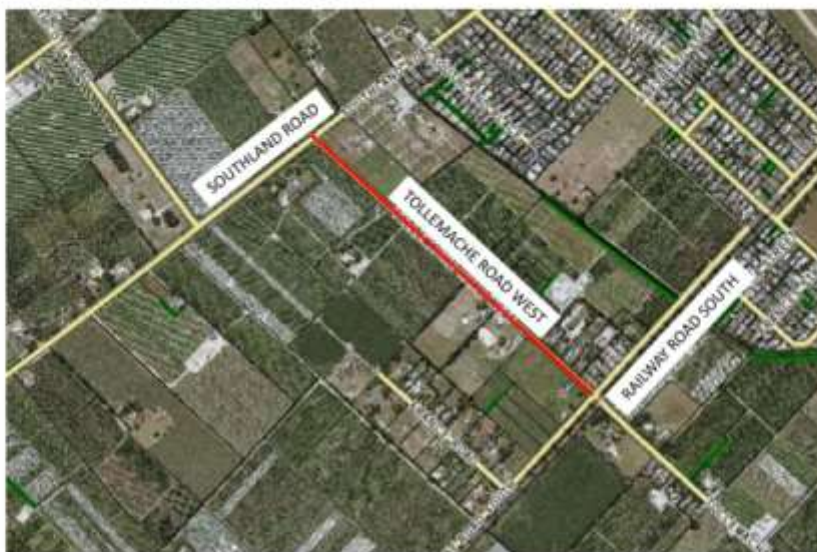
44 Proposal 44: Tollemache Road West

The speed limit review on Tollemache Road West, from Southland Road to Railway Road South, is a part of the area wide speed limit review including the roads between Maraekakaho Road and Southland Road.

- The speed limit be reduced from 100km/h to 80km/h along the section of Tollemache Road West between Southland Road and Railway Road South.

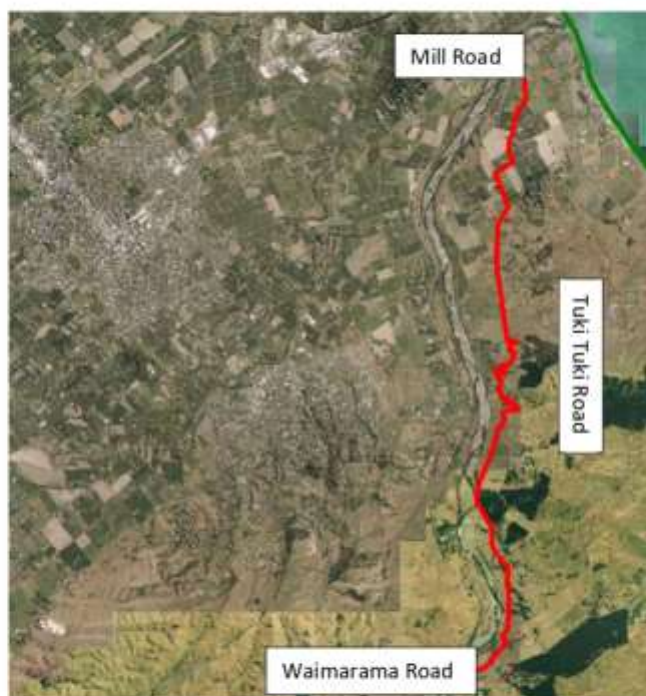
45 Proposal 45: Tuki Tuki Road

The speed limit review on Tuki Tuki Road was undertaken due to public requests, and the section from Mill Road to Moore Road has been identified as a top ten percent site for Death and Serious Injury reductions through speed management.

- The speed limit be reduced from 100km/h to 80km/h along the section of Tuki Tuki Road between Mill Road and Waimarama Road.

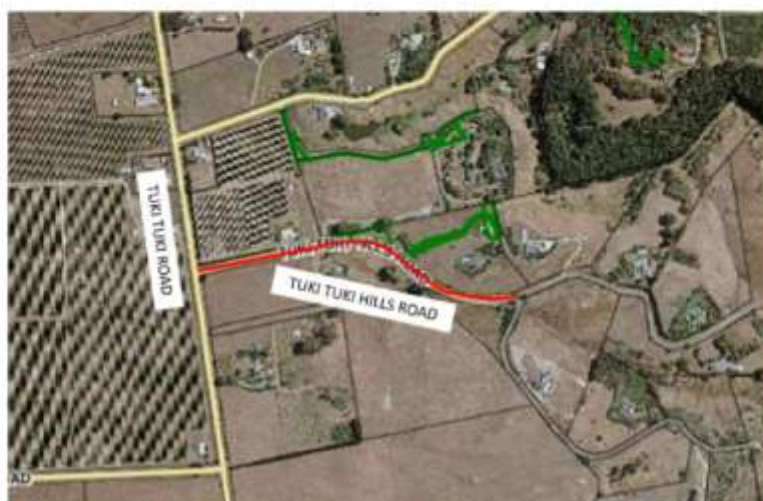
46 Proposal 46: Tuki Tuki Hills Road

Tuki Tuki Hills Road has been reviewed due to the proposed change to the speed limit on Tuki Tuki Road (from 100km/h to 80km/h)

- The speed limit be reduced from 100km/h to 80km/h along the whole length of Tuki Tuki Hills Road

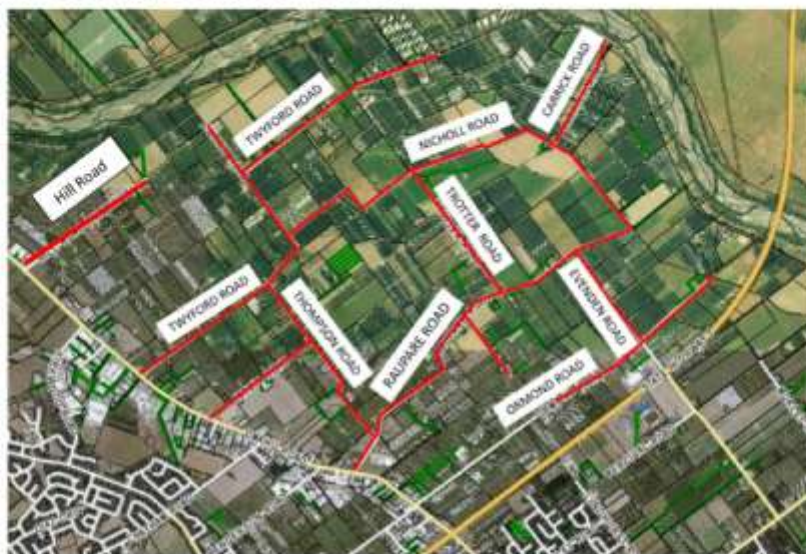
47 Proposal 47: Twyford area wide review

A number of roads in the Twyford area have been reviewed individually and discussed separately in this statement of proposal document. However, a number of public requests have also been received suggesting a wider speed limit review is required for the Twyford area. Reviewing crashes in this area shows that the most Death and Serious Injury crashes were actually on Ormond Road so it has also been included in this review. This approach also gives a clearer boundary to any speed limit change and ensures the whole area is treated in a consistent manner.

- McNab Road – full length
- Nichol Road - full length
- Ormond Road – From the existing 100km/60km/h speed limit signs to the end of the road at the River access
- Ruapare Road – full length
- Thompson Road – full length
- Trotter Road – full length
- Twyford Road – from Thompson Road to the existing 70km/h signs, with the remainder being 60km/h to align with Omaha Road proposal.

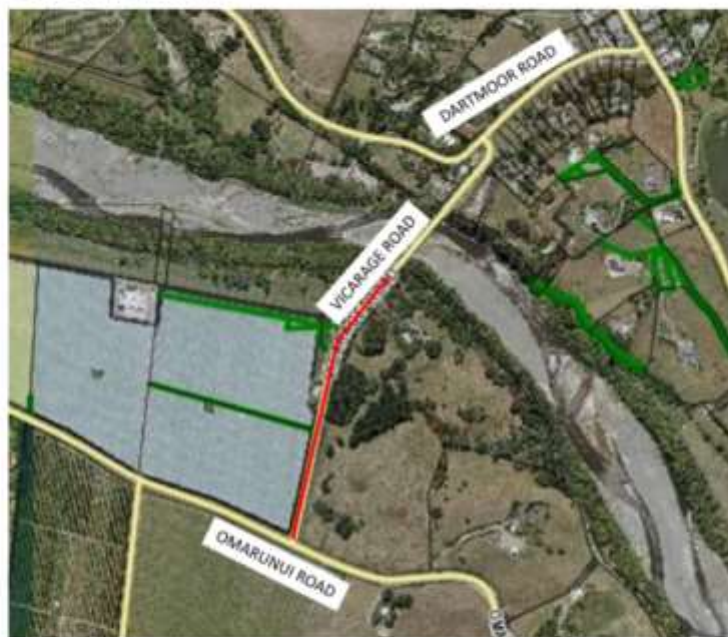
48 Proposal 48: Vicarage Road

The speed limit review on Vicarage Road, between Omarunui Road and Dartmoor Road, is a part of the road network speed limit review associated to the wider Puketapu domain.

- The speed limit be reduced from 100km/h to 80km/h between the start of the 50km/h speed limit at the south end of the one lane bridge and the intersection with Omarunui Road.
- A seasonal speed limit of 50km/h be introduced on Vicarage Road between the current 50km/h limit and Omarunui road between 1 December and 31 January inclusive each year, when it is the most heavily used for river access.

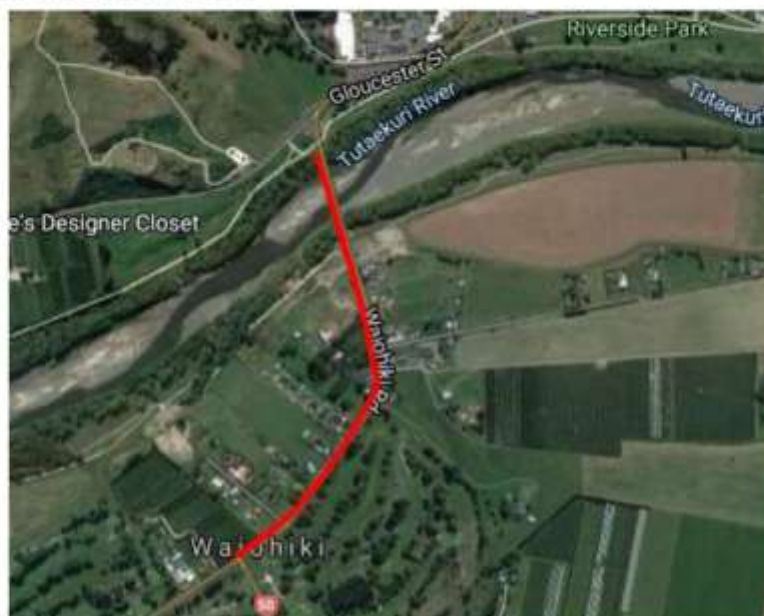
49 Proposal 49: Waiohiki Road

Waiohiki Road is an arterial road that links SH50/Links Road and Gloucester Street in Napier over the Tutaekuri River and has been reviewed due to it being a top ten site for potential Death and Serious Injury crash reductions through lowering of speed limits.

- The speed limit on Waiohiki Road be reduced from 70km/h to 50km/h between SH50/Links Road and the Napier City Council Boundary.

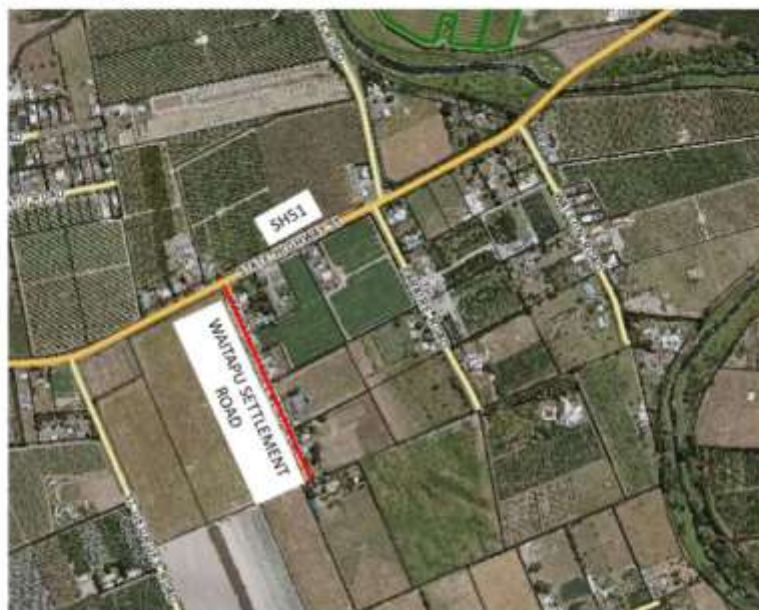
50 Proposal 50: Waipatu Settlement Road

Waipatu Settlement Road is one of the three roads that are all parallel no through roads that intersect with SH51 in Waipatu. The request to review the speed limit on this road relates to the speed limit review on SH51 by NZTA.

- The speed limit on Waipatu Settlement Road be reduced from 80km/h to 60km/h along the whole road.

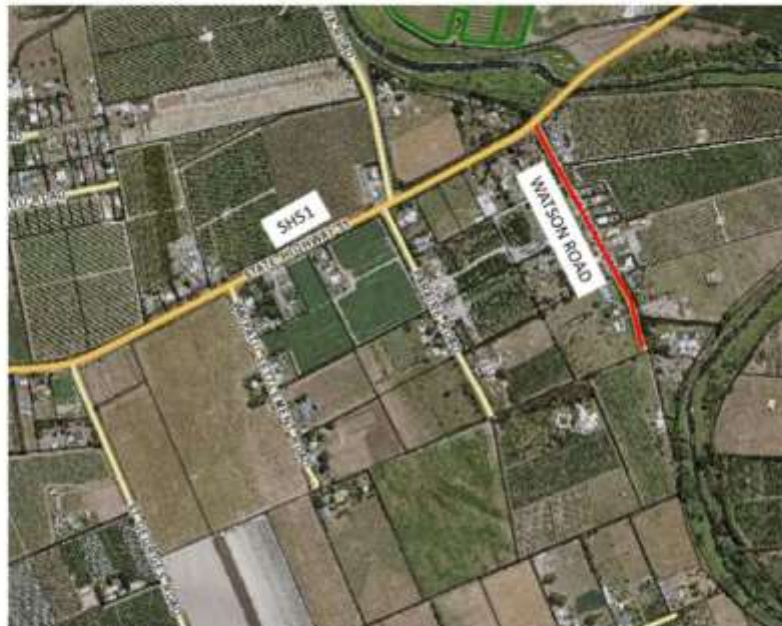
51 Proposal 51: Watson Road

Watson Road is one of the three roads that are all parallel no through roads and intersects with SH51 in Waipatu. The request to review the speed limit on this road relates to the speed limit review on SH51 by NZTA.

- The speed limit on Watson Road be reduced from 80km/h to 60km/h along the whole road.

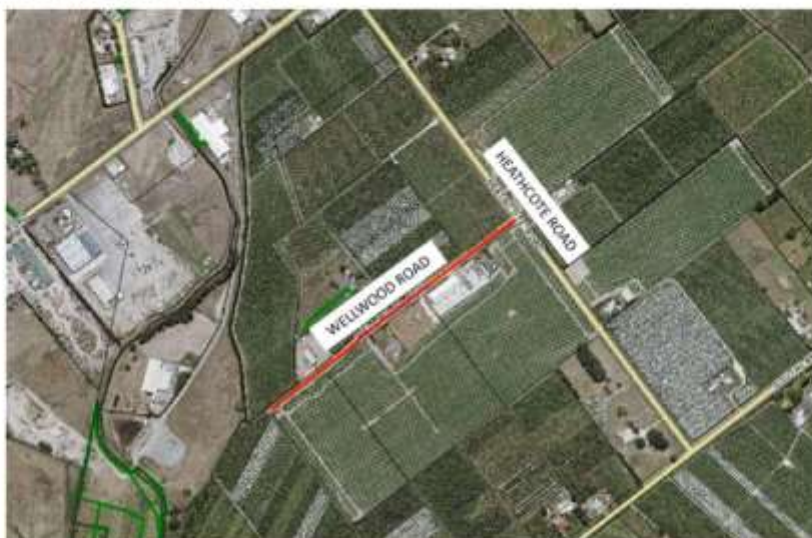
52 Proposal 52: Wellwood Road

The speed limit review on Wellwood Road is a part of the road network speed limit review for the area south of Hastings.

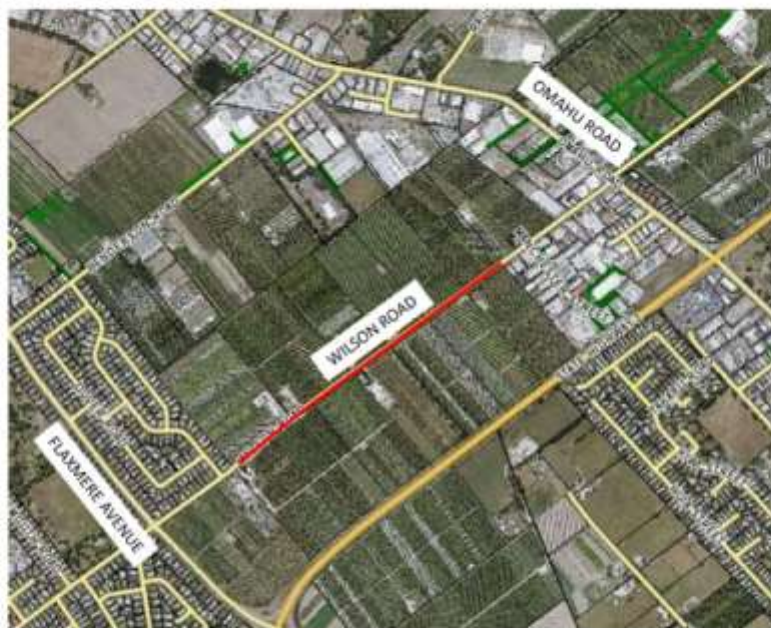
53 Proposal 53: Wilson Road

Wilson Road is one to the four roads that intersect with Omaha Road and provide direct access to Flaxmere. The speed limits on each of these routes are currently inconsistent, therefore it is proposed to assess each route and determine a consistent approach which works for all options.

As discussed previously, there is a desire within the community for the four roads that connect Omaha Road to Flaxmere Road to be treated with the same speed limit. Wilson Road is one of the three roads that intersect where Omaha Road is 50km/h but is currently signed as 70km/h. For consistency, it is recommended to reduce speed limit to 60km/h on Wilson Road between 50/70km/h speed signs west Manchester Street and 50/70km/h speed sign east Folkstone Drive.

- The speed limit be reduced from 70km/h to 60 km/h on the section of Wilson between 50/70km/h speed signs west of Manchester Street and the 50/70km/h speed sign east of Folkstone Drive.

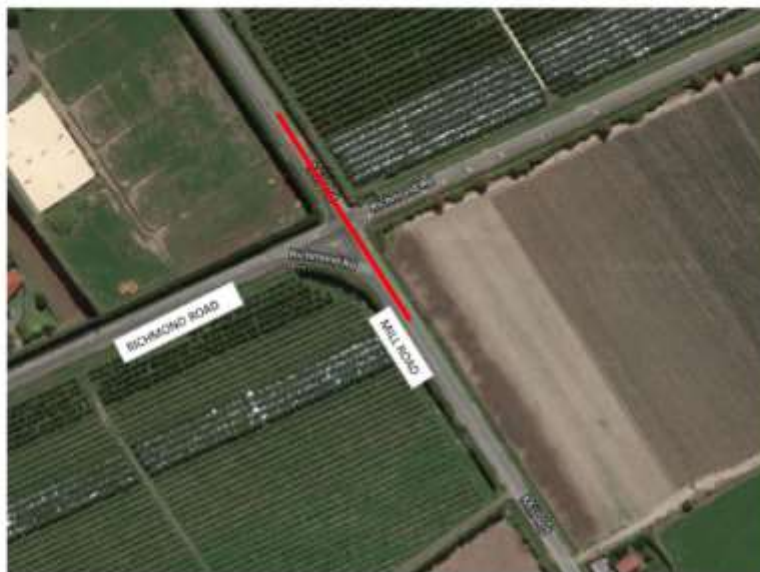
54 Proposal 54: Richmond Road / Mill Road Intersection (RIAWS)

The Richmond Road / Mill Road intersection is a rural priority-controlled crossroads, and the roads are two-lane, two-way. Both roads have a speed limit of 100km/h. The Safe And Appropriate Speed is 80km/h for Richmond Road, and 100km/h for Mill Road (at this location). Mill Road is proposed to reduce to 80km/h under this proposal.

- Introduce 80/60km/h RIAWS zone on Mill Road from a distance 150m south of the intersection with Richmond Road to a distance 150m north of the intersection.

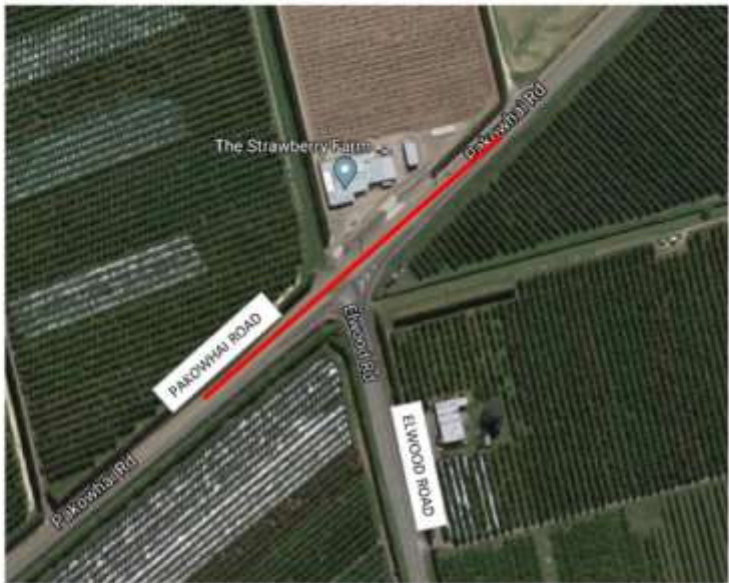
55 Proposal 55: Pakowhai Road / Elwood Road Intersection (RIAWS)

The Pakowhai Road / Elwood Road intersection is a rural priority-controlled T-intersection, and both adjoining roads are two-lane, two-way. The Safe And Appropriate Speeds and the posted speed limit is 80km/h for both roads.

- Introduce 80/60km/h RIAWS zone on Pakowhai Road from a distance 150m northeast of the intersection with Elwood Road to a distance 150m southwest of the intersection.

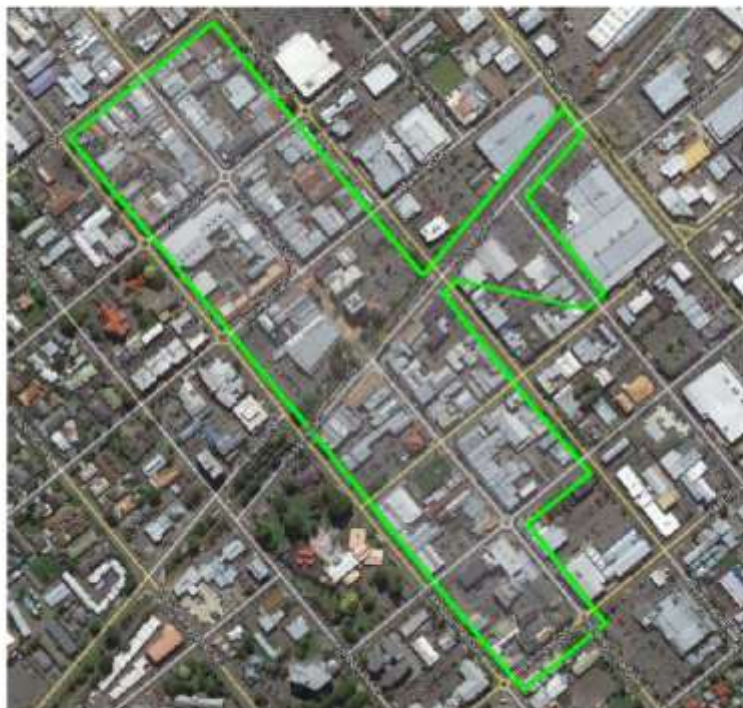
Figure 3-1: Hastings CBD review area (Google Earth)

A request was made to consider the introduction of a 30km/h speed limit in the centre of Hastings in the area highlighted in Figure 3-1. Roads that are included within this area are listed in Table 3-1.

| Figure 3-1: Hastings CBD review area (Google Earth)..... | 3 |

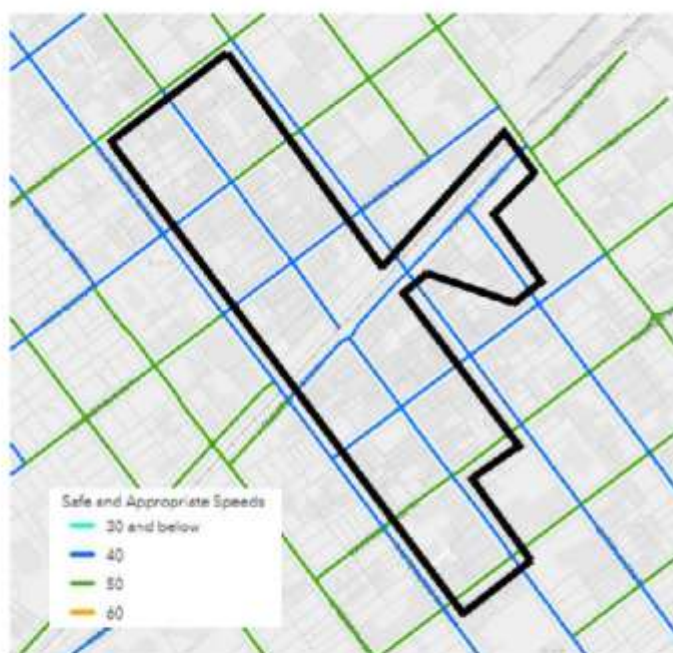
Figure 3-2: Calculated safe and appropriate speeds in Hastings CBD

All of the above roads have been reviewed in the Safer Journeys Risk Assessment Tool. Maps showing the ONRC, road safety metrics and IRR are contained in Appendix B for reference. A map of the calculated safe and appropriate speeds on these roads is shown on the following page.

| Figure 3-2: Calculated safe and appropriate speeds in Hastings CBD..... | 4 |

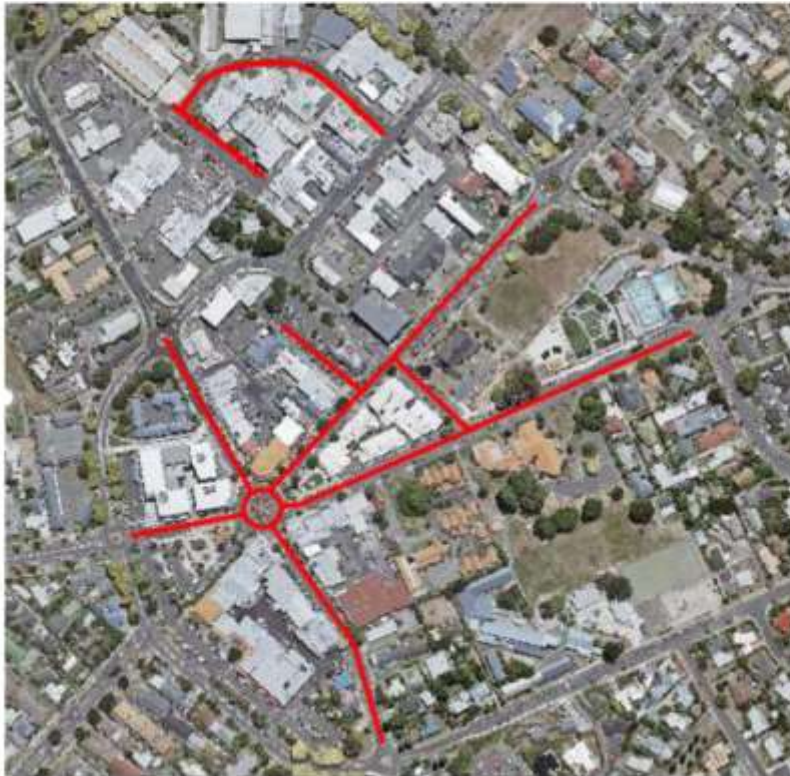
Figure 4-1: Havelock North CBD area for potential speed limit reduction

The request in Havelock North was to review the possibility of introducing a 30km/h speed limit of the roads the town centre as shown on Figure 4-1 below (highlighted in red).

| Figure 4-1: Havelock North CBD area for potential speed limit reduction..... | 6 |

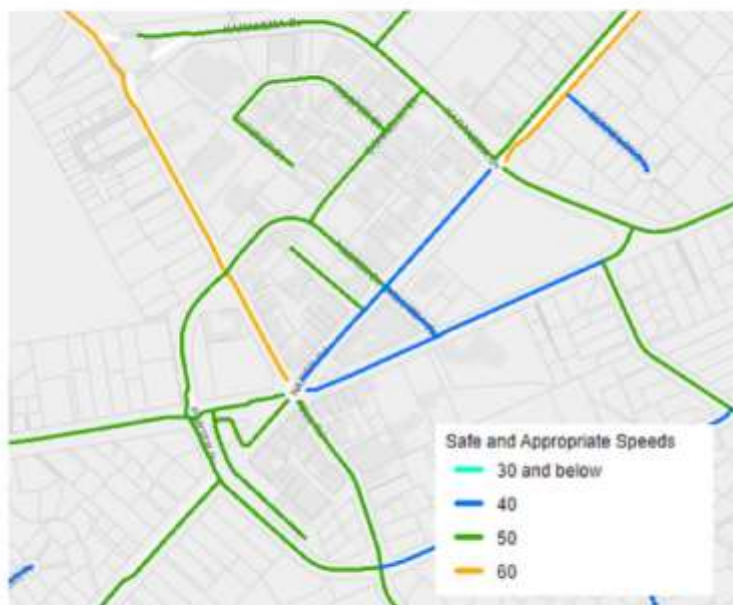
Figure 4-2: Havelock North CBD safe and appropriate speeds.

From the above data the safe and appropriate speeds have been calculated by the Safer Journeys Assessment Tool and these are 40km/h on Te Mata Road, Napier Road and Columba Way which connects the two and 50km/h on all of the other roads. This is shown in Figure 4-2 on the following page.

Of note above is that Havelock Road is shown as having a safe and appropriate speed of 60km/h. Clearly that is not correct or appropriate on this link. On review we found that the full length out to St Andrew Road has been considered as one link when in fact the road changes quite significantly between those extents.

| Figure 4-2: Havelock North CBD safe and appropriate speeds..... | 7 |
