Te Hui o Te Kaunihera ā-Rohe o Heretaunga
Hastings District Council
Council Meeting

DRAFT STATEMENT OF PROPOSAL

PROPOSED SPEED LIMIT
AMENDMENTS TO THE
SPEED LIMITS BYLAW 2012

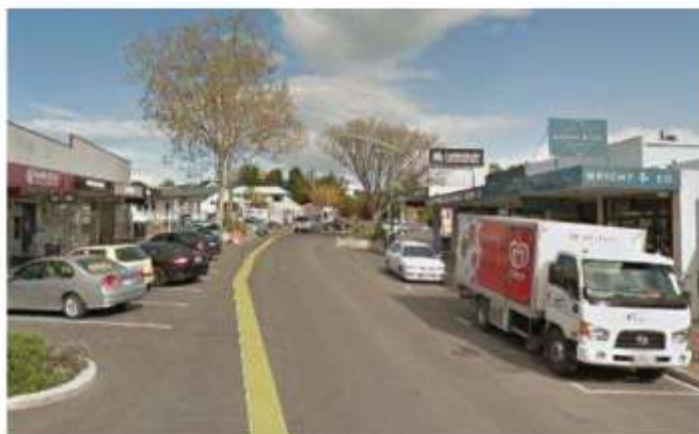
Figure 4-3: View of section of Joll Road (Google Earth)

Having reviewed a number of the links that have a safe and appropriate speed of 50km/h it is clear that the function they perform does lend itself to a lower figure than that within the area inside that boundary chosen for review. As an example, an image of Joll Road is shown below where the calculated safe and appropriate speed is 50km/h yet it is a very constrained environment with a high level of pedestrian traffic. There would appear to be a case to support the introduction of a 40km/h CBD speed limit in this area.

| Figure 4-3: View of section of Joll Road (Google Earth)..... | 8 |

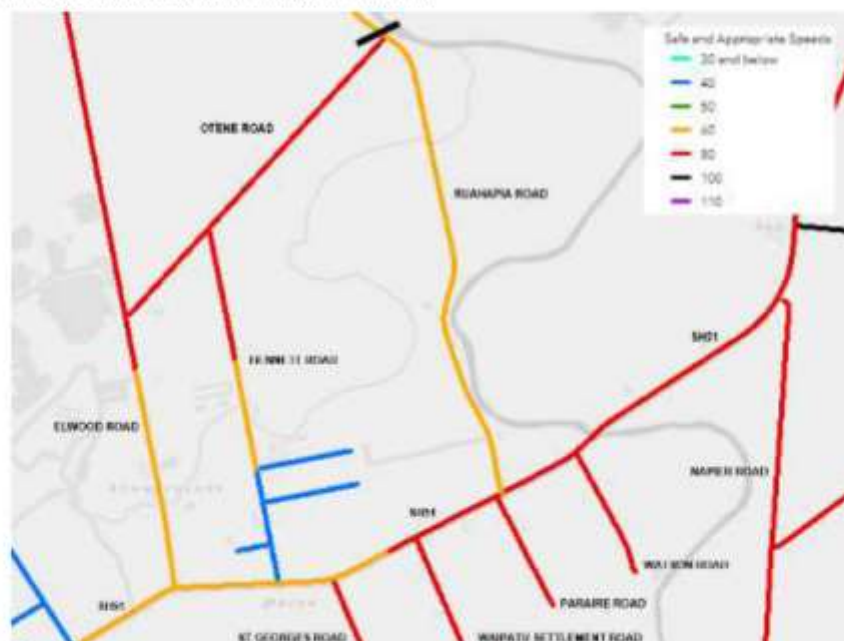
Figure 5-1: Calculated safe and appropriate speeds in the Waipatu area

Figure 5-1 shows the calculated safe and appropriate speeds on the roads in this area. On SH51 the results indicate that the 80km/h section has a safe and appropriate speed of 80km/h however a reduction to 60km/h is being considered. The section that is currently signed as 70km/h has a calculated safe and appropriate speed of 60km/h therefore the Transport Agency may wish to use this data to seek a reduction in the speed limit. A question to be resolved by NZTA is should the section between St Georges Road and Kenilworth Road be reduced from 70km/h to 50km/h.

| Figure 5-1: Calculated safe and appropriate speeds in the Waipatu area..... | 9 |

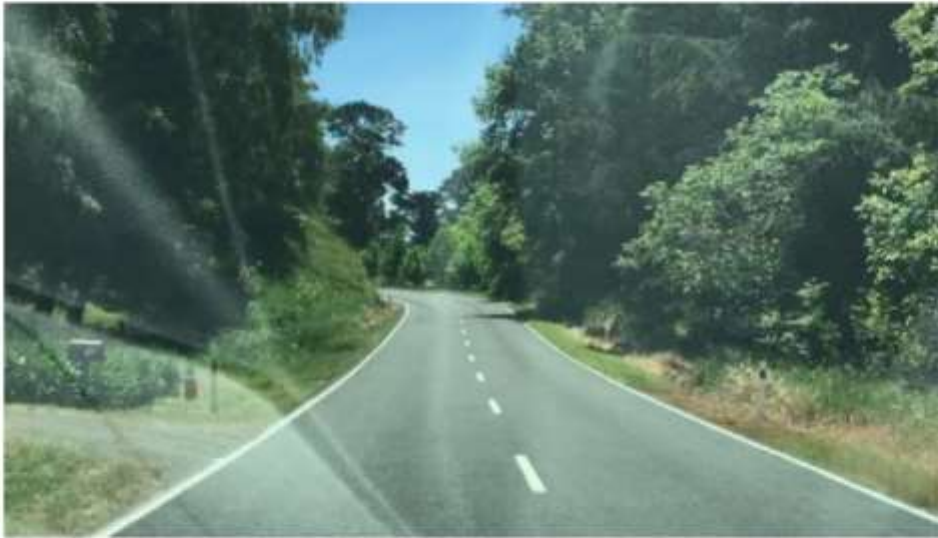
| Hastings District Council 2019 Speed Limit Assessment Apley Road | | | |
|--|---|---|---|
| <p>Discussion</p> <p>Apley Road is 7km long flowing road that connects Dartmoor Road in the south to Puketitiri Road in the north. At the time of our review the road surface was in a generally good condition with excellent road markings. In places the shoulder was non-existent, as shown below.</p> | | | |
| <p><i>Apley Road</i></p> <p>The curves on Apley Road are connected by sections where it is relatively easy to travel close to the current 100km/h speed limit. The 85th percentile speed of 94km/h is somewhat higher than the calculated safe and appropriate speed of 80km/h which does indicate that it would not be easy to slow traffic.</p> | | | |

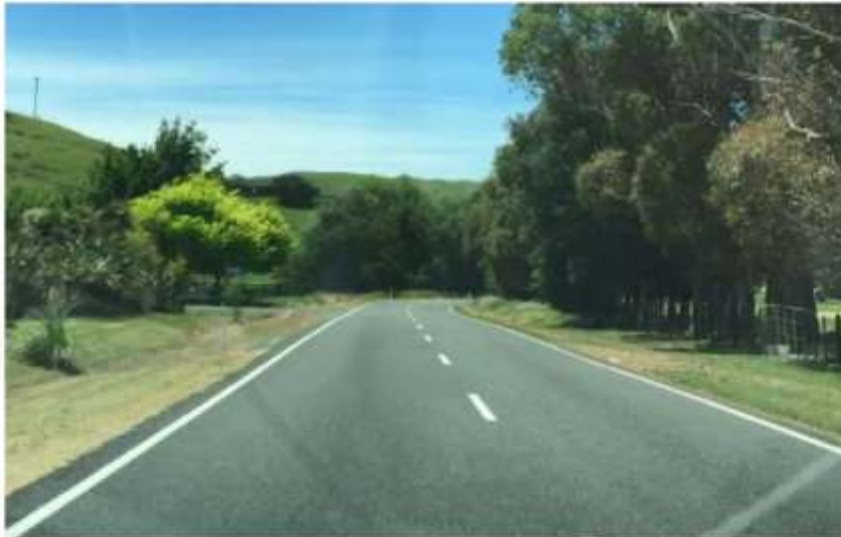
The higher speeds that are found on Apley Road do result in the demand for good curve signage however there are a number of unsigned curves that should have advisory speeds on them and a higher level of delineation than is currently provided. The high quality road markings could cause issues at night encouraging higher speeds in to curves that are poorly defined.

Example of unsigned curve with high approach speed on Apley Road

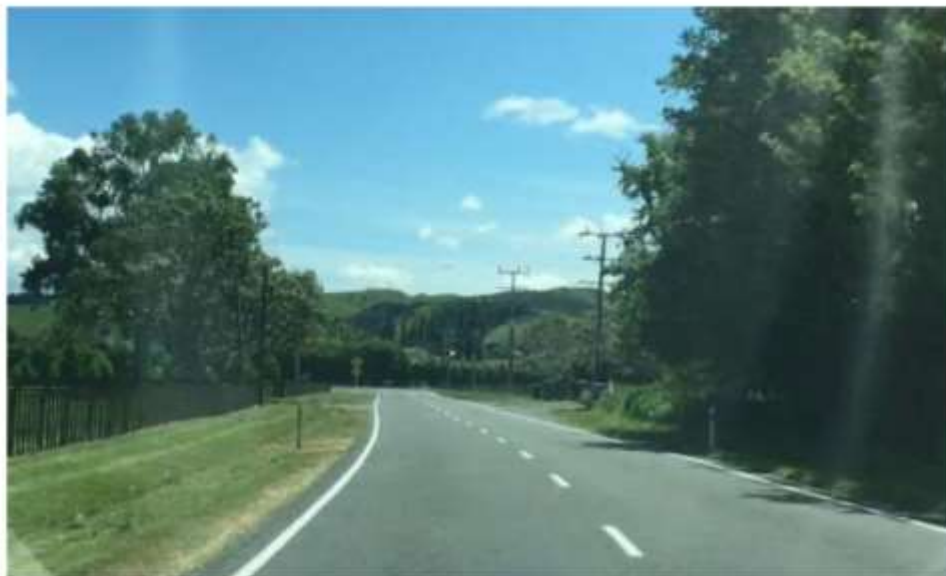
| Hastings District Council 2019 Speed Limit Assessment Dartmoor Road | | | |
|--|---|---|---|
| <p>Discussion</p> <p>The speed limit on Dartmoor Road was reviewed in 2017. The request then was to determine if the 50km/h speed limit could be extended out as far as the Puketapu Park entrance however this section of road is very much rural in nature. The recommendation made was to consider introducing an 80km/h speed limit from the start of the 50km/h speed limit 250m west of Vicarage Road through to the crest/cutting 300m east of the main Puketapu Park vehicle entrance.</p> <p>The Safer Journeys Risk Assessment Tool has incorrectly recorded around 1,100m of what is 100km/h road as having an existing speed limit of 50km/h. This extends as far as 750m west of the Puketapu Park entrance and influences the results on that section.</p> <p>The Safer Journeys Risk Assessment Tool indicates a safe and appropriate speed of 60km/h on Dartmoor Road from Puketapu out to the Apley Road intersection. On the section that is 100km/h this is due to the Medium-high IRR band. The reason for this high rating of 1.68 is that the roadside environment risk has been judged to be moderate on one side of the road and high on the other. Compared to many other roads under review the roadside environment is much more benign as there are only short sections where there may be deep ditches in the shoulder, trees are set well back from the road and there is a distinct lack of power poles in the shoulder. Dartmoor Road has the same rating for roadside hazards as Farndon Road which is clearly not correct.</p> <p>If the roadside hazard rating is considered as moderate on both sides of the road which appears to be fair then the IRR drops below 1.6 in to the medium band which then indicates a safe and appropriate speed of 80km/h. This is much more in line with the actual situation however is still below the measured 85th percentile speed on this road.</p> | | | |

After reviewing the site again we believe that if an 80km/h speed limit is progressed it should extend beyond the entrance to Puketapu Park. Just beyond the crest west of this access is a 65km/h reverse curve with an orchard access between the two curves. The logical solution would be to extend the 80km/h curve further so that it includes this curve as well.

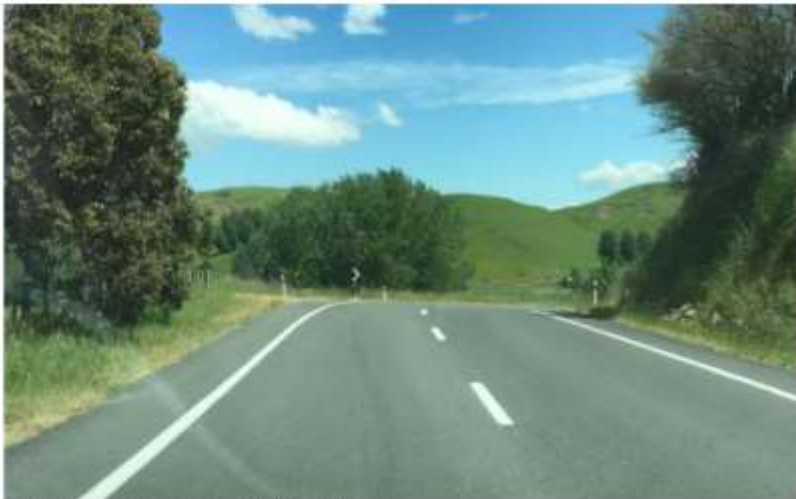
| Hastings District Council 2019 Speed Limit Assessment Puketapu Road (north of Puketapu) | | | |
|---|---|---|---|
| <p>Discussion</p> <p>We have split Puketapu Road north and south of the township due to the two sections having quite different characteristics and being coded differently in the Safer Journeys Risk Assessment Tool. On this section between Puketitiri Road and Puketapu the road is a secondary collector with a Medium-high IRR band. This rating results in a safe and appropriate speed of 60km/h.</p> <p>The Safer Journeys Risk Assessment Tool shows the mean operating speed as being between 50 and 55km/h while the last speed survey in 2009 showed an 85th percentile speed of 89km/h. It is clear that in places the alignment restricts vehicle speeds so that they are likely to be close to the safe and appropriate speed. There are many tight curves and vertical crests on the route that require slow speeds to negotiate them. The serious injury crash occurred on a curve signed as 45km/h however there are many curves on the route that are either not signed at all or not signed to the current MOTSAM standard. We noted that where chevron signs are used these are predominantly black and white which suggests they are quite old and their night time performance is likely to be poor.</p> | | | |
| <p><i>Typical curve signage on Puketapu Road</i></p> | | | |

Also shown on the photos is the sealed shoulder which is present for much of Puketapu Road. This does reduce the amount of side friction and in places will mean that vehicle speeds are not as constrained as they would be on other roads that have little to no shoulder. The cross section of Puketapu Road does mean that while 60km/h may be the safe and appropriate speed it is only likely to be achieved on the tighter sections of the route and not on sections such as that shown below.

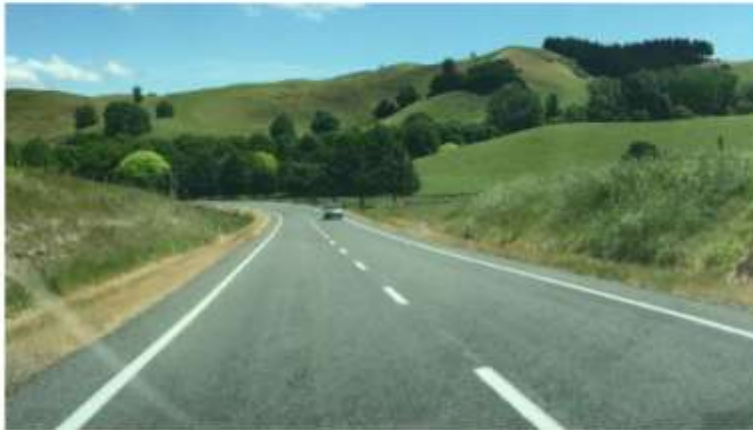
Puketapu Road just north of Puketapu

Within the tighter section of the road speeds are already going to be below 80km/h due to the alignment. For that reason a review of curve signage should be undertaken, not only to identify those curves where the signage is old and poor performing but also those curves such as shown above where no signage is present.

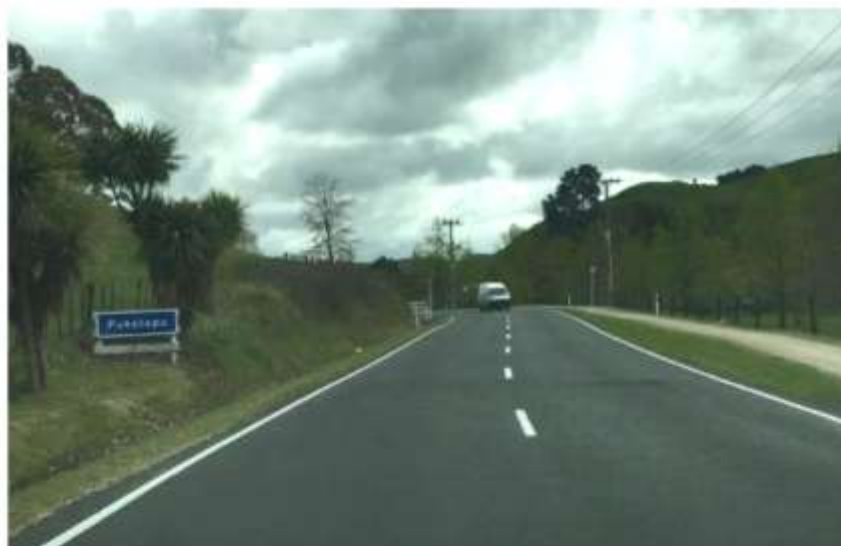
The current location of the change from 50 to 100km/h is on a curve, as shown below. This would be better if the signs were combined with the Puketapu place name sign to provide a threshold treatment that would mean extending the 50km/h speed limit by 70m to the south.

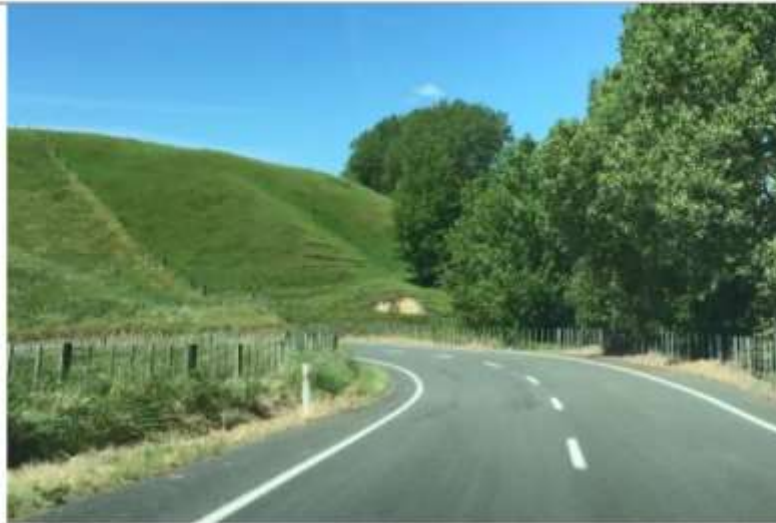
Sharp unsigned curve on downhill grade with relatively high approach speeds

By improving the signage of curves lower speeds may result. The curve above is possibly a 45km/h curve however with no signage provided vehicle speeds on the downhill approach will be much higher leading to a reduced level of safety.

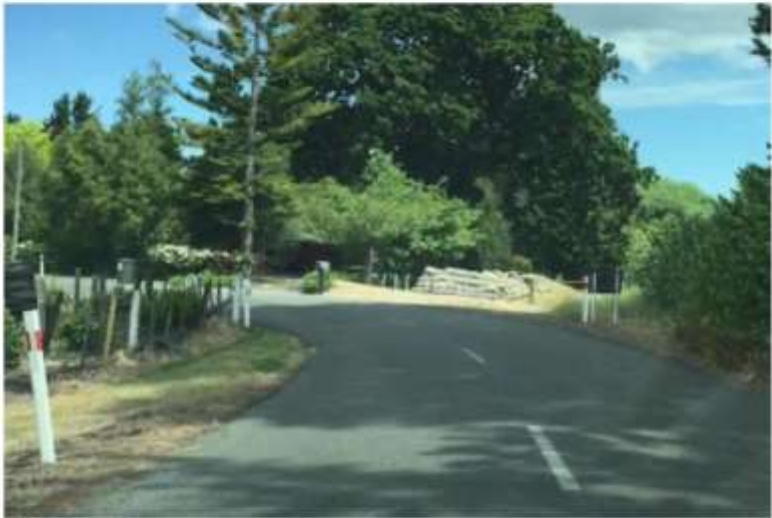
| Hastings District Council 2019 Speed Limit Assessment Springfield Road | | | |
|---|---|---|---|
| <p><i>Unsigned curve on Springfield Road</i></p> | | | |
| <p>Like a number of other roads in this area of the District, greater safety gains may be realised by providing a consistent level of delineation. On Springfield Road even edge lines would be of benefit on curves such as that above.</p> | | | |

| Hastings District Council 2019 Speed Limit Assessment Springfield Road | | | |
|---|---|---|---|
| <p>Discussion</p> <p>Springfield Road is much narrower than the roads that access it and has no edge line. The road is generally straight however there are a number of out of context curves that are unsigned, some of which are very hard to read when approaching –</p> | | | |

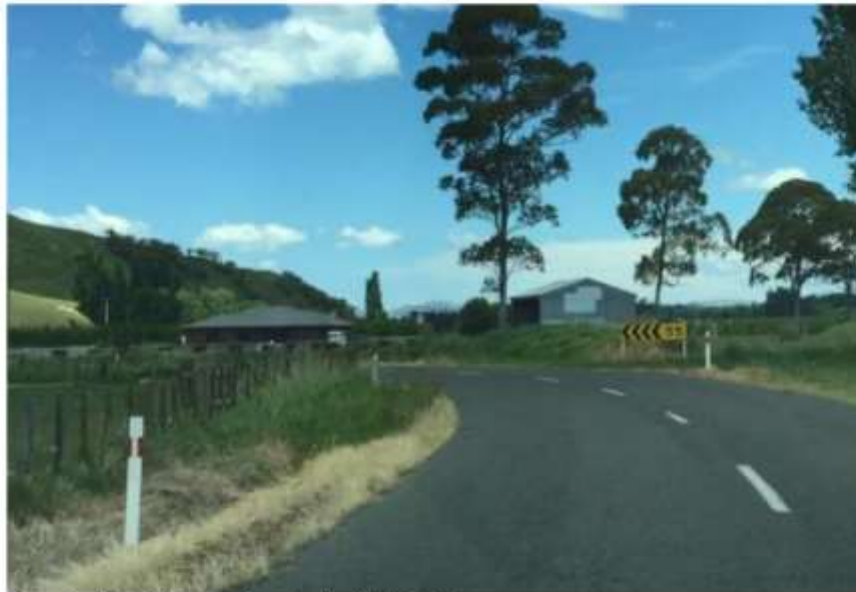
Site of serious injury crash on Springfield Road

We note two crashes have occurred on the same corner, one of which resulted in serious injuries. This corner has a 55km/h chevron board on it however there is no advance warning at all, no edge lines and a wooden power pole on the outside of the curve that was hit in both crashes.

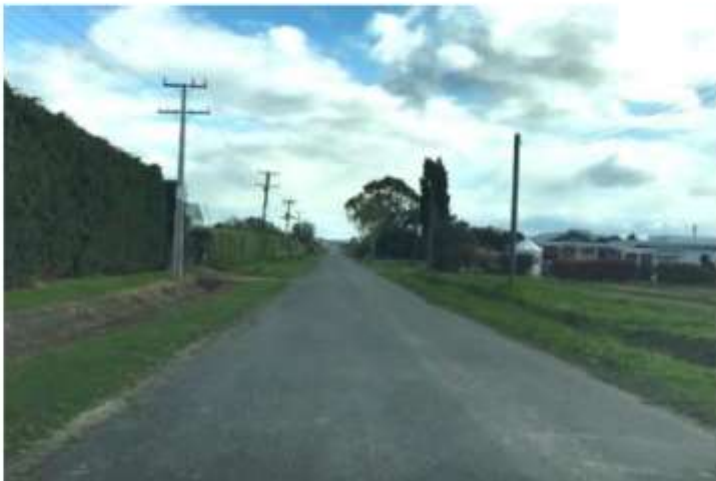
| Hastings District Council 2019 Speed Limit Assessment Jarvis Road | | | |
|---|---|---|---|
| <i>Typical layout of Jarvis Road</i> | | | |
| <p>We note that there are no accesses on the last 110m of Jarvis Road which is currently signed as 70km/h. It would appear unlikely that by introducing an 80km/h speed limit along the full length there would be any issues however any changes should be considered along with the proposals for Omahu Road.</p> | | | |

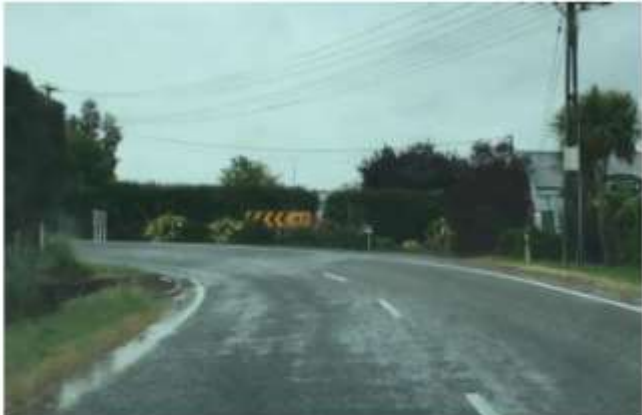
Signage on Raupare Road

The corner where Raupare Road meets Nicholl Road is signed with a 15km/h advisory speed. We note that this is quite a speed difference even from 80km/h therefore the signage should be reviewed to ensure it is appropriate.

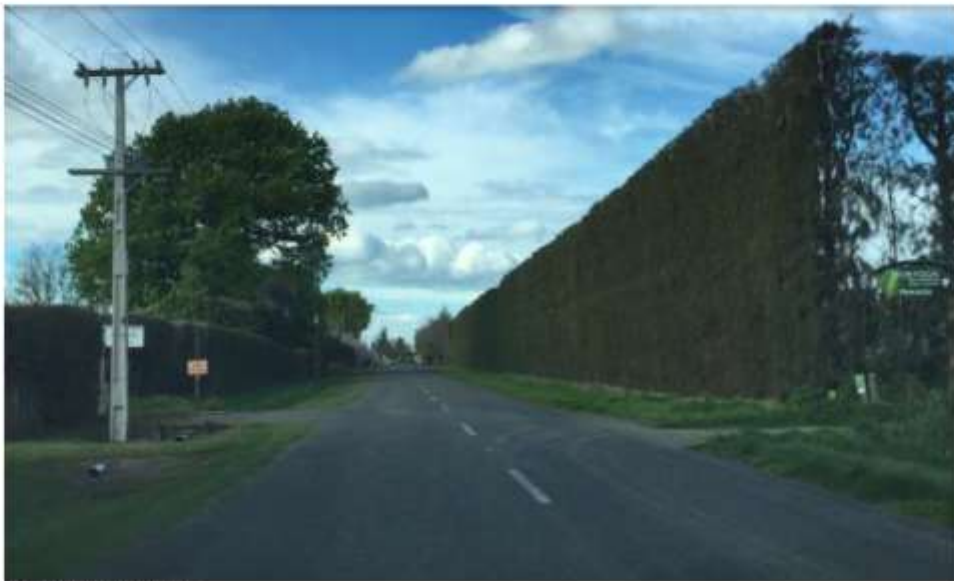
| Hastings District Council 2019 Speed Limit Assessment Twyford Road | | | |
|--|---|---|---|
| <i>Twyford Road typical layout</i> Twyford School is located on the section just beyond Thompson Road and is signed as having a 50km/h courtesy speed limit. As detailed above, this speed limit is not legal and cannot be enforced however proposed rule changes by the MOT suggest that a 50 or 60km/h speed limit may be able to be formalised in the future. | | | |

| Hastings District Council 2019 Speed Limit Assessment Twyford Road | | | |
|--|---|---|---|
| Discussion Twyford Road links Omahu Road to Thompson Road forming the northern boundary of the area under review. Over this length Twyford Road is provided with a centre line but beyond Thompson Road there is no delineation provided. The safe and appropriate speed for the full length of Twyford Road is 80km/h which is on a par with the latest speed survey data that recorded an 85 th percentile speed of 81km/h. Previous surveys showed lower speeds. The surrounding development does support an area wide 80km/h speed limit being introduced. | | | |

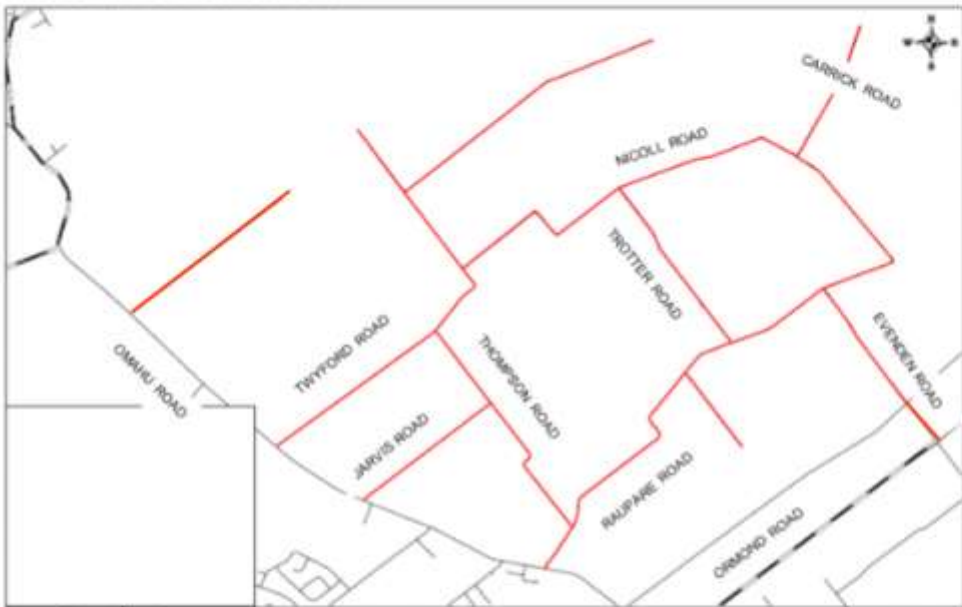
| Hastings District Council 2019 Speed Limit Assessment Twyford area wide review | |
|--|--|
| <p><i>Map of Twyford area</i></p> <p>With the roads feeding off Omaha Road having proposed 80km/h speed limits it is logical that the roads accessing them also have the same, particularly given that they are generally no through routes</p> <p>On several roads within the Twyford area we noted the lack of road markings or signs at isolated rural curves. While a reduction in the posted speed limit is recommended and should reduce impacts speeds a review of unmarked curves should also be undertaken to reduce crash frequency.</p> | |

| Hastings District Council 2019 Speed Limit Assessment Twyford area wide review | |
|--|--|
| <p>Discussion</p> <p>A number of roads in the Twyford area have been reviewed individually however there are a number of other minor roads in Twyford as shown below. These include an extension of Twyford Road, Hill Road and Raupare Road as well as Evans Road, Trotter Road, McNab Road, Nicholl Road, and the section of Evenden Road north of Ormond Road. Reviewing crashes in this area we noted that the most DSI crashes were actually on Ormond Road so we have also included that in our review.</p> | |

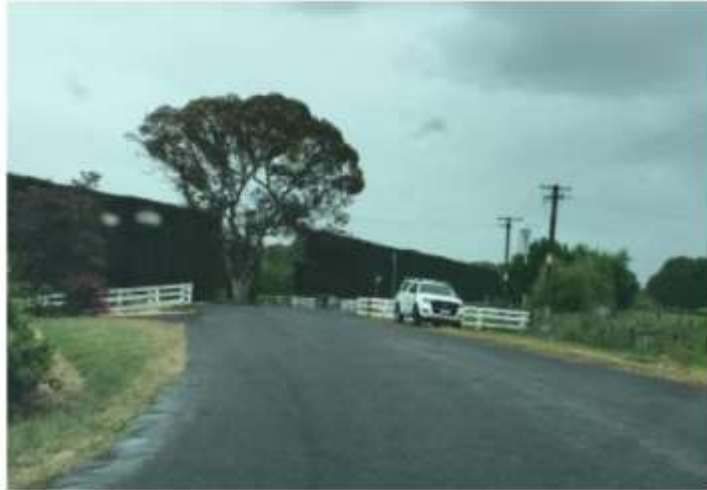
End of Ormond Road

We noted on Twyford Road that there was no warning of the end of the road. The same is true at the eastern end of Ormond Road when the road curves to the left and ends abruptly, with a tree located where there is a good chance it would be hit if a car braked suddenly and lost control – in fact it was hit and resulted in serious injuries to a driver in June 2018. No exit signage and better warning of the end of the road is required.

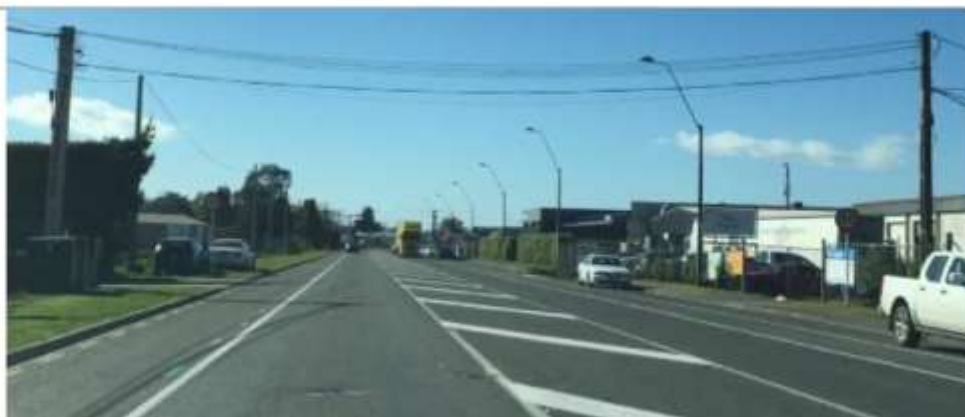
Existing location of 50/70 250m east of Jarvis Road

This 500m increase in the length of the 50km/h speed limit would result in the speed limit starting at the beginning of the flush median where the 70km/h repeater signs are currently positioned.

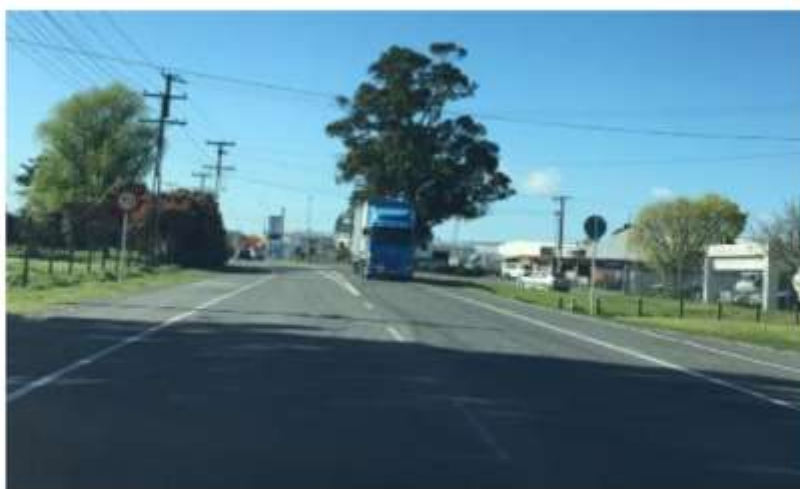
Existing location of 70km/h repeater signs 250m west of Jarvis Road

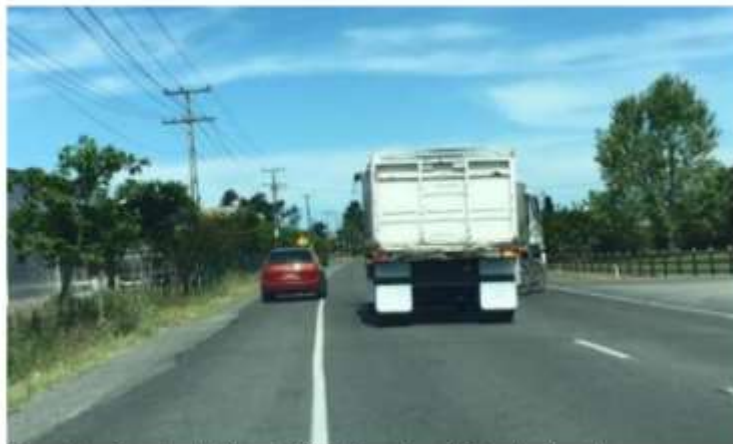
Example of turning traffic on 100km/h section of Omaha Road

The development on both sides of the road does result in vehicles turning right from Omaha Road and being potentially exposed to a rear end crash. A number of these are large commercial vehicles which are stationary in the 100km/h traffic lane as shown on the following page.

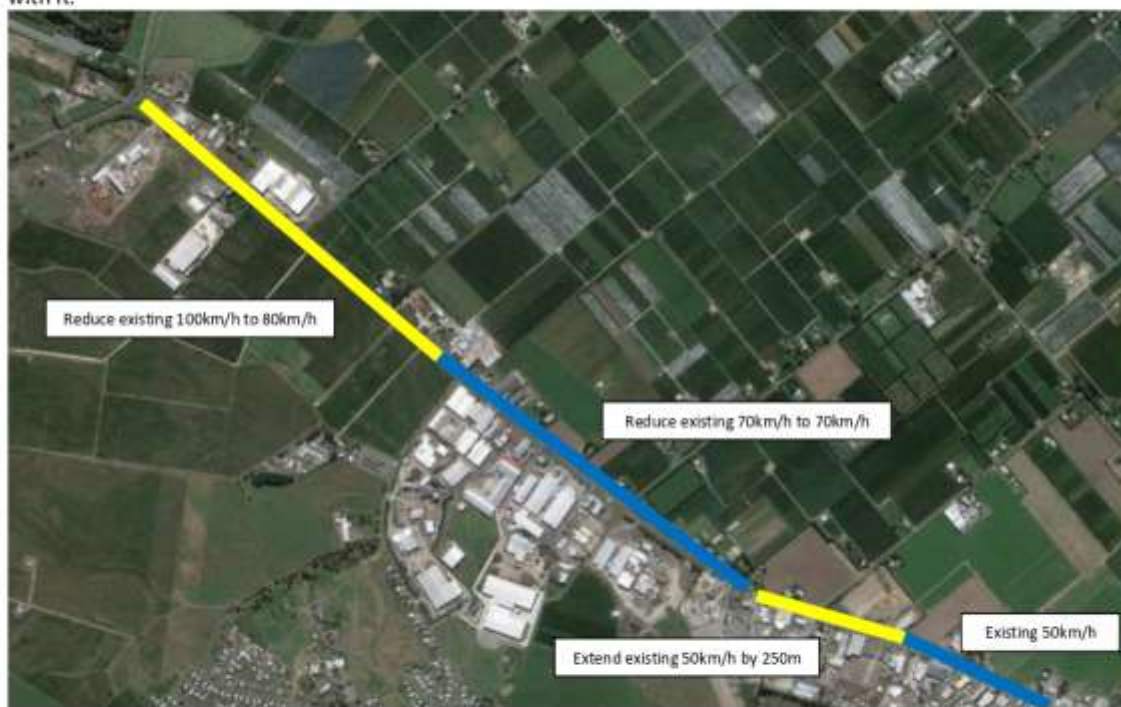
Plan of potential speed limit changes on Omaha Road

Consider reducing the remaining length of 70km/h speed limit on Omaha Road to 60km/h.

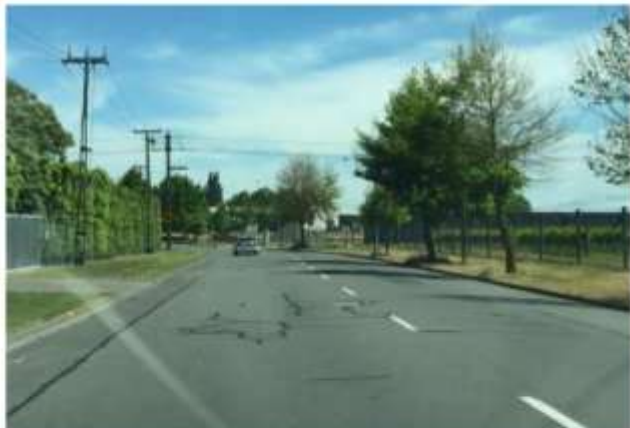
Wide open nature of 70km/h section of Kirkwood Road

The safe and appropriate speed for the 70km/h section of Kirkwood Road is shown as 50km/h. Simply introducing a 50km/h speed limit is unlikely to result in those speeds given the width and wide open nature of Kirkwood Road as shown below. The 85th percentile speed of 65km/h reflects the speeds that would be expected if the speed limit was 60km/h.

The three other roads that connect Omahu Road to Flaxmere have safe and appropriate speeds of 60km/h. The reason for the difference appears to be the curve on Kirkwood Road shown above.

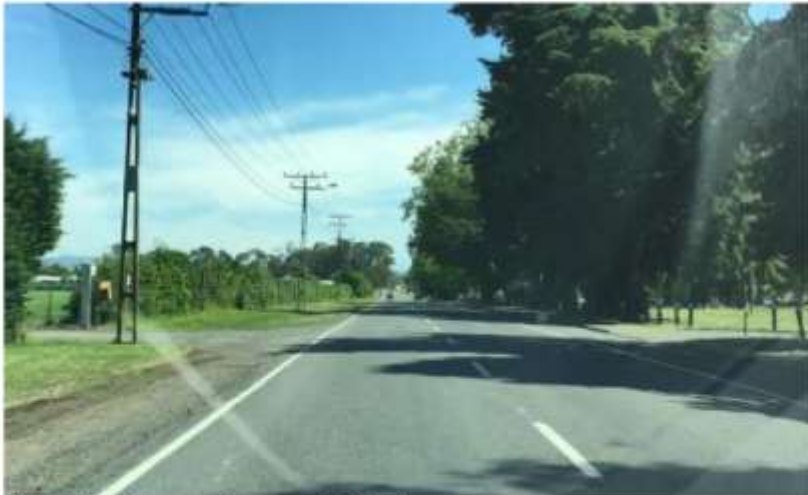
| Hastings District Council 2019 Speed Limit Assessment Chatham Road | | | |
|---|---|---|---|
| View of Chatham Road, currently 50km/h | | | |

The Safer Journeys Risk Assessment Tool indicates a safe and appropriate speed of 60km/h along here which corresponds with actual travel speeds.

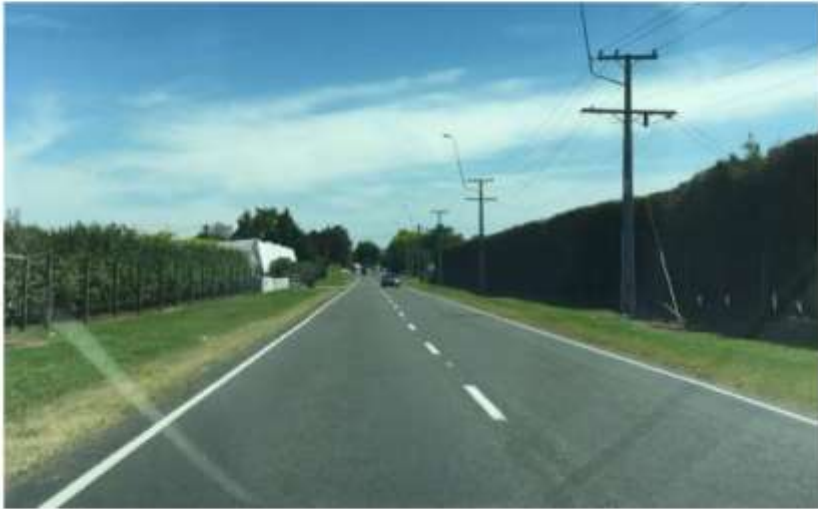
| Hastings District Council 2019 Speed Limit Assessment Henderson Road | | | |
|---|---|---|---|
| <p><i>View of 70km/h section of Henderson Road</i></p> <p>We believe that the current speeds support the introduction of a 60km/h speed limit on Henderson Road and that a fully urban 50km/h speed limit would be too restrictive. A 60km/h speed limit may be an acceptable compromise to retain the required consistency on the four routes.</p> | | | |

| Hastings District Council 2019 Speed Limit Assessment Henderson Road | | | |
|---|---|---|---|
| <p>Discussion</p> <p>Like Chatham Road to the north and Wilson Road to the south Henderson Road has a calculated safe and appropriate speed of 60km/h and sits between the 70km/h speed limit on Omaha Road and the 50km/h speed limit in Flaxmere. Also like Chatham Road the measured 8th percentile speed is more in line with a 60km/h speed limit than one that is 70km/h.</p> <p>Within the existing 70km/h section there are seven accesses, generally to orchards and fruit packing businesses. As shown below, Henderson Road has very wide and flat shoulders that do not help to present an urban feel and do little to encourage low speeds.</p> | | | |

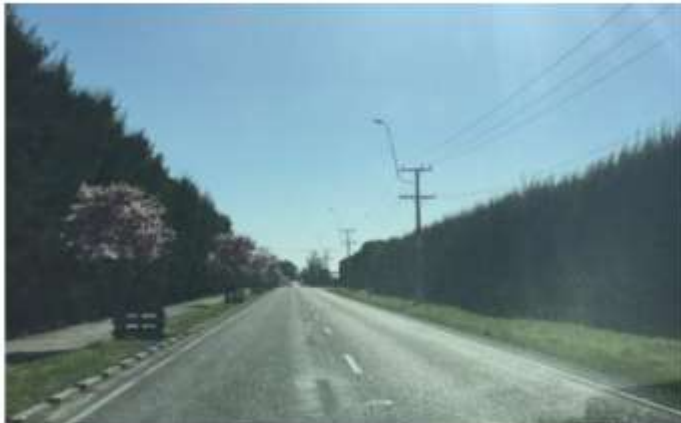
Like Henderson Road, Wilson Road connects Flaxmere Avenue to Omahu Road and has a 70km/h speed limit in the mid-section with 50km/h speed limits at either end. Also like Henderson Road, there are few accesses within the 1km length of 70km/h. This section is notable by having a separate footpath on one side with a grassed berm with regularly placed trees on it behind a concrete kerb.

View of 70km/h section of Wilson Road

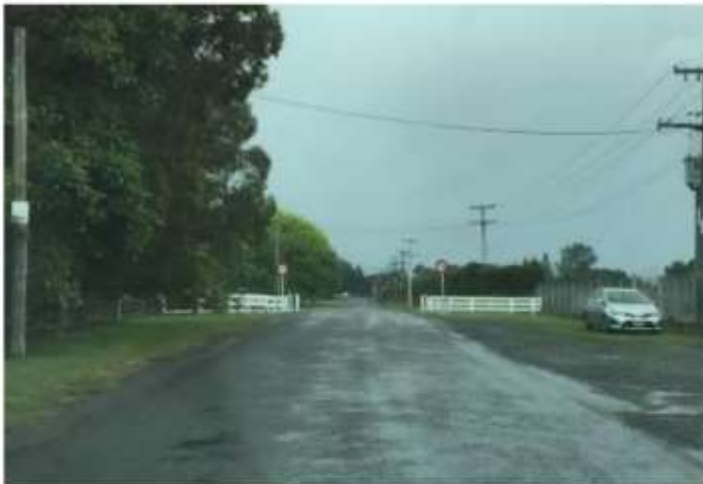
| Hastings District Council 2019 Speed Limit Assessment Bennett Road | | | |
|--|---|---|---|
| <p>Discussion</p> <p>Bennett Road is currently signed as 80km/h for the northern part, from Otene Road south for 630m and then it is 70km/h through to the intersection with SH51. By default the three side roads that intersect with Bennett Road are also 70km/h, Panapa Road, Apatu Road and Kauru Road.</p> <p>The safe and appropriate speeds have been calculated at 80km/h on the section posted as 80km/h, 60km/h on part of the 70km/h section and 40km/h on the section from Panapa Road south. Part of the reason for this appears to be that the ONRC classification changes along the road, with Bennett Road from Panapa Road south being classed as an access while to the north it is a secondary collector.</p> | | | |
| <p><i>Bennett Road where speed limits drops from 80 to 70km/h</i></p> | | | |

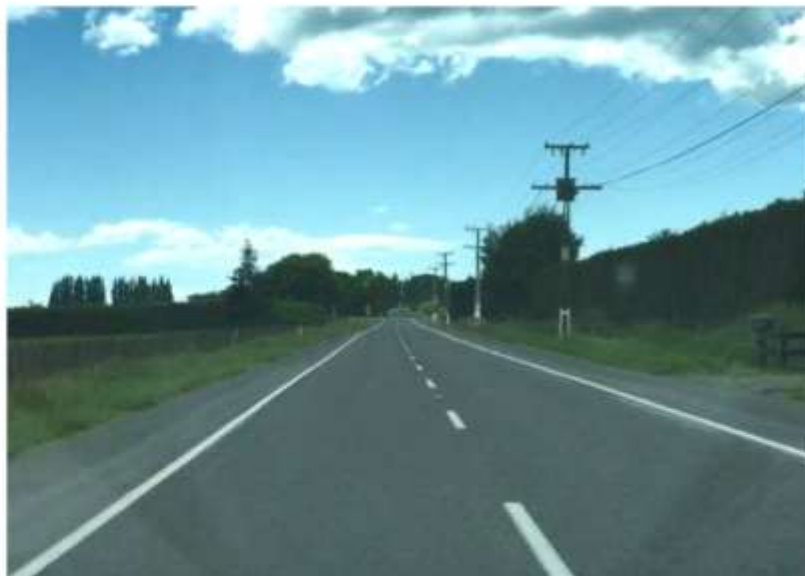
Brookfields Road looking towards Sisson Road

The curve at Sisson Road is signed with a 55km/h advisory speed. The advance signs are oversize and gated suggesting that there have been safety issues on this curve in the past. With a one lane bridge only 400m away reduced approach speeds to both would not be inappropriate. We therefore believe that Council should consider an 80km/h speed limit on Brookfields Road from Pakowhai Road to the one lane bridge.

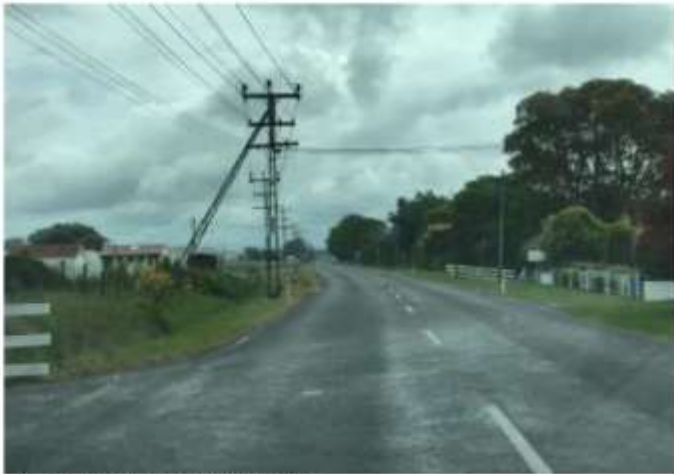
| Hastings District Council 2019 Speed Limit Assessment Elwood Road | | | |
|--|---|---|---|
| <p>Discussion</p> <p>The Safer Journeys Risk Assessment Tool shows 800m of Elwood Road being subject to a 70km/h speed limit with the 200m prior to Otene Road being 80km/h. In fact the two speed limits are of almost equal length. The Tool shows that the safe and appropriate speed is 60km/h and 80km/h respectively which are the same outputs as the parallel Bennett Road.</p> | | | |
| Elwood Road within 70km/h area | | | |

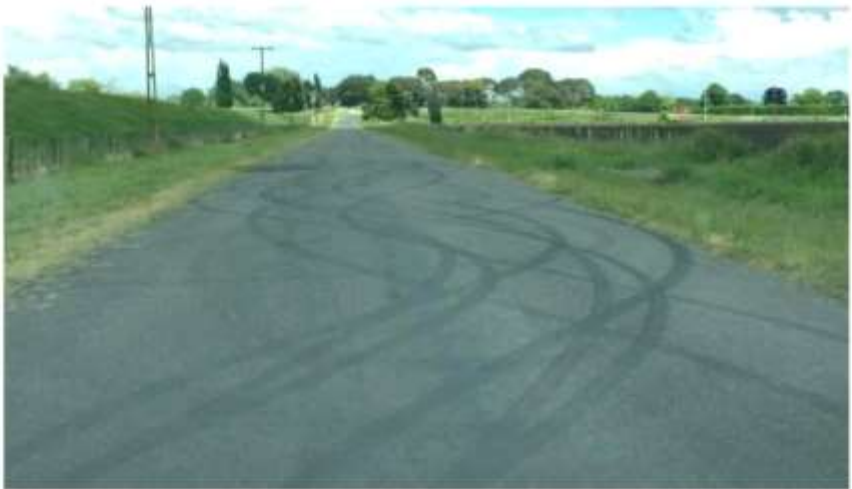
| Hastings District Council 2019 Speed Limit Assessment Gilbertson Road | | | |
|---|---|---|---|
| Gilbertson Road | | | |

On site it is quite clear that this is a rural road and it would be difficult to achieve operating speeds of 60km/h. A reduction in potential DSI crashes could be achieved through improved delineation and this should be considered before installing an urban type 60km/h speed limit on a rural road. At present there are no road markings at all and no edge marker posts. Some hazards such as the concrete power pole shown below are located in the direct path of a vehicle that may miss the mild but currently unsigned curve.

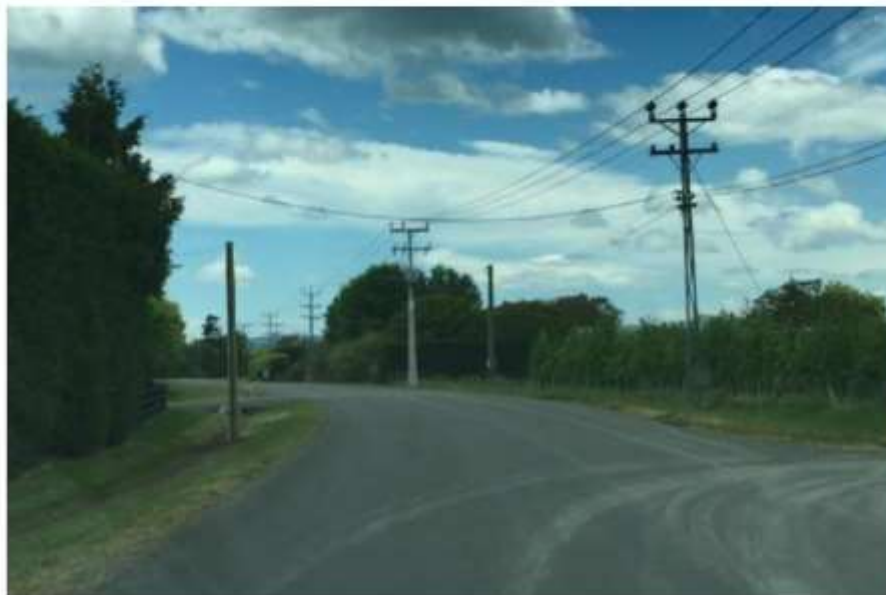
Concrete power pole on outside of curve on Gilbertson Road

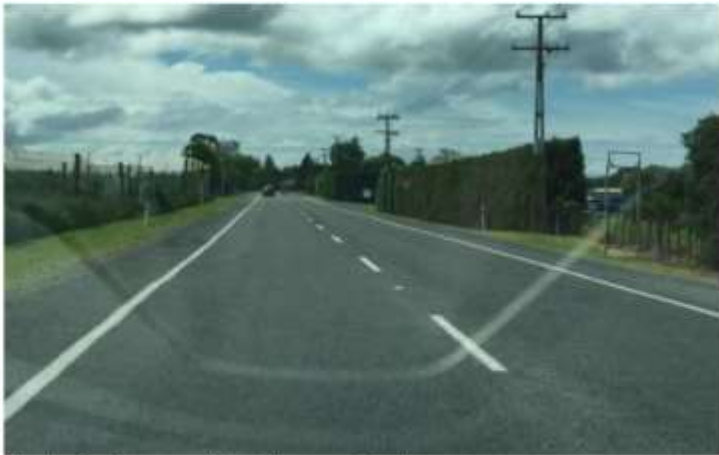
| Hastings District Council 2019 Speed Limit Assessment Napier Road | | | |
|--|---|---|---|
| Napier Road approaching Thompson Road | | | |

Napier Road is well delineated and generally straight with wide shoulders. It does not give the impression of a fully rural route as do many others we have reviewed and therefore we do not believe that an increase in the speed limit should be sought. This would also be at odds with the Safer Journeys Risk Assessment Tool. Several surveys have been carried out with 85th percentile speeds of 85 and 95 km/h being recorded. The latter is a reflection of the rural aspect of the road while the former is the speed expected on a road subject to an 80km/h speed limit.

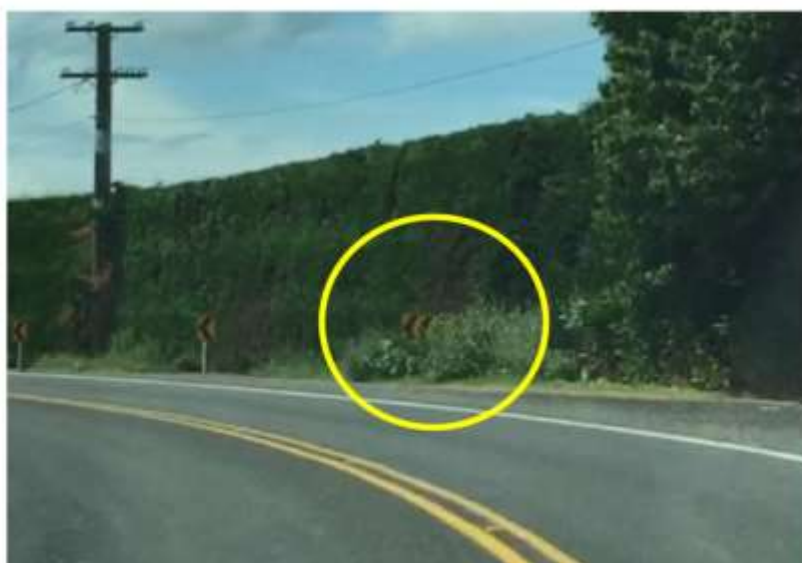
Due to the fact two crashes occurred on the same curve within the site we did consider safety improvements here. We noted that due to overgrown vegetation the chevron board on the curve north of Thompson Road was partially obscured and, as is common in Hastings, urban size signs were used on rural roads. Other than that Napier Road was one of the better quality roads reviewed as part of the speed limit assessment.

Curve sign obscured by vegetation

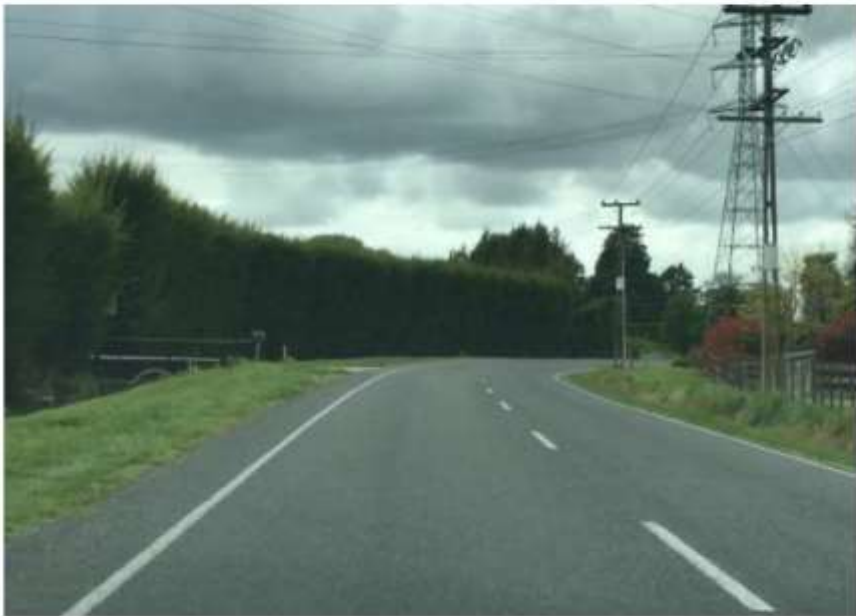
| Hastings District Council 2019 Speed Limit Assessment Omarunui Road | | | |
|--|---|---|---|
| <p>Discussion</p> <p>The section of Omarunui Road that has been identified is the 800m section between SH50 and Strome Road. This primary collector has a Low-medium collective risk and Medium personal risk with a Medium IRR band. The Safer Journeys Risk Assessment Tool indicates a safe and appropriate speed of 80km/h on this section.</p> <p>Immediately east of the Strome Road intersection is a large culvert and from there a very deep ditch runs along the northern side of Omarunui Road for around half of its length. After an unsigned curve the ditch deviates off to the left however just after the same curve tangent there is an electricity pylon with two of its legs less than 3m from the edge line, protected only by a wooden sight rail. The ditch, associated driveway culvert shown below and the pylon are significant hazards on this section of Omarunui Road.</p> | | | |
| <p><i>Deep ditch and access culvert on Omarunui Road</i></p> | | | |

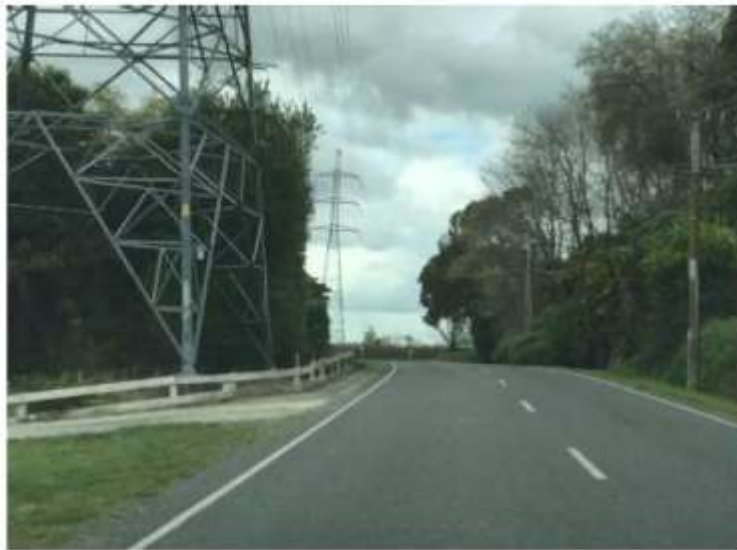
Electricity pylon within 3m of edge line on Omarunui Road

Given the hazards on this short section of road and fact that it is approaching a T intersection where the main road has a lower speed limit the introduction of what is in affect a buffer speed limit is potentially warranted. We do feel however that other work is also required on this short section of road to reduce the potential for a serious injury crash in addition to a reduced speed limit.

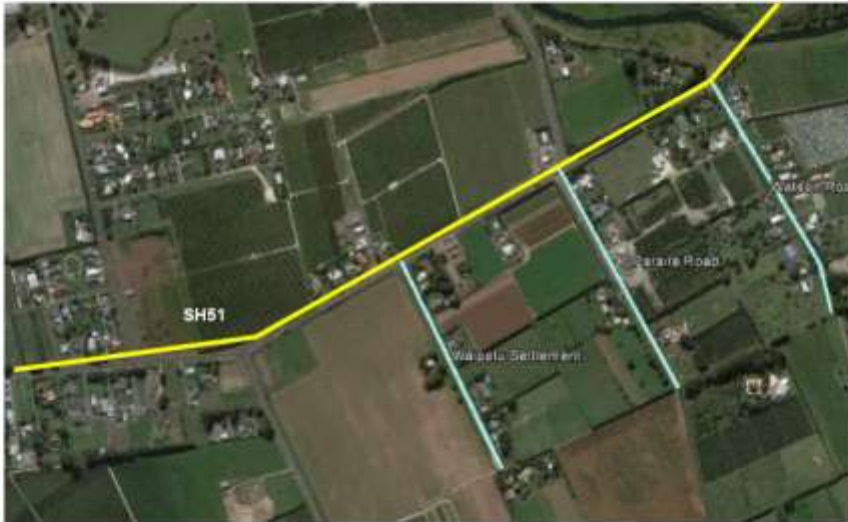
| Hastings District Council 2019 Speed Limit Assessment Watson Road, Paraire Road and Waipatu Settlement Road | | | |
|--|---|---|---|
| All three of these roads provide access to a mix of residential and commercial premises. With none of them providing a through function traffic is likely to be related to that development and is likely to consist of regular users. | | | |
| For a consistent approach if NZTA reduce the speed limit to 60km/h on SH51 then the same should be done on these three side roads. With an 85 th percentile speed of 49km/h on Waipatu Road and 52km/h on Paraire Road it is unlikely that measured speeds will change. | | | |

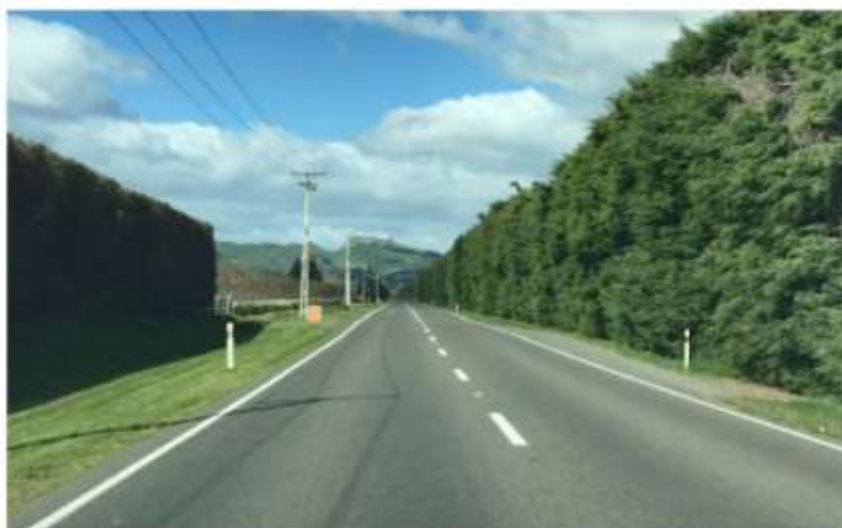
Notwithstanding the power poles on one side of this arterial road, if any roads within the district are suitable to retain the current 100km/h speed limit then this would be one of them due to its alignment and quality. The out of context curve is signed as such, the only other consideration would be that there are around 70 accesses along the approximate 5.5km length. There has been one crash recorded involving a vehicle turning in to the side road.

Te Mata Mangateretere Road looking south

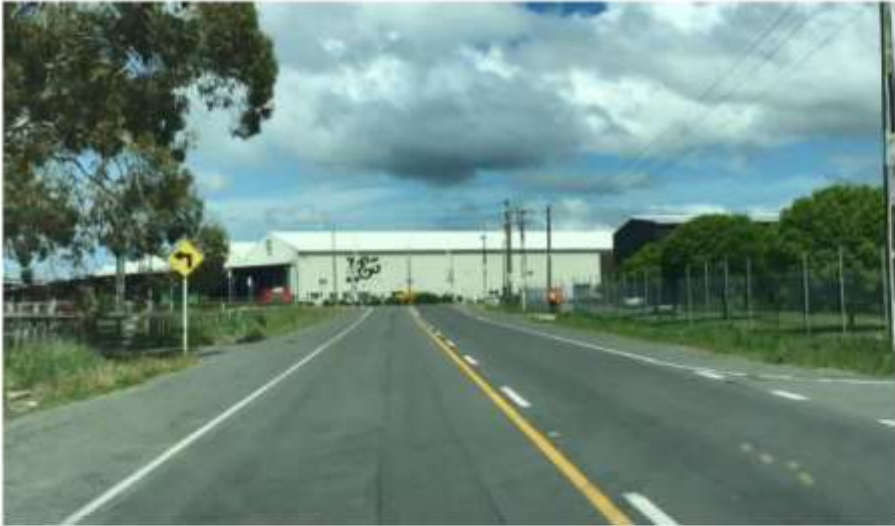
| Hastings District Council 2019 Speed Limit Assessment Whakatu Road | | | |
|--|---|---|---|
| <p>Discussion</p> <p>Whakatu Road is included in the review due to part of it being classed as a top ten percent site. The road consists of two parts, a straight connecting the new roundabout with Rangitane Road and from a right turn bay another straight connecting with Anderson Road. It is this second part that is in the top ten percent of sites. Four of the five crashes occurred at the two intersections which are both sharp 90° corners. At Anderson Road the curve is immediately south of a railway line. This curve is signed with a PW16 sign in advance but no advisory speed is provided. The curve itself has chevron signs in one direction but again no indication of a safe speed in what is currently an 80km/h speed zone.</p> | | | |
| <p><i>Whakatu Road looking south towards rail crossing</i></p> | | | |

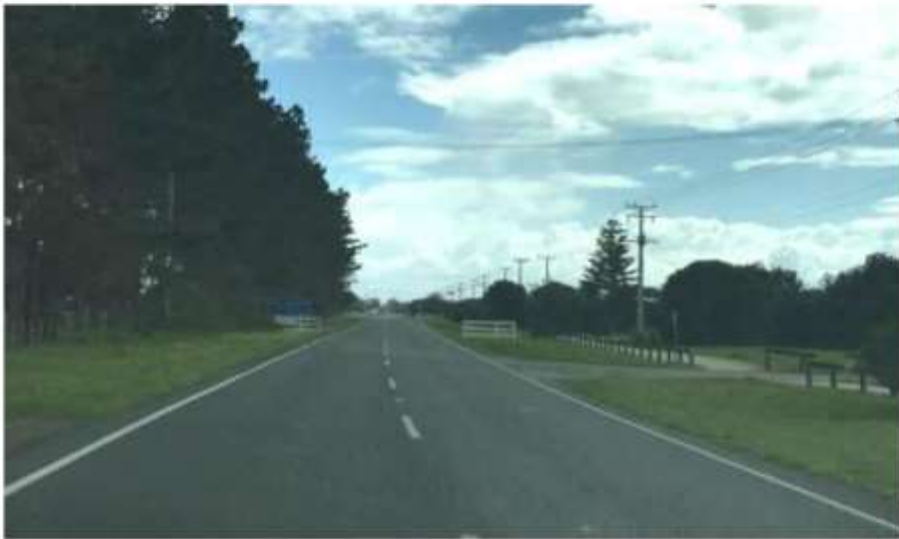
| Hastings District Council 2019 Speed Limit Assessment Clifton Road between Cape View and Te Awanga | | | |
|---|---|---|---|
| <p><i>Clifton Road showing shared path and beach access</i></p> | | | |
| <p>Clifton Road provides direct access to the beach in a number of places and has a campsite and the popular Elephant Hill vineyard within its length. Give the mixed use of this road including cyclists and horses we support the speed limit being reduced to better reflect the safe and appropriate speed of 80km/h.</p> | | | |
