Te Hui o Te Kaunihera ā-Rohe o Heretaunga
Hastings District Council
Council Meeting

DRAFT STATEMENT OF PROPOSAL

PROPOSED SPEED LIMIT
AMENDMENTS TO THE
SPEED LIMITS BYLAW 2012

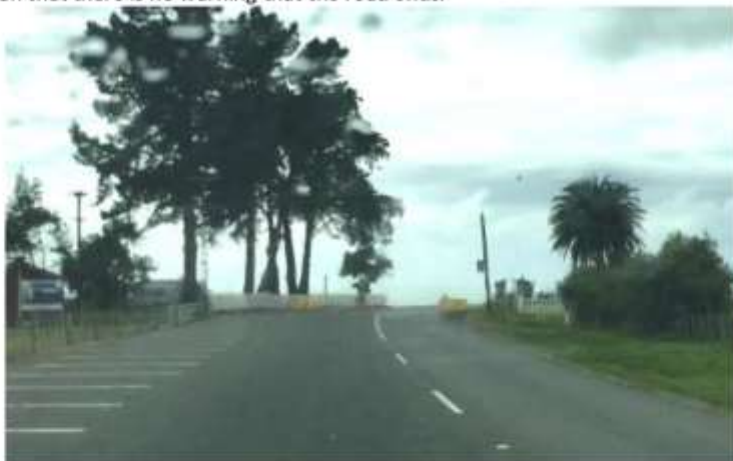
| Hastings District Council 2019 Speed Limit Assessment Clifton Road at Te Awanga | | | |
|--|---|---|---|
| View of end of Clifton Road | | | |

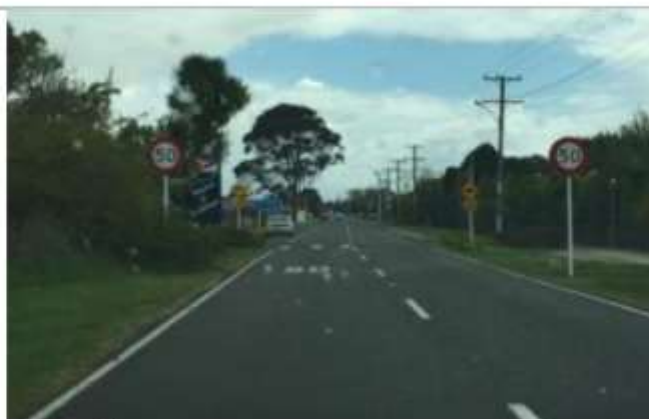
Entering Te Awanga from the south

The image above shows the starts of the 50km/h speed limit and the speed hump immediately behind it with a 20km/h advisory speed. Even if the speed limit is reduced to 80km/h it is likely that vehicles will enter the lower speed area at a speed greater than 50km/h. There is a risk due to the limited separation between the speed limit change point and speed hump that would be reduced if the speed limit was extended by around 30m to the south. This should be considered regardless of the result of consultation on the potential speed limit change out to the end of the road.

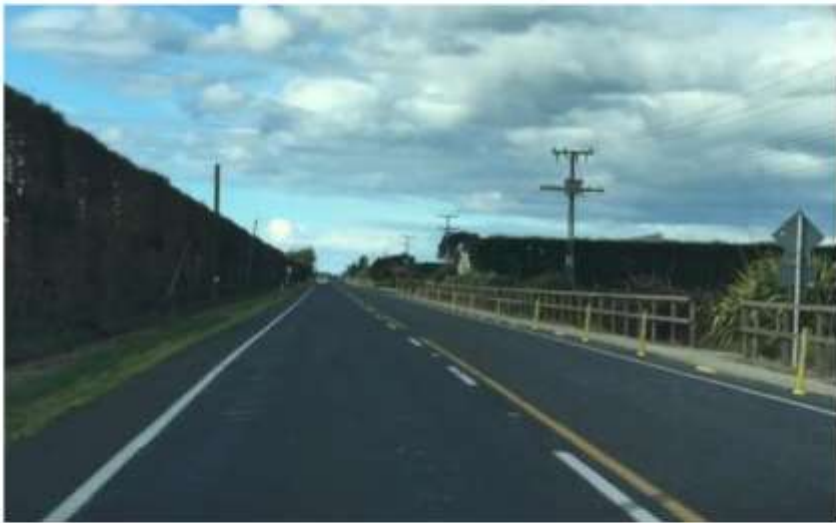
| Hastings District Council 2019 Speed Limit Assessment East Road | | | |
|---|---|---|---|
| <p><i>East Road looking north</i></p> | | | |
| <p>It would appear appropriate to commence the 80km/h speed limit at or just before the start of the right turn bay for the intersection which is 100m north of East Road on Parkhill Road therefore the full length of 100km/h speed limit on East Road should be reduced to 80km/h.</p> | | | |

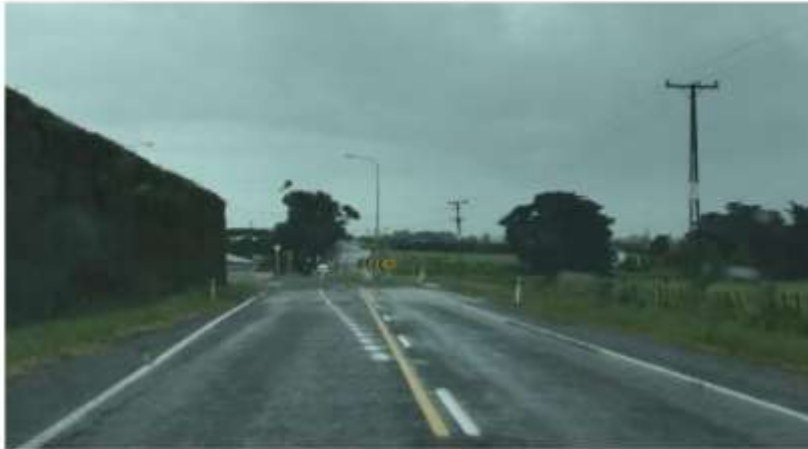
Parkhill Road looking east

The image above is taken from that approximate position and shows the sharp left hand curve and intersection directly ahead. The recommendation for this is contained in the Parkhill Road section that follows.

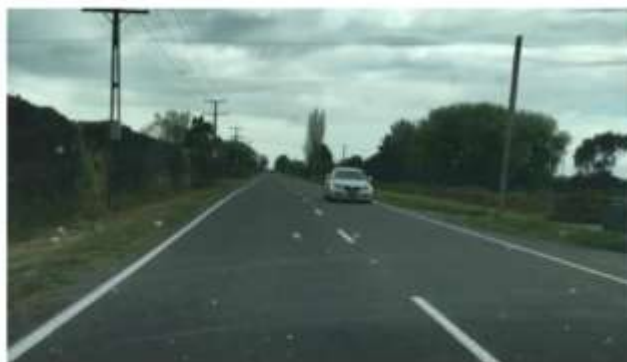
View of Lawn Road showing hazards on both sides of the road

Lawn Road is noticeably straight but has narrow shoulders and a number of hazards close to the road, including power poles and ditches. There are a number of driveways along the route, both residential and to provide access to the numerous orchards. A number of crashes have occurred at these accesses, including in 2019. For a consistent approach it would appear that 80km/h may be the appropriate speed limit, matching the calculated safe and appropriate speed and on a par with the measured 85th percentile speed. We understand that a Crash Reduction Study has recently, been undertaken on this route.

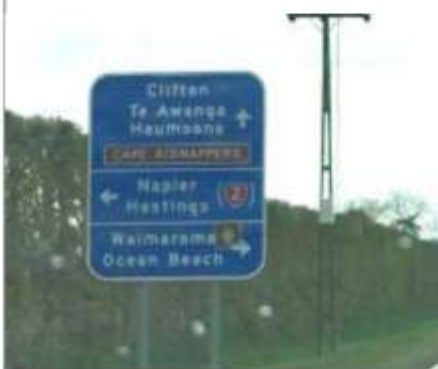
Incorrect style of sign for approach to roundabout on Lawn Road

Our site visit did note that it is unusual to find a roundabout on a 100km/h road in Hastings but there are two on Lawn Road, one at Te Mata Mangateretere Road/Pilcher Road and one at Mill Road. At Mill Road there are additional signs to warn of an intersection ahead but there is nothing to warn of the roundabout at Te Mata Mangateretere Road. The destination signs in advance of the intersection provides no indication that it is a roundabout and should be reviewed.

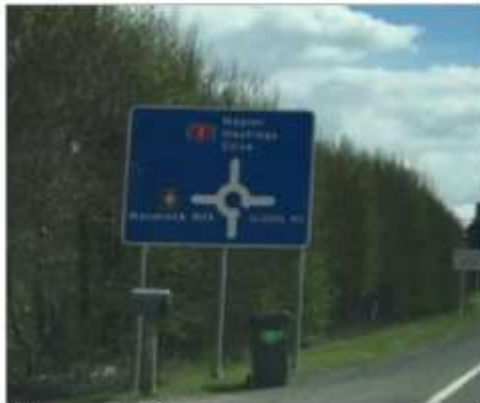
Correct style of sign for approach to roundabout (Mill Road)

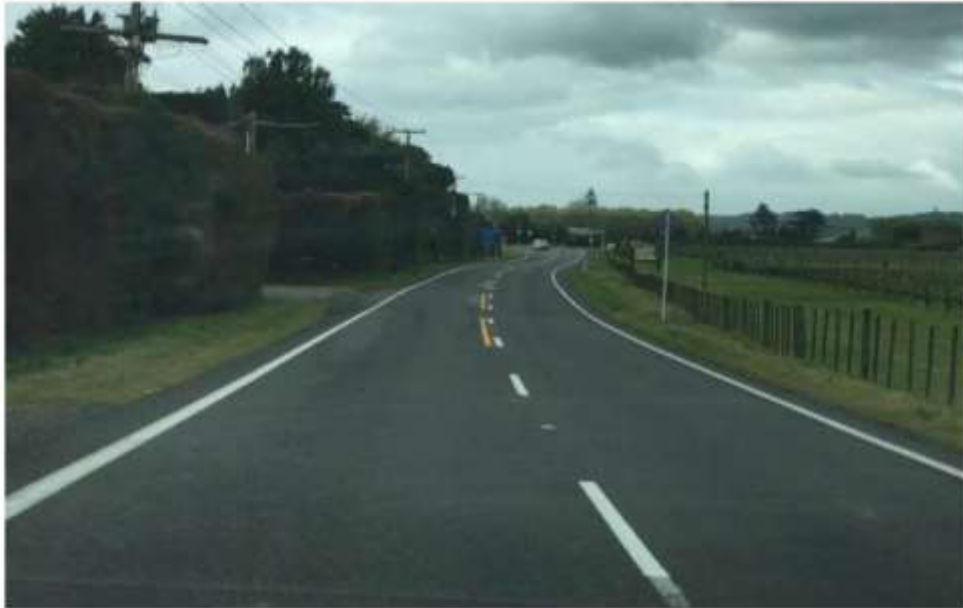
Mill Road looking south towards Tuki Tuki Road intersection

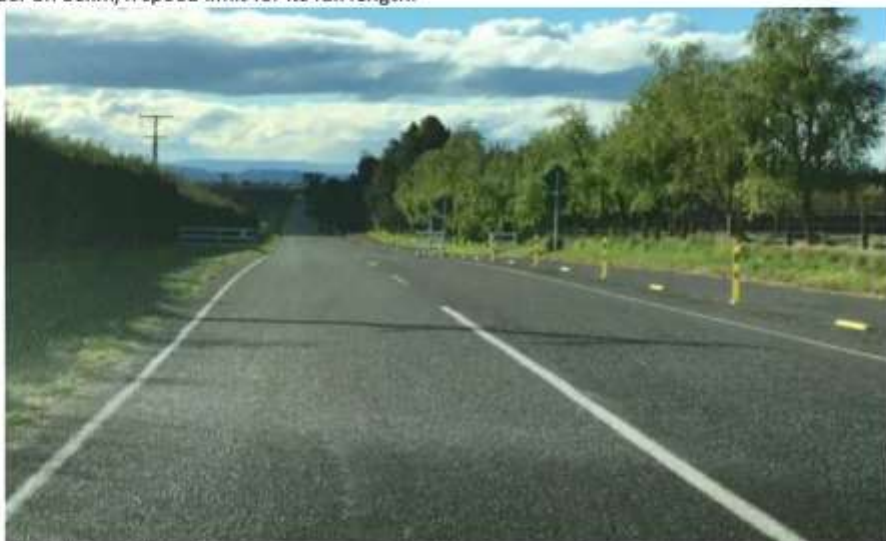
Parkhill Road looking north

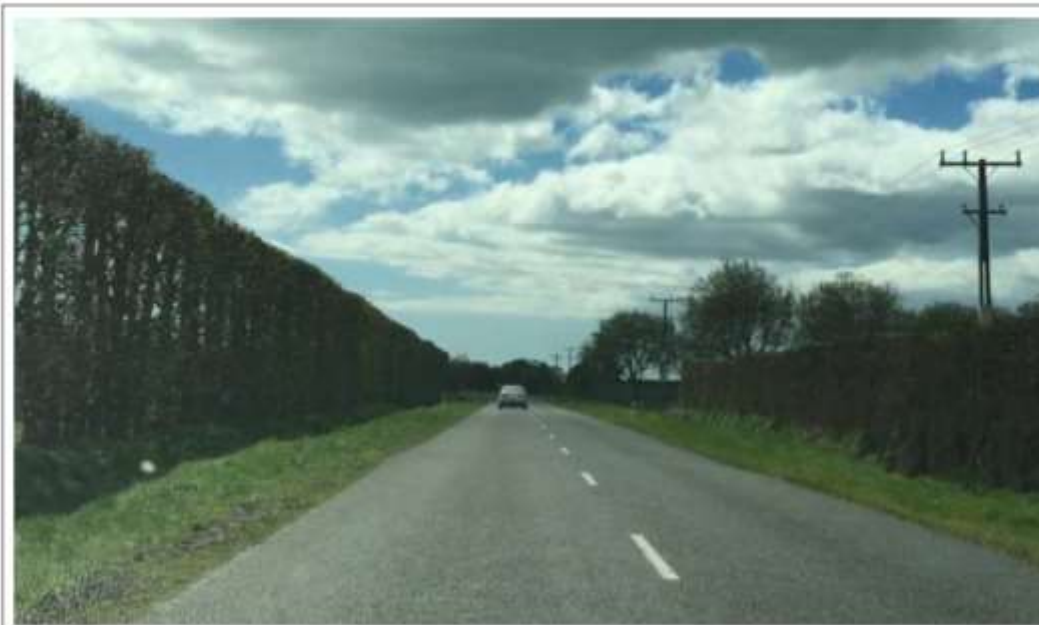
View of Tuki Tuki Road

| Hastings District Council 2019 Speed Limit Assessment Tuki Tuki Road | | | |
|--|---|---|---|
| <p>Discussion</p> <p>A significant length of Tuki Tuki Road has been identified as a top ten percent site, 5.2km between Mill Road and Moore Road to the south. Tuki Tuki Road is a secondary collector with a Medium collective and High personal risk. The IRR band is Medium on this section. It is the collective and personal risk on this section that result in the Safer Journeys Risk Assessment Tool indicating the safe and appropriate speed is 60km/h. This speed would be very difficult to achieve on this route given the fully rural outlook as shown below.</p> | | | |

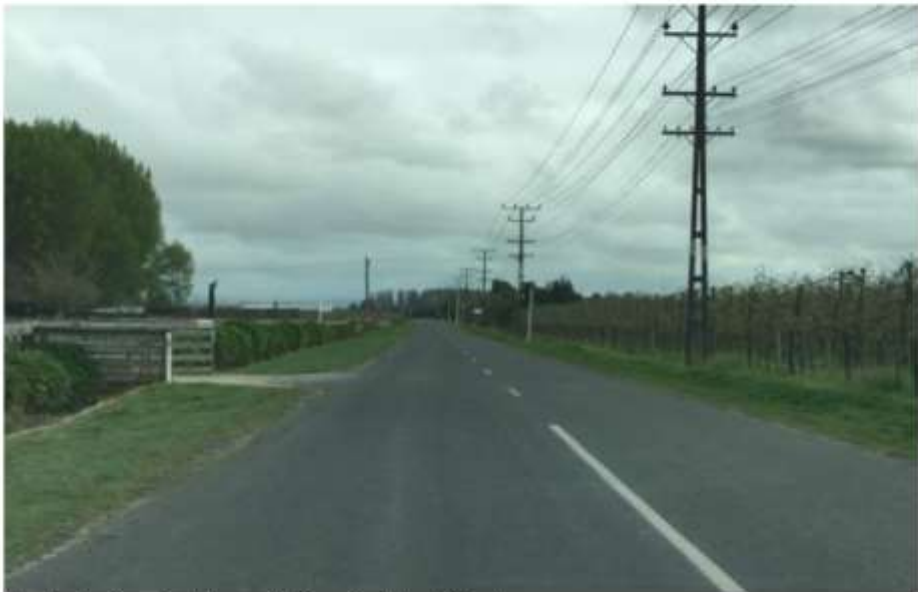
| Hastings District Council 2019 Speed Limit Assessment Heathcote Road | | | |
|--|---|---|---|
| <p><i>Heathcote Road looking north from Southland Road</i></p> | | | |

| Hastings District Council 2019 Speed Limit Assessment Heathcote Road | | | |
|--|---|---|---|
| <p>Discussion</p> <p>Heathcote Road is a fairly typical rural road on the outskirts of Hastings with power poles along one side and a relatively deep ditch on the other, with associated driveway culverts. Delineation consists solely of a centre line.</p> <p>At its northern end Heathcote Road intersects with Maraekakaho Road. The speed limit on this section of Maraekakaho Road was reduced to 80km/h in the most recent round of speed limit changes. At its southern end Heathcote Road intersects with Southland Road which also forms part of this current review.</p> | | | |

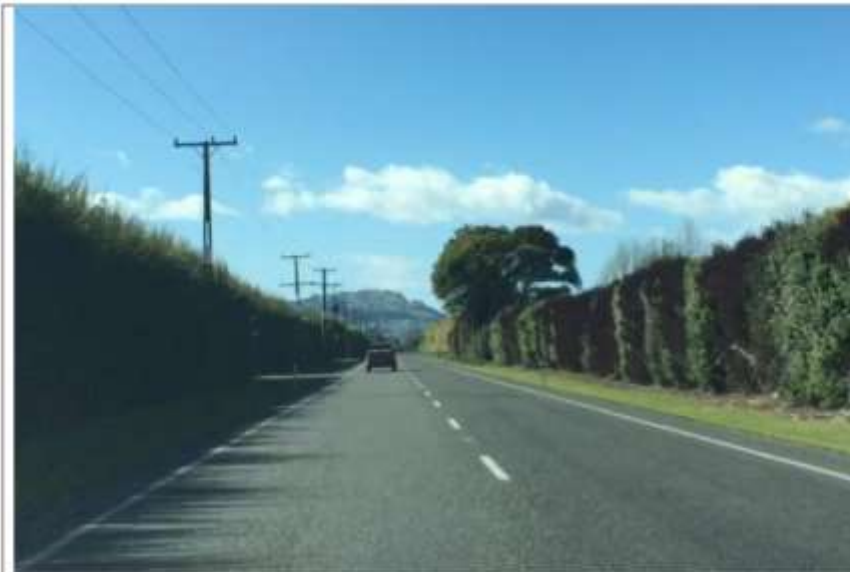
General view of Longlands Road East looking south

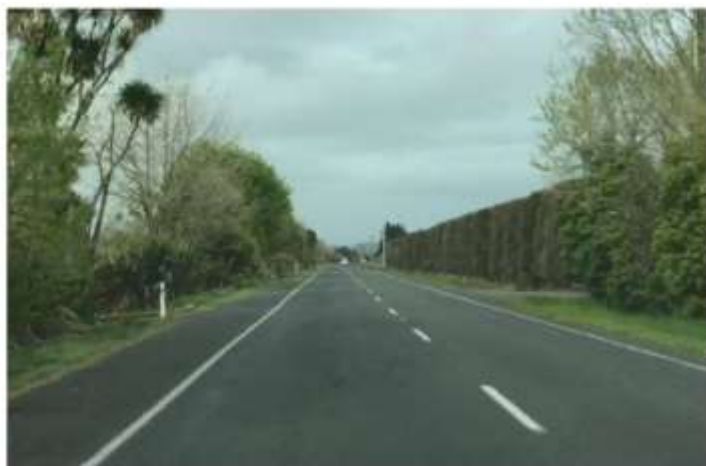
Railway Road South looking west between Longlands Road and Tollemache Road

There are other roads in the district that look similar to Railway Road South, some of which are signed as 80km/h, some 100km/h. The images above do show that towards the SH50 end the road is much more open which would generally result in higher speeds and greater difficulty with speed limit compliance.

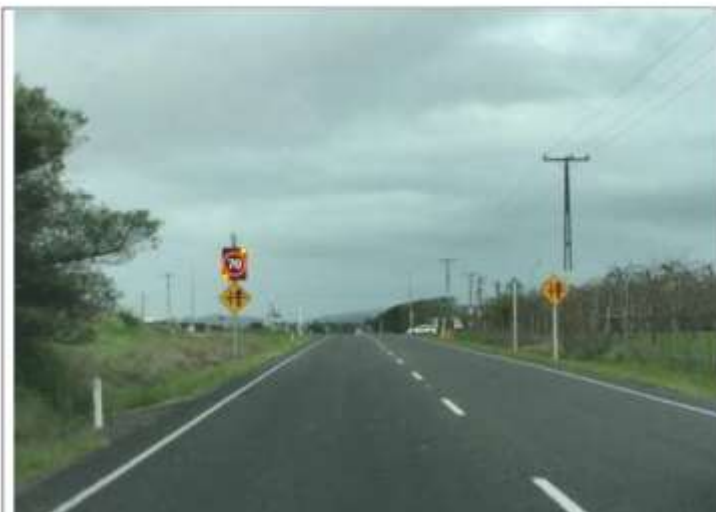
Railway Road South RIAWS in operation

This does not take in to account the number of crashes at this intersection that resulted in the RIAWS being installed. It is noted that there have been no injury crashes reported in the four years since the RIAWS was introduced at this intersection.

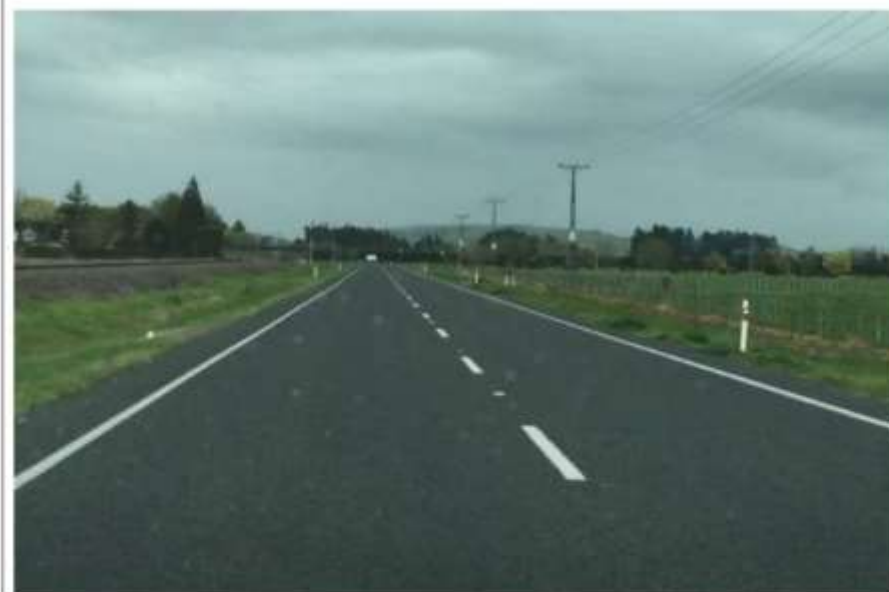
Railway Road South looking west between Longlands Road and SH50

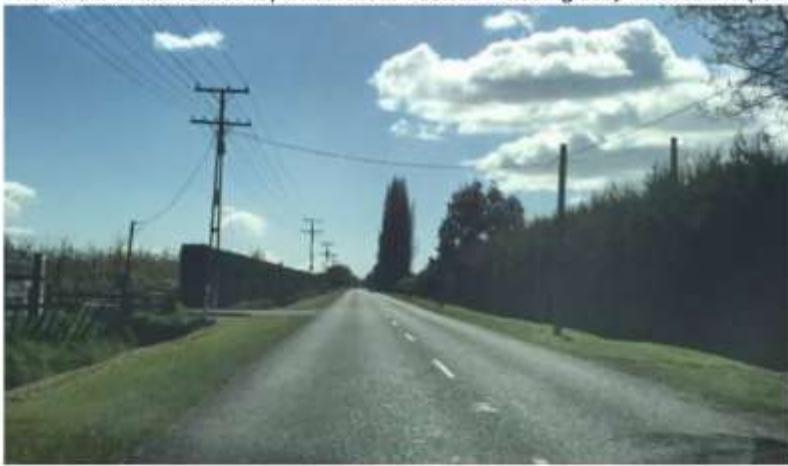
| Hastings District Council 2019 Speed Limit Assessment Riverslea Road South | | | |
|---|---|---|---|
| <p><i>Riverslea Road South looking east towards Hastings</i></p> <p>As shown above, there is no edge definition along Riverslea Road South, just a centre line and centre line RRPMS are provided.</p> | | | |

Edge definition could be improved by installing edge lines however it is unlikely that the number of hazards could be removed or protected. The 85th percentile speed of 89km/h indicates that an 80km/h speed limit would not be far from the current travel speeds and would reduce potential impact forces.

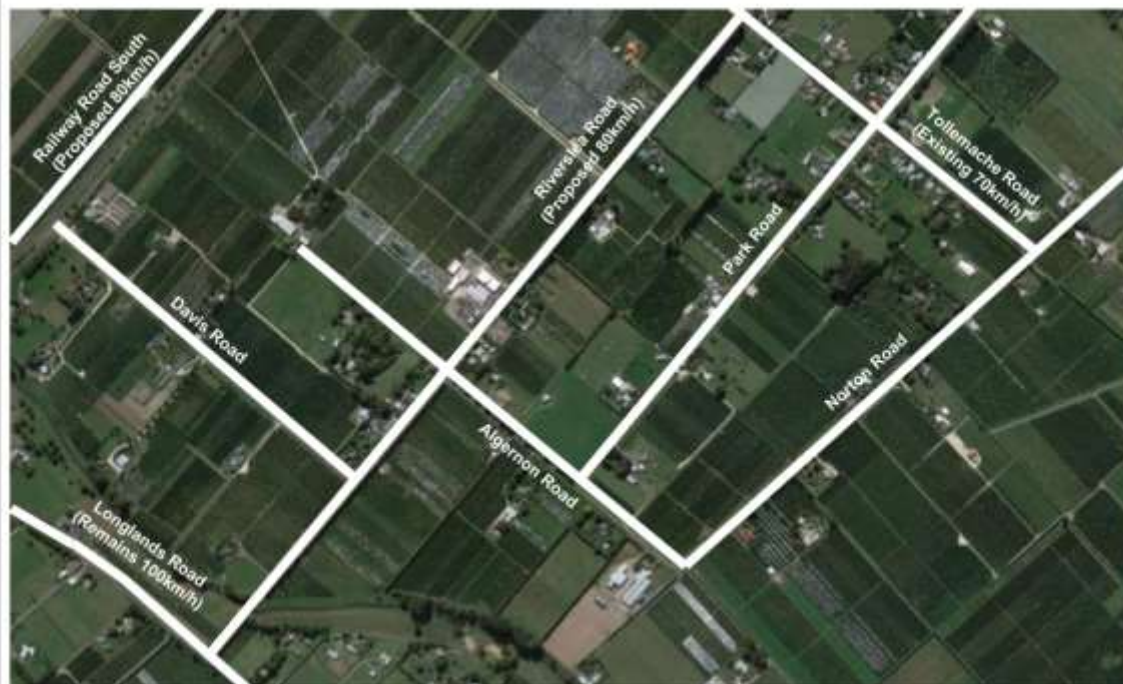
Potential area wide 80km/h area

A number of side roads will be effected by this change. Consideration should be given to an area wide 80km/h speed limit that includes Davis Road, Algernon Road, Park Road and Norton Road as shown below.

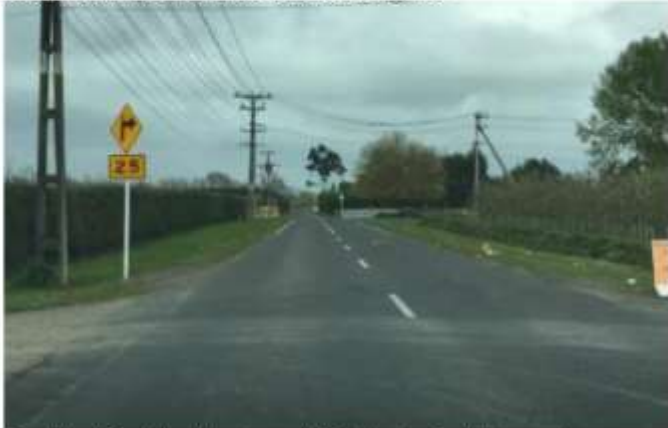
| Hastings District Council 2019 Speed Limit Assessment Southland Road | | | |
|--|---|---|---|
| <p><i>Southland Road looking towards Heathcote Road intersection</i></p> | | | |

| Hastings District Council 2019 Speed Limit Assessment Southland Road | | | |
|--|---|---|---|
| <p>5yr crash history</p> <p>The only crashes recorded on Southland Road are all at the intersection with Heathcote Road where six have been reported in the last five years, four non-injury and two minor injury. These crashes were all related to the 90° corner signed with a 25km/h advisory speed at the intersection. We note that there was one crash in 2015, one in 2016, one in 2017 and three in 2018. All but one crash occurred when it was dark.</p> <p>Five crashes involved vehicles on Southland Road failing to negotiate the right hand corner in to Heathcote while one crash involved a vehicle southbound on Heathcote that attempted to drive through the 25km/h curve at 70km/h.</p> <p>Discussion</p> <p>Southland Road is similar to other roads under review being generally flat and straight with very little delineation other than a centreline. At the T intersection with Heathcote Street edge lines are provided to guide traffic around the corner. West of this intersection Southland Road is a no exit road that provides access to a number of residential properties and orchard businesses.</p> | | | |
| <p>RAMM data shows an 85th percentile speed of 77km/h on this section of Southland Road which will be due in part to the relatively short distance between Tollemache Road and Heathcote Road. This speed is in line with the safe and appropriate speed therefore for consistency with other roads in the Akina area we are recommending that the speed limit is reduced from 100 to 80km/h.</p> <p>The main safety issue on this section of road is the intersection of Southland Road are Heathcote Road which should therefore be subject to a safety review.</p> | | | |

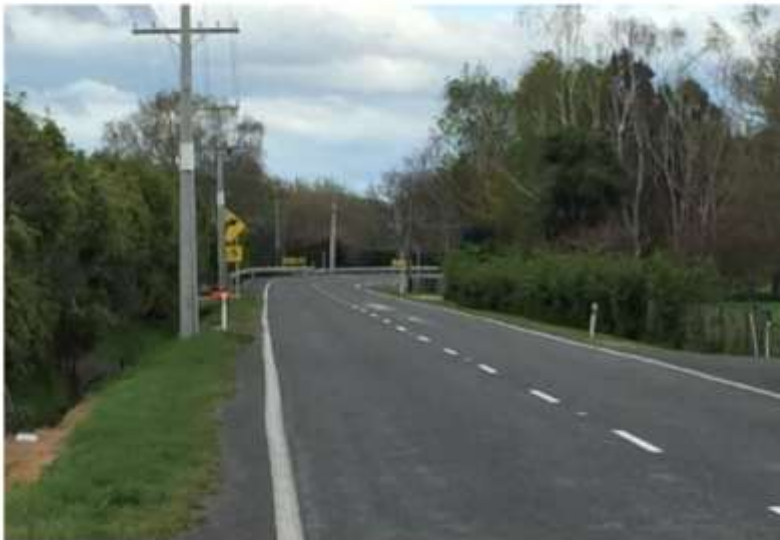
| Hastings District Council 2019 Speed Limit Assessment Te Aute Road | | | |
|--|---|---|---|
| <i>Curve on Te Aute Road</i> | | | |

| Hastings District Council 2019 Speed Limit Assessment Te Aute Road | | | |
|--|---|---|---|
| <p>The combination of IRR and collective/personal risk ratings results in a safe and appropriate speed of 60km/h on Te Aute Road. This is some way from the various speed survey results in RAMM with 85th percentile speeds of 102 and 104km/h west of Longlands Road and 87 and 89km/h to the east. It also appears somewhat at odds with the surrounding roads. These results flag an issue with the route hence the crash reduction study undertaken in 2018. A reduction in the personal risk would result in a safe and appropriate speed of 80km/h which is consistent with a number of other roads in this area west of Hastings.</p> <p>Longlands Road East intersects with Te Aute Road midway along its length which is also a point that defines the different layout of Te Aute Road both east and west. To the east of the intersection there are several curves on Te Aute Road that are provided with advisory speed signs. The two main curves also feature intersections that have a recent crash history. To the west of Longlands Road Te Aute Road has a single mild curve before a straight almost 3km in length. Whilst this is undoubtedly part of the reason for the varying speed results it also points to a potential speed limit solution.</p> | | | |

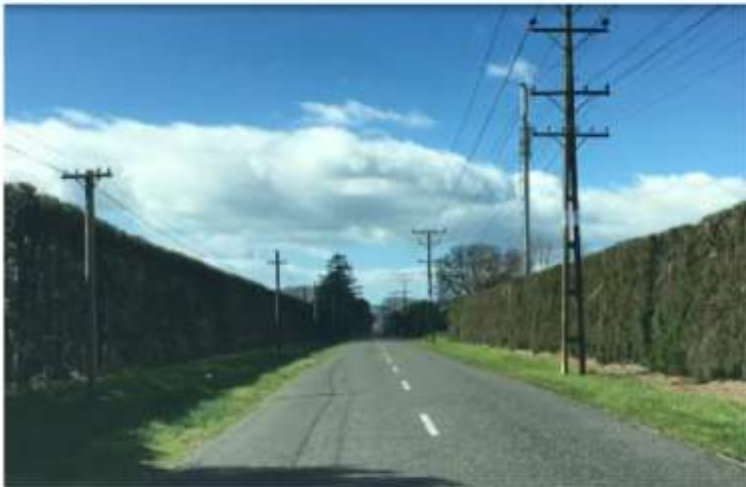
| Hastings District Council 2019 Speed Limit Assessment Tollemache Road West | | | |
|--|---|---|---|
| <p>Discussion</p> <p>This section of Tollemache Road links Southland Road to Railway Road providing a similar role to Heathcote Road a block to the north. We have recommended the speed limit be lowered to 80km/h on all of those roads. As part of an area wide speed limit change it would be prudent to reduce the speed limit to 80km/h on this section as well. The safe and appropriate speed has been calculated and while we do not have surveyed speeds it is hard to believe that they will be much higher than this given the layout of Tollemache Road shown below.</p> | | | |
| <p><i>Tollemache Road West looking south towards Railway Road</i></p> <p>The roadside environment on Tollemache Road is particularly unforgiving with power poles on both sides of the road. There have been no run off road crashes in the last five years but if any were to occur in the area shown above there is a possibility of a high severity crash due to the multiple hazards.</p> | | | |

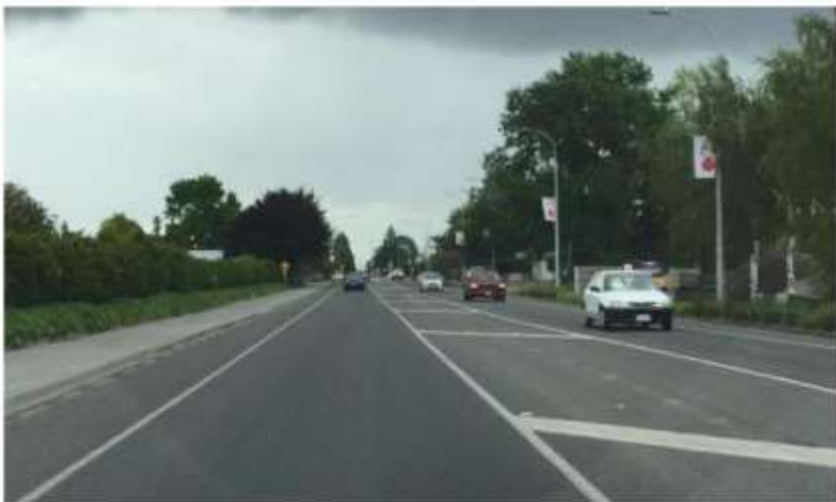
| Hastings District Council 2019 Speed Limit Assessment Havelock Road | | | |
|--|---|---|---|
| <p><i>Havelock Road between St Andrew Street and St Georges Road</i></p> | | | |

Havelock Road is the main arterial route connecting Hastings and Havelock North. The road is subject to a 70km/h speed limit from 130m south of Norton Road at the Hastings end through to a point around 160m north of the roundabout at Karanema Drive as you enter Havelock North, a distance of around 2km. Only this 400m section is a top ten percent site but this short section of 70km/h speed limit would not be lowered in isolation therefore we have considered the full length of 70km/h speed limit for this assessment.

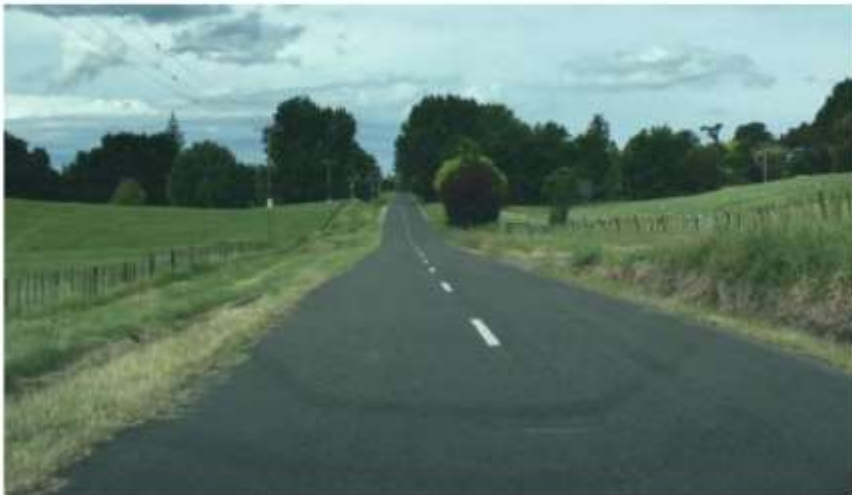
| Hastings District Council 2019 Speed Limit Assessment Iona Road | | | |
|---|---|---|---|
| <p><i>Iona Road from Middle Road end</i></p> | | | |

| Hastings District Council 2019 Speed Limit Assessment Iona Road | | | |
|---|---|---|---|
| Discussion <p>Iona Road intersects with Middle Road in a 100km/h speed limit zone on the outskirts of Havelock North. Iona Road is posted as 100km/h for the first 500m from Middle Road before it becomes 50km/h approximately 130 west of Iona Road. Iona Road gradually becomes more developed as you move further east. When turning from Middle Road, Iona Road looks very much rural as shown below -</p> | | | |
| <p>Without considering the Safer Journeys Risk Assessment Tool the above does look like a 100km/h rural road suggesting that lower speeds may be difficult to achieve. This is countered to some extent by the fact that this section of 100km/h road is only 500m in length with an intersection at one end and a 50km/h speed limit at the other. When leaving the 50km/h zone it is possible to see the intersection ahead therefore it is very unlikely that high speeds are recorded here. The 85th percentile speed recorded in RAMM is 81 km/h while the Safer Journeys Risk Assessment Tool shows an operating speed of between 55 and 59km/h.</p> | | | |

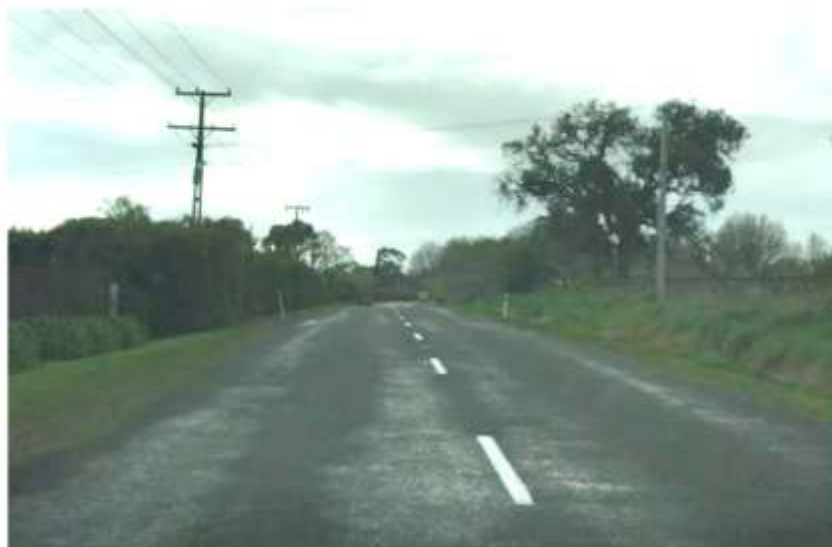
The picture below is looking east from School Road and shows how rural in nature this road looks.

Although we were requested to review the speed limit as far as School Road the above would indicate that the start of a potential 80km/h speed limit may be better closer to the Gilpin Road curve than at School Road. This would also reinforce the speed reduction required for that curve. On review a location midway between School Road and the eastern Endsleigh Road intersection appears most appropriate due to the curved nature to the east.

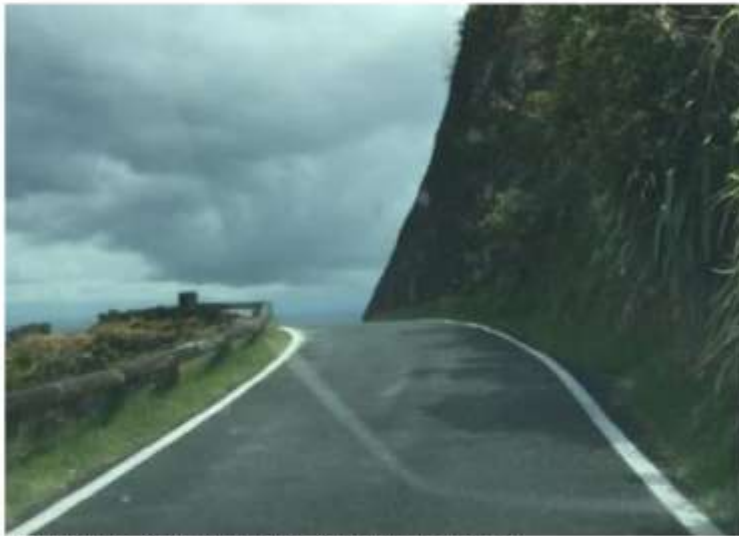
Typical view of 20km/h section of Te Mata Peak Road

Having reviewed both the upper and lower sections of Te Mata peak Road we do not believe that anything will be achieved through altering the speed limit. The 20km/h speed limit on the upper section is along the lines of the travel speeds due to the narrow road and very poor forward visibility due to crests and curves. On the 40km/h section below that the width and alignment combine to influence the travel speeds, more so than a signed speed limit would. On the lower section the 60km/h speed limit reflects the fact that the road is not fully urbanised. The change points for the 20 and 40km/h speed limits do appear logical therefore we see no changes required to the posted speed limits. There were however a number of safety concerns identified during our review.

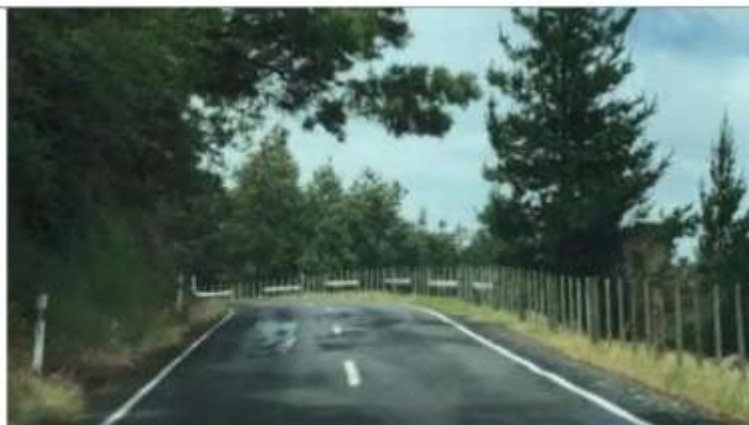
Unorthodox curve delineation

On one of the higher speed curves on the lower slopes some form of delineation is provided by fixing wooden planks to the fence as shown on the following page.

Correctly placed edge markers would perform the same function but also be visible in the dark and in poor weather conditions. Further up the hill the sporadic use of edge marker posts stops. Occasionally some signs can be seen however they are either poorly placed, too small or a combination of both -

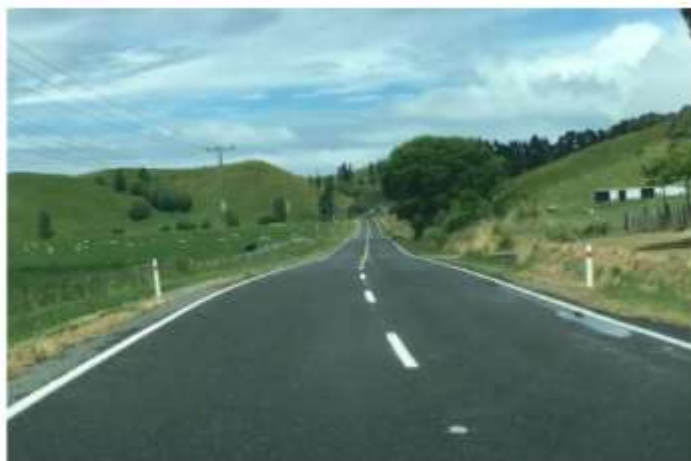
Open nature of parts of Waimarama Road

The photo above shows part of this section of Waimarama Road. If the alignment severity is reduced from being tortuous to reflect the mixed nature the IRR rating improves and the calculated safe and appropriate speed becomes 80km/h. This does appear to be a much more realistic travel speed for this road.

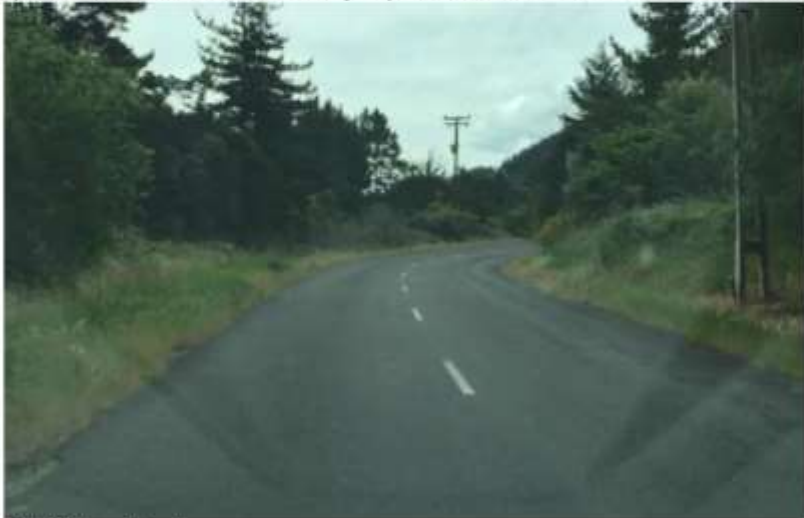
| Hastings District Council 2019 Speed Limit Assessment Ellis Wallace Road | | | |
|--|---|---|---|
| <i>Ellis Wallace Road</i> | | | |

| Hastings District Council 2019 Speed Limit Assessment Ellis Wallace Road | | | |
|--|---|---|---|
| <p>Ellis Wallace Road is provided solely with a centre line. There are a number of sharp curves on this road that are either unsigned or are provided with single chevrons. Whilst there are no reported crashes on this route that may simply be due to the remote nature and potentially low speed of incidents on some of the unsigned curves. A review of curve signage and delineation should be undertaken to identify any gaps.</p> | | | |

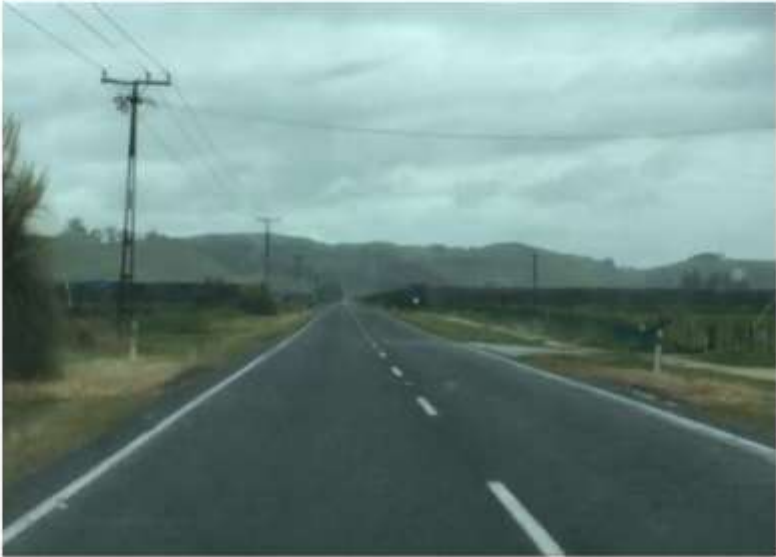
| Hastings District Council 2019 Speed Limit Assessment Ngatarawa Road | | | |
|---|---|---|---|
| Discussion <p>Ngatarawa Road is a long straight road that is not conducive to low speeds. The northern half of the road has little residential development being mainly orchards but the southern half is very much rural residential.</p> <p>The Safer Journeys Risk Assessment Tool shows the full length of Ngatarawa as one node therefore the above results are for the full length. It is clear however that if the two halves were looked at in isolation then the southern half towards the Hastings Aerodrome would achieve a higher IRR rating.</p> <p>It is not clear where the speed surveys were taken but the roadside environment as a result of the residential development at the southern end would suggest lower travel speeds are likely at that end. The development along Ngatarawa Road stretches along 2km of the route.</p> <p><i>Northern section of Ngatarawa Road</i></p> <p>On the section of Ngatarawa Road shown above an 80km/h speed limit would be inconsistent with other routes under consideration. With no crashes on this section of road there does not appear to be any need to reduce the posted speed limit.</p> | | | |

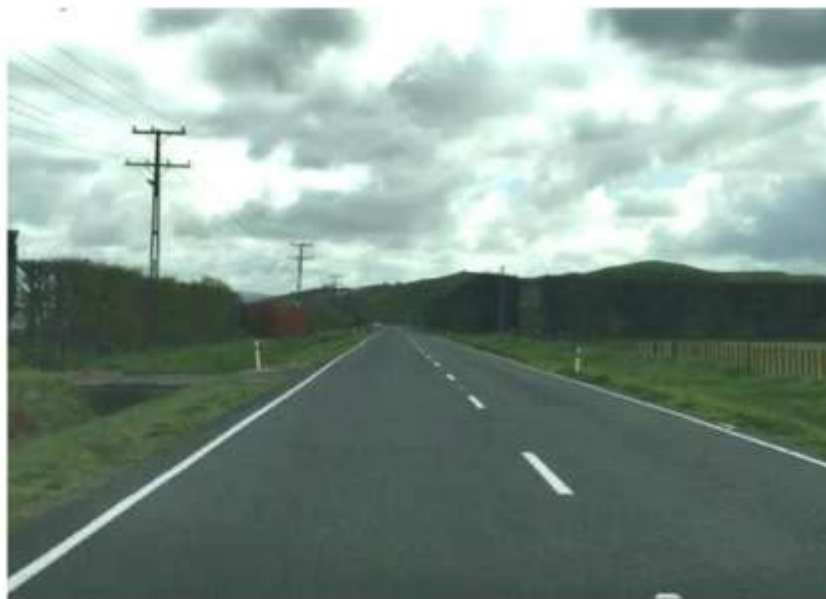
Swamp Road looking north

As shown below, there is a relatively deep water channel on one side of the road with associated driveway culverts-

The majority of crashes on Swamp Road are single vehicles leaving the road. One run off road crash became a fatal crash after the vehicle rolled and came to rest upside down in the water filled ditch. Although that crash was not thought to be speed related a number of other crashes have resulted in vehicles hitting culverts and rolling. Lower travel speeds would reduce the impact forces and improve reaction times.

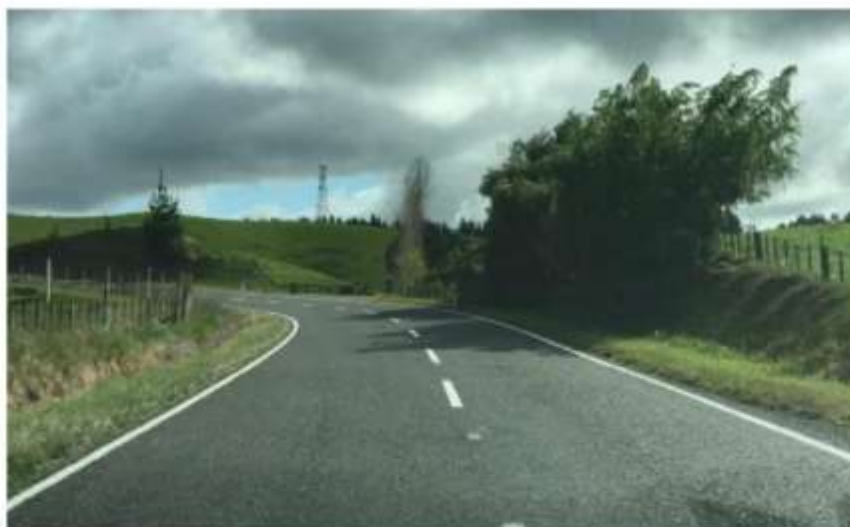
Typical curve on Taihape Road with no curve signage

General delineation levels were found to be very good, particularly in relation to some of the routes elsewhere in the district that have been reviewed. Edge lines, edge marker posts and RRPMS were all provided and were generally in very good condition. We did find however that not all curves where a reduction in travel speed was required provided sufficient warning to an approaching motorist. It could be argued that reduced vehicle speeds would negate the need for this but this assumes that a change in speed limit will result in a change in travel speeds which is not guaranteed on a primary collector such as this.

Over half of the crashes on the route (61 percent) were loss of control on curves. The majority of these crashes occurred on a wet road surface with travelling too fast for the conditions considered a factor in more than half of them. It is quite possible therefore that an improvement in curve delineation will result in a reduction in crashes along this popular route.

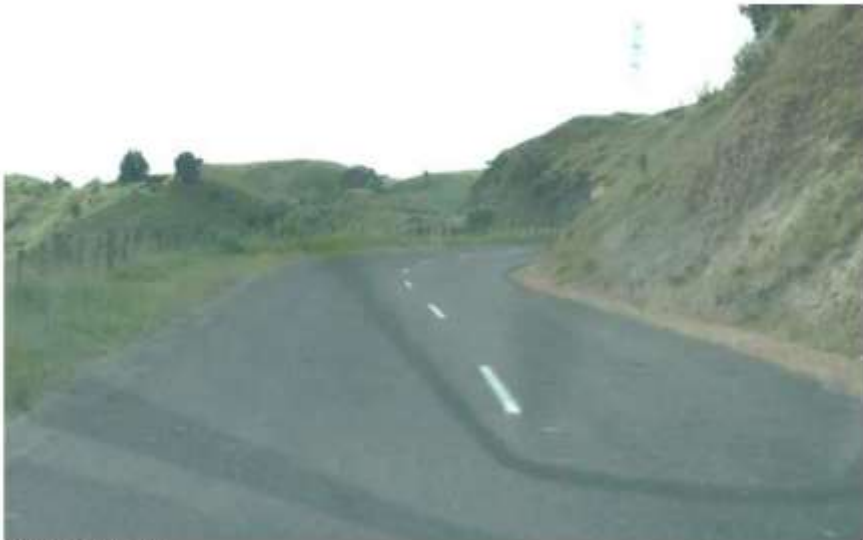
| Hastings District Council 2019 Speed Limit Assessment Waipunga Road | | | |
|--|---|---|---|
| <i>Waipunga Road</i> | | | |

| Hastings District Council 2019 Speed Limit Assessment Waipunga Road | | | |
|--|---|---|---|
| <p>Waipunga Road is similar to Ellis Wallace Road other than it is steeper and longer. Whilst the traffic count suggests a lower volume, logging operations were being carried out at the time of our site visit which significantly increased the number of vehicles using this road. With a Low collective and Low personal risk it is the IRR of Medium-high that results in a safe and appropriate speed of 60km/h. This is a winding road with significant roadside hazards.</p> | | | |

| Hastings District Council 2019 Speed Limit Assessment Waipunga Road | | | |
|--|---|---|---|
| <p>On certain sections of the road, particularly in the downhill direction towards SH5, it is easy to pick up speed however the alignment is such that vehicles are unlikely to exceed 80km/h. The 85th percentile speed of 56km/h does seem quite low however if the survey was carried out while logging was underway this would be explained by the slow speed that logging trucks travel in both directions. Due to the curvilinear nature of the road and its width logging trucks do cross the centre line at some locations. For the same reasons as Ellis Wallace Road, an 80km/h speed limit would reflect the speeds that are being travelled while a 60km/h speed limit would appear unrealistic on such a rural road. Council could consult on an 80km/h speed limit if it wished but this may not result in a change in actual vehicle speeds.</p> | | | |

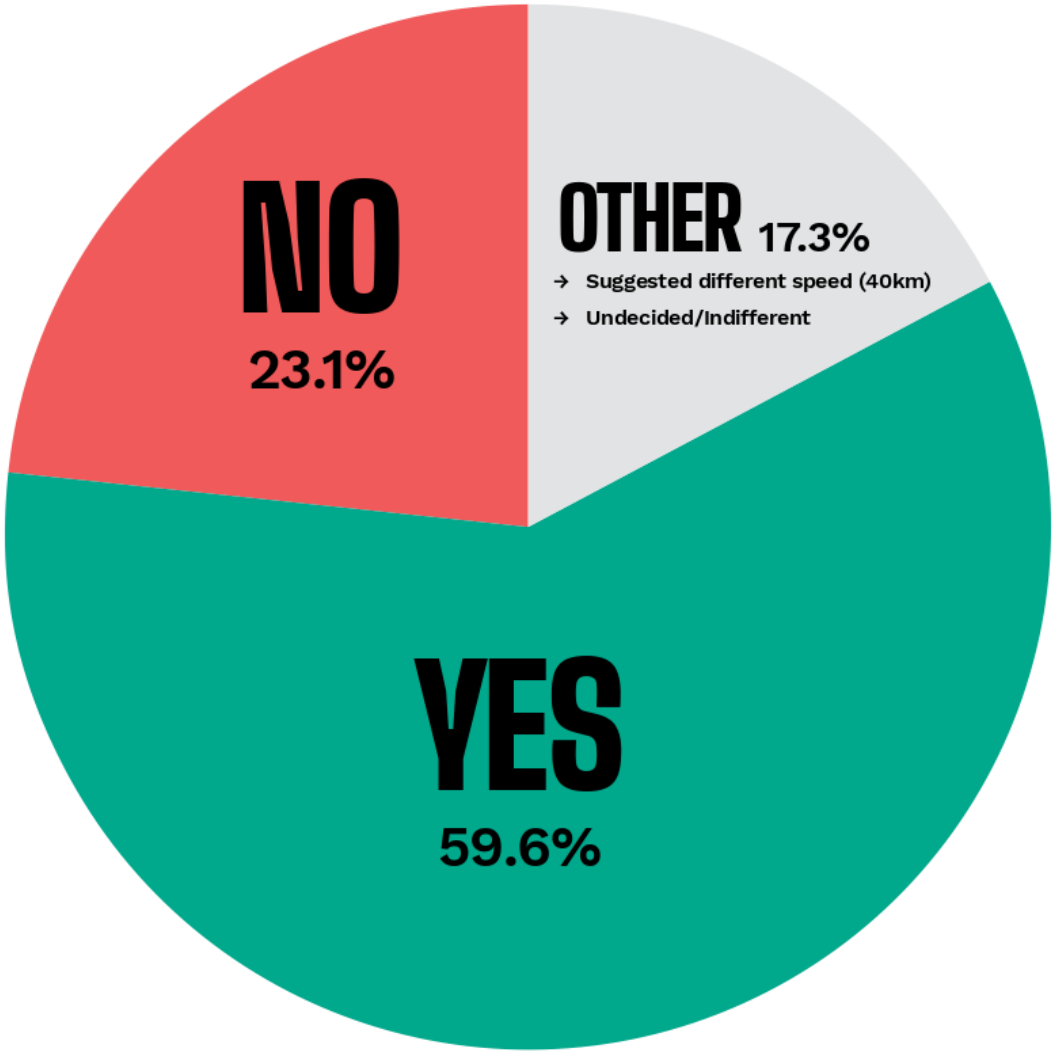
Do you support the proposed speed change to the Havelock North CBD?
